Mold Assessment-Protocol Report

For Bunnell Courthouse  
200 East Moody Blvd.  
Bunnell FL.

Date: January 12, 2014

Job #: 13-235-2

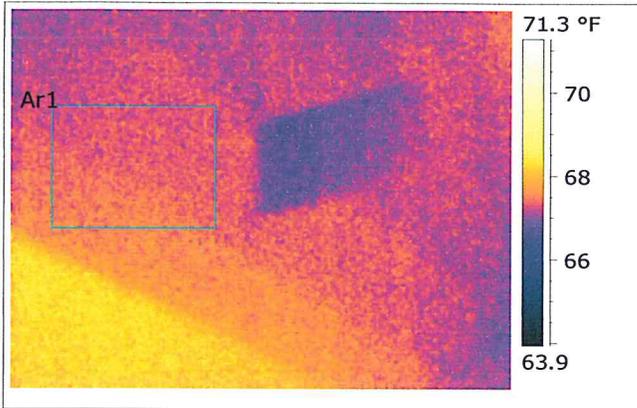
Date	12/30/2013	Location:	<b>New Building- First Floor- Room 104</b>
Image Time	2:06:48 PM	<b>Other remarks:</b>	
Ar1 Max. Temperature	68.0 °F	Wall:	Acceptable
Ar1 Min. Temperature	66.9 °F	Ceilings:	Acceptable
Ar1 Average Temperature	67.4 °F	Lab Results:	<b>Room Air Test-52,560 c/m3</b>
Air Temperature 1	69.8 °F		<b>Supply Vent- 0</b>
Relative Humidity 1	53.9 %	Mold Rating:	<b>5</b>
		Mold Rating:	1-5 (5 being worst)

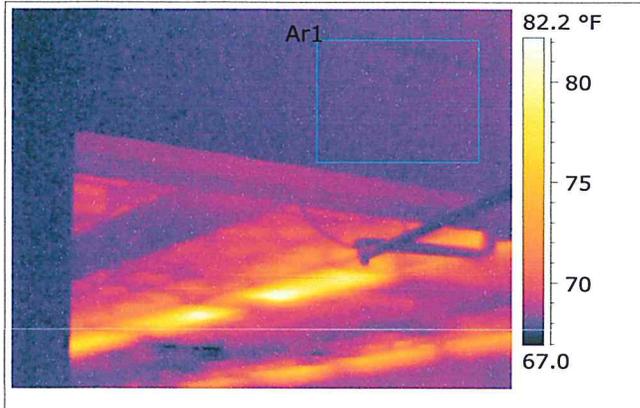
Date	12/30/2013	<b>Location:</b> New Building-First Floor-Room 107 <b>Courtroom</b>
Image Time	3:06:07 PM	
Ar1 Max. Temperature	68.7 °F	
Ar1 Min. Temperature	67.5 °F	
Ar1 Average Temperature	68.1 °F	
Air Temperature 1	70.7 °F	
Relative Humidity 1	52.0 %	
<b>Other remarks:</b> Wall: Acceptable Ceilings: Waste Drain-Leak was visable Lab Results: <b>Room Air Test- 54.960 c/m3</b>  Mold Rating: <b>5</b>  Mold Rating: 1- <b>5</b> ( <b>5</b> being worst)

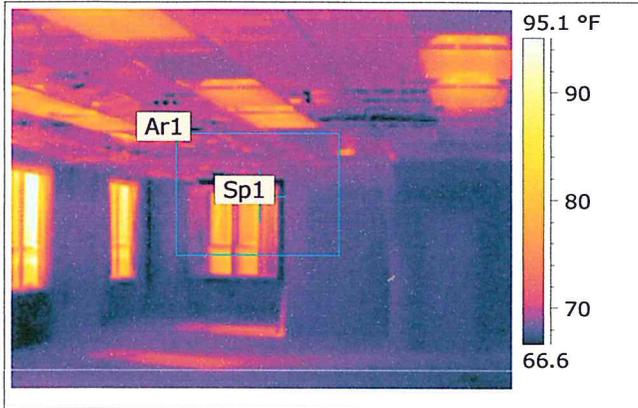
Date	12/30/2013	Location: <b>New Building-First Floor-Room 135</b>
Image Time	10:58:50 AM	
Ar1 Max. Temperature	83.5 °F	<b>Other remarks: Drain in bathroom show previous leaking, noted by orange arrow.</b>  <b>Ceiling in room does not show any evidence of water intrusion.</b>
Ar1 Min. Temperature	66.0 °F	
Ar1 Average Temperature	70.4 °F	
Sp1 Temperature	73.2 °F	
Air Temperature 1	72.1 °F	
Relative Humidity 1	52.7 %

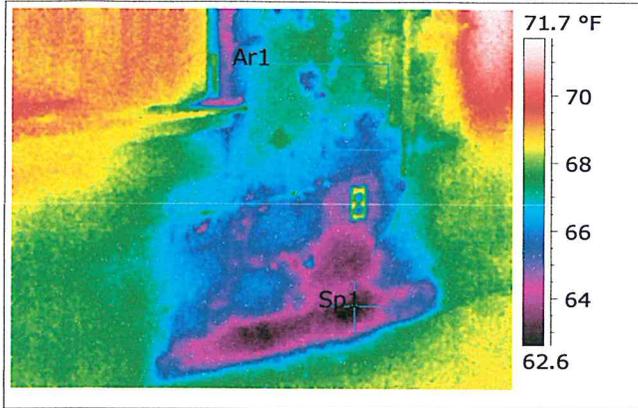
Date	12/30/2013	<b>Location: New building-First Floor-Room 137</b>  Wall: Water intrusion by window, walls high in moisture content Ceilings: Acceptable Lab Results: <b>Room Air Test- 253 c/m3</b>  Mold Rating: 2  Mold Rating: 1-5 (5 being worst)
Image Time	4:06:52 PM	
Ar1 Max. Temperature	68.4 °F	
Ar1 Min. Temperature	64.9 °F	
Ar1 Average Temperature	66.8 °F	
Sp1 Temperature	62.7 °F	
Air Temperature 1	71.6 °F	
Relative Humidity 1	53.8 %

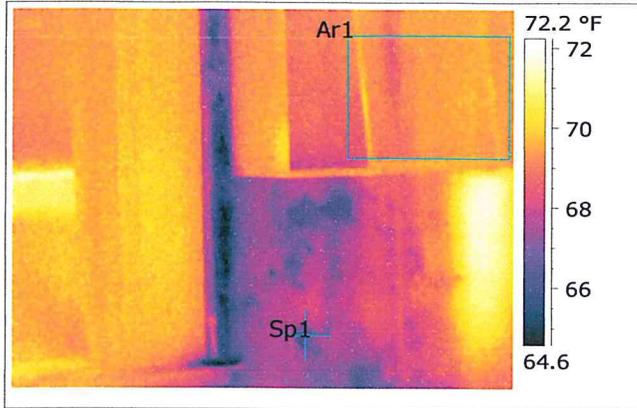
Date	12/30/2013	Location:	Room 137
Image Time	4:07:19 PM	<b>Other remarks:</b>	
Ar1 Max. Temperature	70.4 °F	Wall: Very high moisture readings on outer walls	
Ar1 Min. Temperature	68.0 °F	Lab Results: <b>Wall Swab Test- 2,037 c/m2</b>	
Ar1 Average Temperature	69.3 °F	<b>ATP Test confirmation: 450</b>	
Sp1 Temperature	66.5 °F	Mold Rating: <b>4</b>	
Air Temperature 1	71.6 °F	Mold Rating: 1- <b>5</b> ( <b>5 being worst</b> )	
Relative Humidity 1	53.8 %

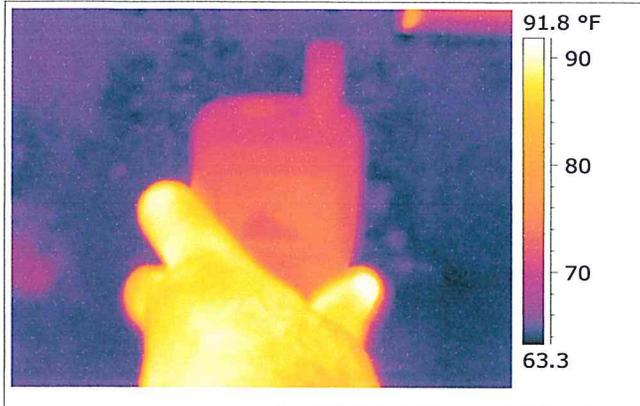
Date	12/30/2013	Location:	Room 137
Image Time	4:12:02 PM	<b>Other remarks:</b>	
Air Temperature 1	70.9 °F	Wall: Internal moisture is high at 37 %	
Internal Moisture 1	33.7 %

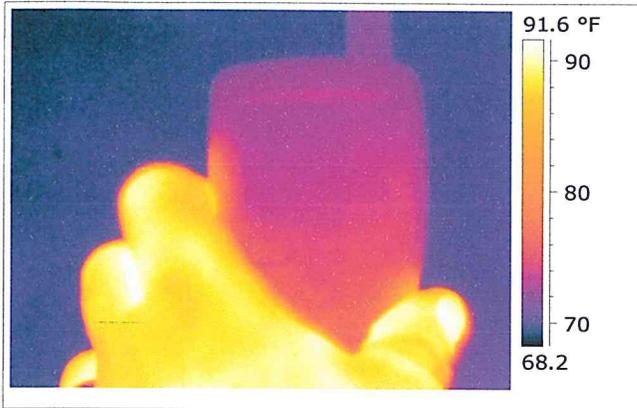
Date	12/30/2013	Location:	Room 137
Image Time	4:12:40 PM	<b>Other remarks:</b>	
Air Temperature 1	71.1 °F	Wall: The meter is showing highest possible reading for moisture	
Internal Moisture 1	99.9 %

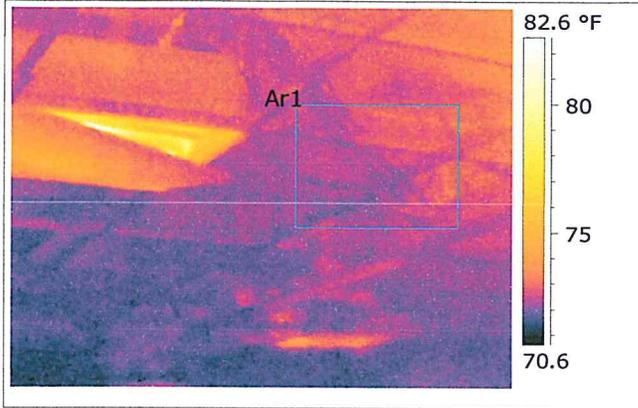
Date	12/31/2013	Location:	New Building-Second Floor-Main Hallways
Image Time	11:04:07 AM	<b>Other remarks:</b>	
Ar1 Max. Temperature	73.6 °F	Wall: Acceptable	
Ar1 Min. Temperature	71.6 °F	Ceilings: Evidence of previous water intrusion around the conduit by the elevators.	
Ar1 Average Temperature	72.5 °F	Lab Results: <b>Swab Test of ductwork- 532,149 c/m3</b>	
		Mold Rating: <b>5</b>	
		Mold Rating: 1- <b>5</b> ( <b>5</b> being worst)

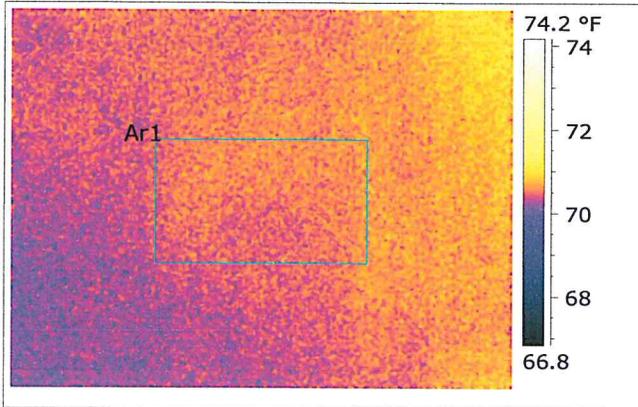
Date	12/31/2013	Location: <b>New Building-1<sup>st</sup>. Floor-Courtroom 3</b>  <b>Other remarks:</b>  <b>Room Air Test: 19,307 c/m3</b>
Image Time	9:59:38 AM	
Ar1 Max. Temperature	71.1 °F	
Ar1 Min. Temperature	70.0 °F	
Ar1 Average Temperature	70.5 °F	
Air Temperature 1	72.3 °F	
Relative Humidity 1	53.8 %

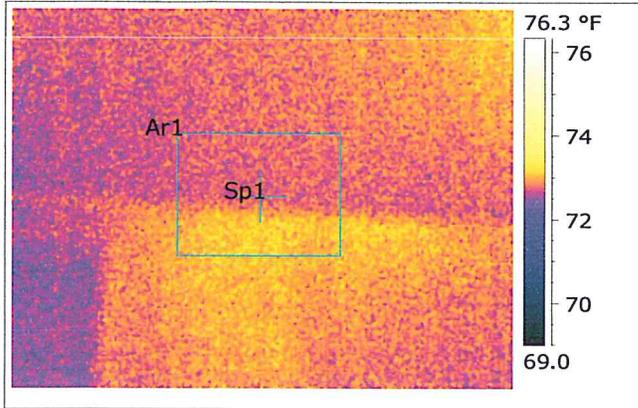
Date	12/31/2013	<table border="1"> <tr> <td>Location:</td> <td><b>New Building-2<sup>nd</sup> Floor- Courtroom 218</b></td> </tr> </table> <p><b>Other remarks:</b></p> <p>Wall: Acceptable Ceilings: Acceptable</p> <p>Lab Results: <b>Room Air Test- 36,387 c/m3</b></p> <p>Mold Rating: <b>5</b></p> <p>Mold Rating: 1-<b>5</b> (<b>5</b> being worst)</p>	Location:	<b>New Building-2<sup>nd</sup> Floor- Courtroom 218</b>
Location:	<b>New Building-2<sup>nd</sup> Floor- Courtroom 218</b>			
Image Time	1:37:28 PM			
Ar1 Max. Temperature	73.5 °F			
Ar1 Min. Temperature	72.3 °F			
Ar1 Average Temperature	72.9 °F			
Sp1 Temperature	72.7 °F			
Air Temperature 1	74.3 °F			
Relative Humidity 1	48.4 %

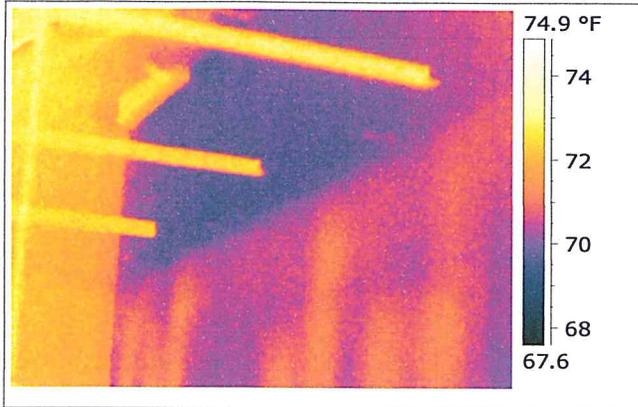
Date	12/31/2013	Location:	(Where)
Image Time	1:45:32 PM	<b>Other remarks:</b>	
Air Temperature 1	74.3 °F	Wall: Paneling	
Relative Humidity 1	48.1 %	Ceilings: Acceptable	
		Lab Results: <b>Room Air Test- 23,547 c/m3</b>	
		Mold Rating: <b>5</b>	
		Mold Rating: 1-5 (5 being worst)

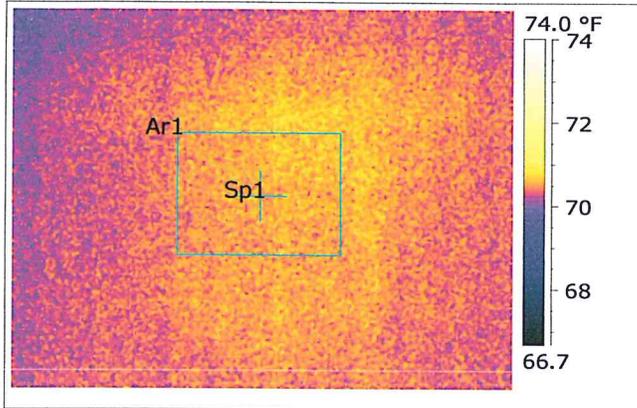
Date	12/31/2013	Location:	New Building-2 <sup>nd</sup> Floor- Men's Room
Image Time	1:09:10 PM	<b>Other remarks:</b>	
Ar1 Max. Temperature	71.1 °F	Wall:	Acceptable
Ar1 Min. Temperature	70.0 °F	Ceilings:	Acceptable
Ar1 Average Temperature	70.6 °F	Lab Results:	<b>Room Air Test- 270,893 c/m3</b>
Sp1 Temperature	70.5 °F	Mold Rating:	<b>5</b>
Air Temperature 1	72.9 °F	Mold Rating:	1- <b>5 (5 being worst)</b>
Relative Humidity 1	53.5 %

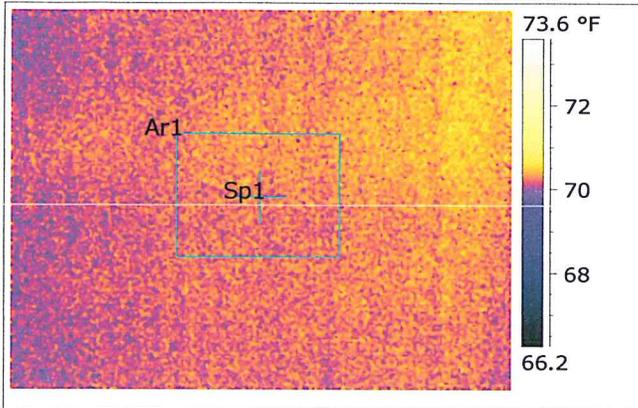
Date	12/31/2013	Location: <b>New Building- 2<sup>nd</sup> Floor-Court Reporter room</b>
Image Time	1:17:26 PM	
Ar1 Max. Temperature	70.8 °F	
Ar1 Min. Temperature	68.5 °F	
Ar1 Average Temperature	70.2 °F	
Sp1 Temperature	70.1 °F	
Air Temperature 1	71.8 °F	
Relative Humidity 1	52.8 %	
<b>Other remarks:</b>		
Wall: Excessive moisture on outer block wall. Readings well exceed normal. RH% is normal		
Ceilings: Acceptable		
Lab Results: <b>Room Air Test- 37,240 c/m3</b>		
Mold Rating: <b>5</b>		
Mold Rating: 1- <b>5</b> ( <b>5</b> being worst)

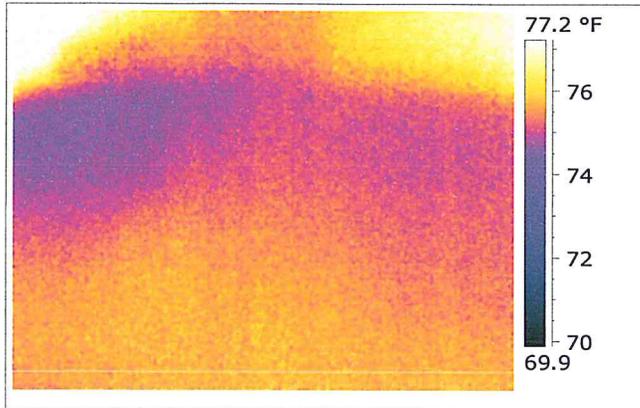
Date	12/31/2013	Location:	New Building-2 <sup>nd</sup> Floor- 206-Front Room
Image Time	1:46:06 PM	<b>Other remarks:</b>	
Air Temperature 1	74.3 °F	Lab Results:	<b>Room Air Test- 2,667 c/m3</b>
Relative Humidity 1	48.1 %	Mold Rating:	2
		Mold Rating:	1-5 (5 being worst)

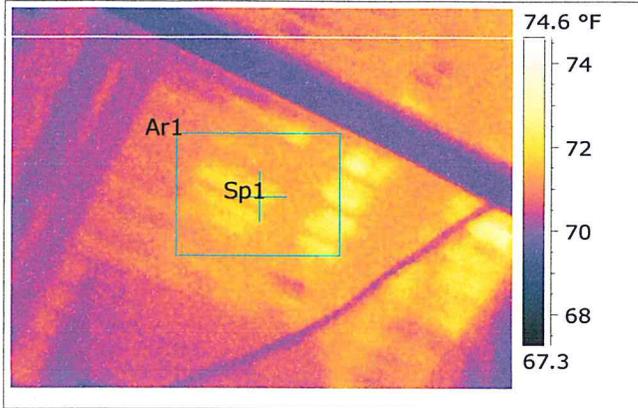
Date	12/30/2013	Location:	<b>New Building-2<sup>nd</sup> Floor-206 Right Office</b>
Image Time	2:08:32 PM	<b>Other remarks:</b>	
Ar1 Max. Temperature	72.6 °F	Wall: Paneling was acceptable	
Ar1 Min. Temperature	70.6 °F	Ceilings: Acceptable	
Ar1 Average Temperature	71.5 °F	Lab Results: No test taken	
Sp1 Temperature	72.0 °F		
Air Temperature 1	70.2 °F		
Relative Humidity 1	53.1 %

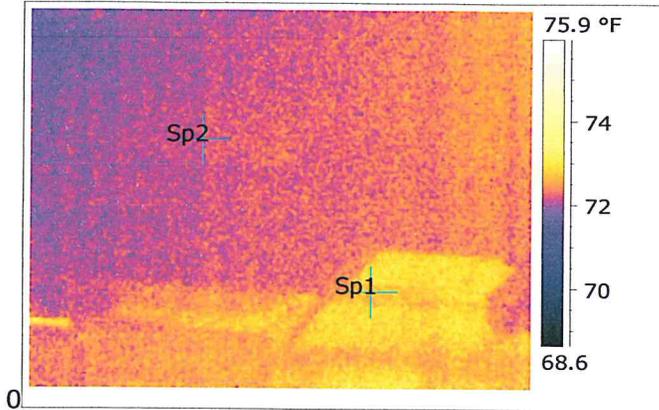
Date	12/31/2013	Location:	New building-2 <sup>nd</sup> Floor-Room 222
Image Time	10:32:43 AM	<b>Other remarks:</b>	
Sp1 Temperature	72.8 °F	Wall: Surface readings are dry	
Sp2 Temperature	72.2 °F	Ceilings: Acceptable	
Air Temperature 1	72.7 °F	Lab Results: <b>Room Air Test- 34,333 c/m3</b>	
Relative Humidity 1	59.3 %	Mold Rating: <b>5</b>	
		Mold Rating: 1-5 (5 being worst)

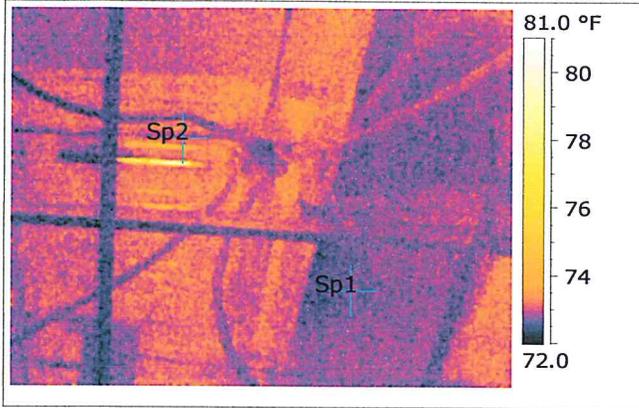
Date	12/31/2013	Location:	Room 222
Image Time	10:34:29 AM	<b>Other remarks:</b>	
Sp1 Temperature	72.9 °F	Wall: Surface of paneling is within normal range.	
Sp2 Temperature	73.1 °F	Flooring: Dry	
Air Temperature 1	73.2 °F		
Relative Humidity 1	52.4 %

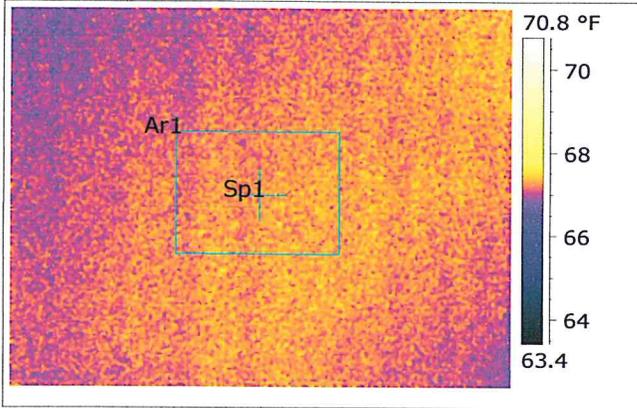
Date	1/10/2014	Location: <b>New building-3<sup>rd</sup> Floor-Men's Room</b>  <b>Other remarks:</b>  Wall: Acceptable Ceilings: Acceptable Lab Results: Air Test: 2,827 c/m3 Mold Rating: 2  Mold Rating: 1-5 (5 being worst)
Image Time	11:40:19 AM	
Ar1 Max. Temperature	67.8 °F	
Ar1 Min. Temperature	66.7 °F	
Ar1 Average Temperature	67.3 °F	
Sp1 Temperature	67.3 °F	
Air Temperature 1	70.2 °F	
Relative Humidity 1	69.6 %

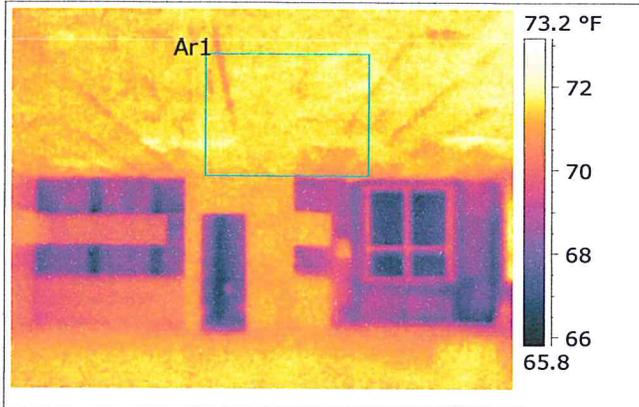
Date	12/31/2013	<b>Location:</b> <b>New building-3<sup>rd</sup> Floor-Room 312</b>  <b>Other remarks:</b>  Wall: Wall shows excessive moisture on the outer block walls Ceilings: Lab Results: 733 spores per c/m3 Mold Rating: 1  Mold Rating: 1-5 (5 being worst)
Image Time	3:11:52 PM	
Ar1 Max. Temperature	72.3 °F	
Ar1 Min. Temperature	69.5 °F	
Ar1 Average Temperature	71.5 °F	
Air Temperature 1	75.6 °F	
Relative Humidity 1	46.6 %

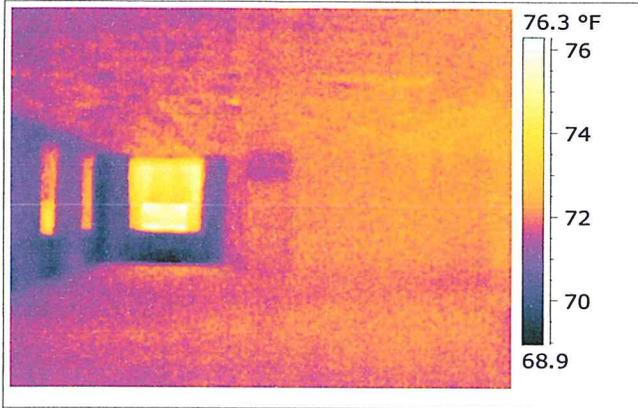
Date	12/31/2013	Location:	(Where)
Image Time	3:12:05 PM	<b>Other remarks:</b>	
Air Temperature 1	75.7 °F	Wall: Excessive wall moisture	
Relative Humidity 1	46.6 %

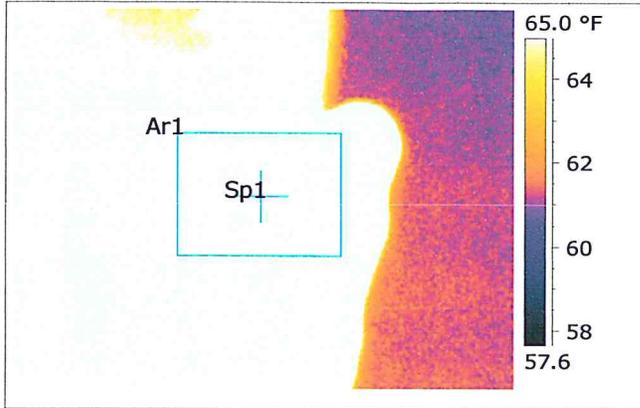
Date	1/10/2014	Location: (Where)  <b>Other remarks:</b>  Wall: Acceptable Ceilings: Acceptable
Image Time	11:12:57 AM	
Ar1 Max. Temperature	89.1 °F	
Ar1 Min. Temperature	65.8 °F	
Ar1 Average Temperature	77.3 °F	
Sp1 Temperature	73.3 °F	
Air Temperature 1	64.9 °F	
Air Temperature 2	64.9 °F	
Internal Moisture 1	12.5 %	
Internal Moisture 2	12.7 %

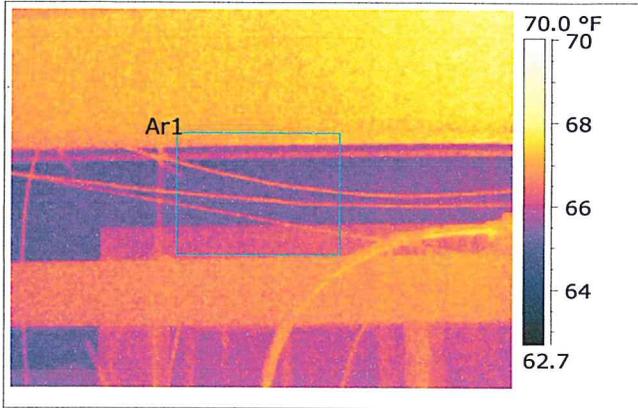
Date	1/2/2014	Location:	Old Building-Room 111
Image Time	3:32:03 PM	<b>Other remarks:</b>	
Ar1 Max. Temperature	67.7 °F	Wall:	
Ar1 Min. Temperature	64.6 °F	Ceilings:	
Ar1 Average Temperature	65.9 °F	Lab Results:	1,907 c/m3
Air Temperature 1	68.4 °F	Mold Rating:	1
Relative Humidity 1	73.1 %	Mold Rating:	1-5 (5 being worst)

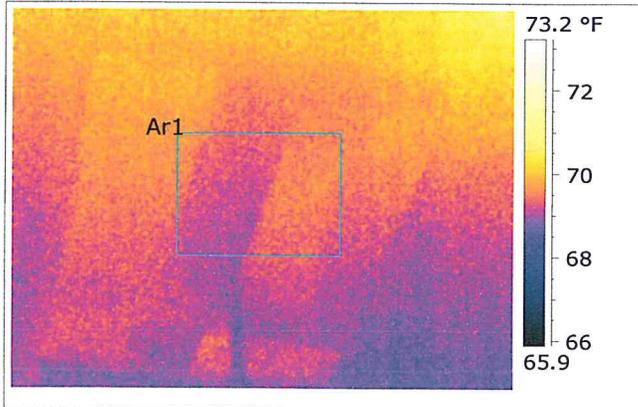
Date	1/2/2014	<table border="1"> <tr> <td>Location:</td> <td>Room 111</td> </tr> </table> <p><b>Other remarks:</b></p> <p>Ceilings: Previous water damaged noted. Appears to be fixed.</p>	Location:	Room 111
Location:	Room 111			
Image Time	3:36:23 PM			
Ar1 Max. Temperature	70.0 °F			
Ar1 Min. Temperature	68.7 °F			
Ar1 Average Temperature	69.3 °F			
Air Temperature 1	68.9 °F			
Relative Humidity 1	70.0 %

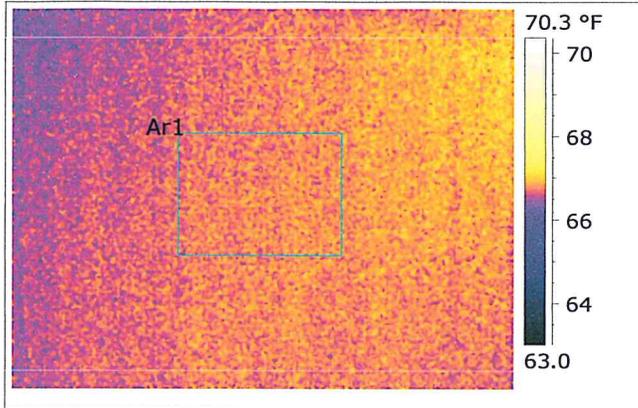
Date	1/2/2014	Location:	Old Building-Room 114
Image Time	3:56:09 PM	<b>Other remarks:</b>	
Ar1 Max. Temperature	67.3 °F	Lab Results: 2,760	
Ar1 Min. Temperature	66.2 °F	Mold Rating: 1	
Ar1 Average Temperature	66.8 °F	Mold Rating: 1-5 (5 being worst)	
Air Temperature 1	68.2 °F		
Relative Humidity 1	72.1 %

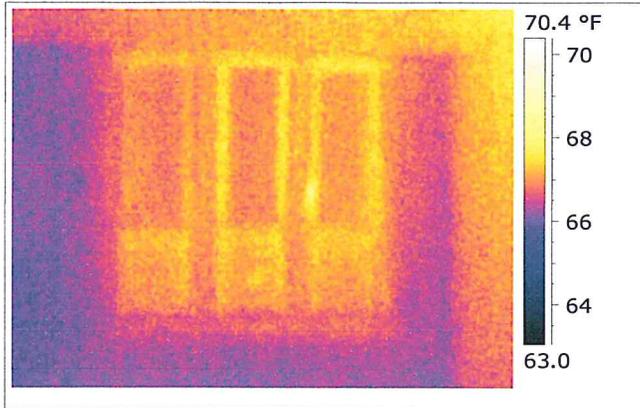
Date	1/2/2014	Location: <b>Room 115</b>  <b>Other remarks:</b>  Wall: Metal walls Ceilings: Acceptable Lab Results: <b>19,640 c/m3</b> Mold Rating: <b>5</b>  Mold Rating: 1-5 ( <b>5</b> being worst)
Image Time	3:24:58 PM	
Air Temperature 1	69.3 °F	
Air Temperature 2	69.1 °F	
Relative Humidity 1	70.1 %	
Relative Humidity 2	70.1 %

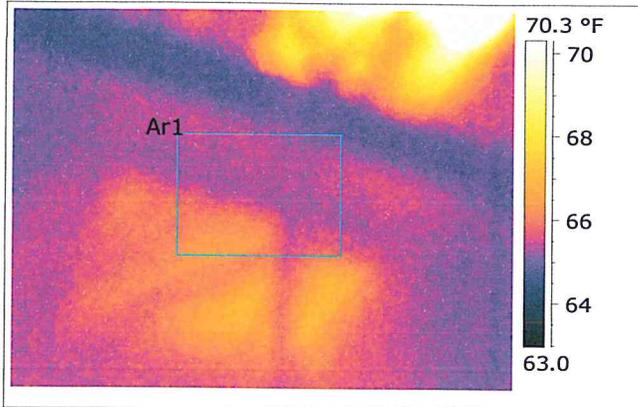
Date	1/10/2014	Location:	Old Building-2 <sup>nd</sup> floor-Main Hallway
Image Time	11:19:01 AM	<b>Other remarks:</b>	
Ar1 Max. Temperature	66.9 °F	Wall:	Acceptable
Ar1 Min. Temperature	64.8 °F	Ceilings:	See comment
Ar1 Average Temperature	65.6 °F	Lab Results:	
Air Temperature 1	64.4 °F	Mold Rating:	
Relative Humidity 1	80.8 %	Mold Rating:	1-5 (5 being worst)

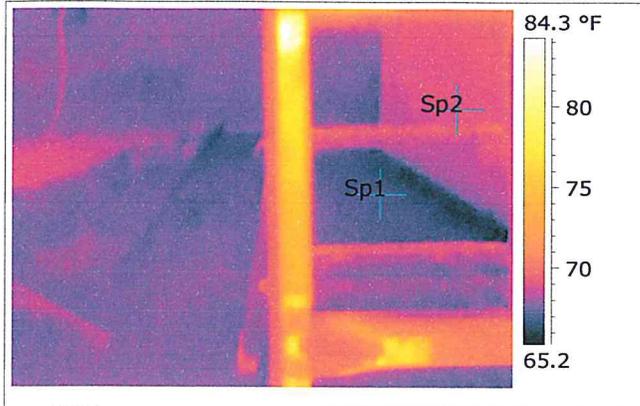
Date	1/2/2014	Location:	Small Room
Image Time	10:55:01 AM	<b>Other remarks:</b>	
Sp1 Temperature	66.9 °F	Ceilings:	Room where leak is occurring
Sp2 Temperature	69.1 °F	Lab Results:	
Air Temperature 1	70.5 °F	Mold Rating:	
Relative Humidity 1	75.9 %	Mold Rating:	1-5 (5 being worst)

There is one major roof leak (identified in room and on the roof). This needs to be addressed immediately before any remediation work can begin.

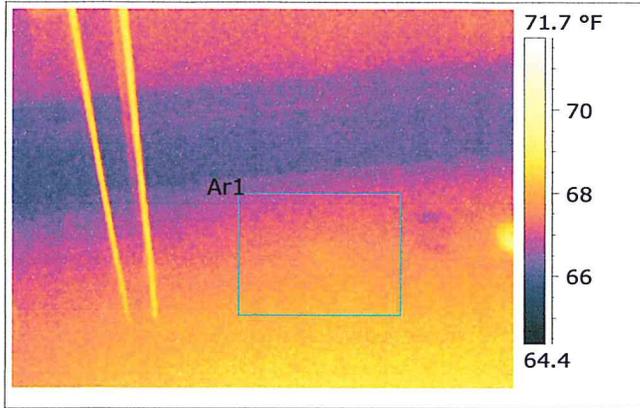
Date	1/2/2014	Location:	Room 221
Image Time	2:03:19 PM	<b>Other remarks: Sills are becoming wet due to high RH%</b>	
Ar1 Max. Temperature	68.6 °F		
Ar1 Min. Temperature	66.4 °F		
Ar1 Average Temperature	67.6 °F		
Air Temperature 1	70.7 °F		
Relative Humidity 1	70.1 %

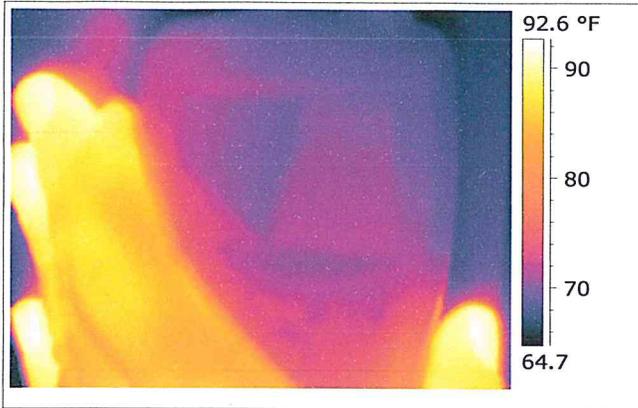
Date	1/10/2014	Location:	Room 225
Image Time	11:25:29 AM	<b>Other remarks:</b>	
Air Temperature 1	66.7 °F	Wall: Surface dry	
Internal Moisture 1	5.9 %

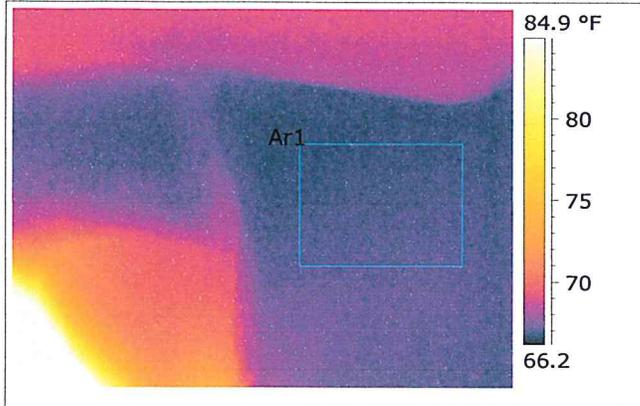
Date	1/10/2014	Location:	Room 225
Image Time	11:26:01 AM	<b>Other remarks:</b>	
Ar1 Max. Temperature	67.6 °F	Window sill, condensate drops, From high humidity	
Ar1 Min. Temperature	66.3 °F		
Ar1 Average Temperature	67.0 °F		
Air Temperature 1	66.6 °F		
Air Temperature 2	66.4 °F		
Relative Humidity 2	78.0 %		
Internal Moisture 1	18.0 %

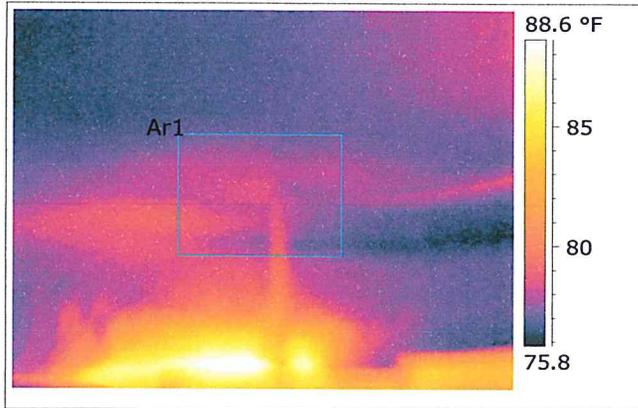
Date	1/2/2014	Location: (Where)  <b>Other remarks:</b>  Ceilings: It appears that the plaster is in good condition under the drop ceiling.
Image Time	9:28:49 AM	
Ar1 Max. Temperature	79.5 °F	
Ar1 Min. Temperature	76.6 °F	
Ar1 Average Temperature	77.9 °F	
Air Temperature 1	73.2 °F	
Relative Humidity 1	62.0 %

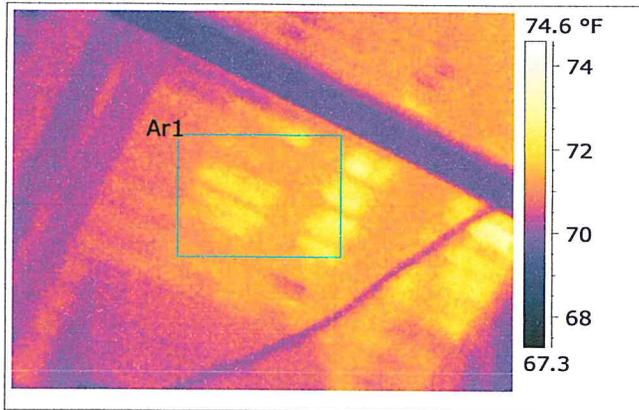
Date	12/30/2013	Location:	Old Building-Northwest Bathroom
Image Time	2:08:32 PM	<b>Other remarks:</b>	
Ar1 Max. Temperature	72.6 °F	Wall:	Dry at time of inspection
Ar1 Min. Temperature	70.6 °F	Ceilings:	Dry at time of inspection
Ar1 Average Temperature	71.5 °F	Lab Results:	Not required
Air Temperature 1	70.2 °F		
Relative Humidity 1	53.1 %

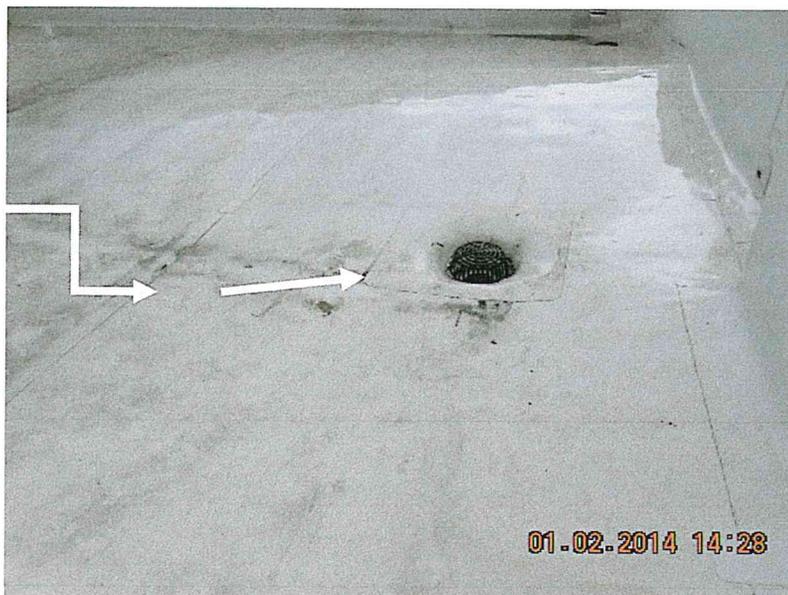
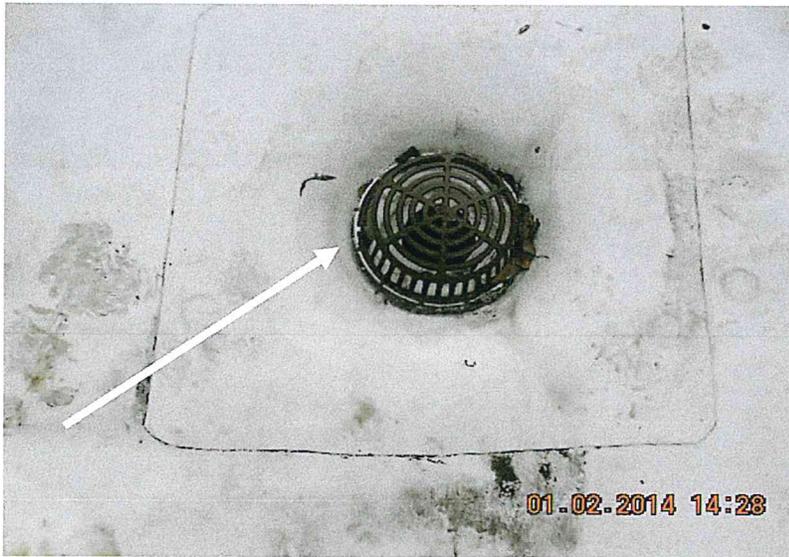
Leak appears to be between drain cover and TPO material
