Structural Assessment of the Flagler County Historic Courthouse

County Project No. FC-07-007

20 February 2009

**FLAGLER COUNTY HISTORIC COURTHOUSE
ASSESSMENT of EXISTING STRUCTURE**

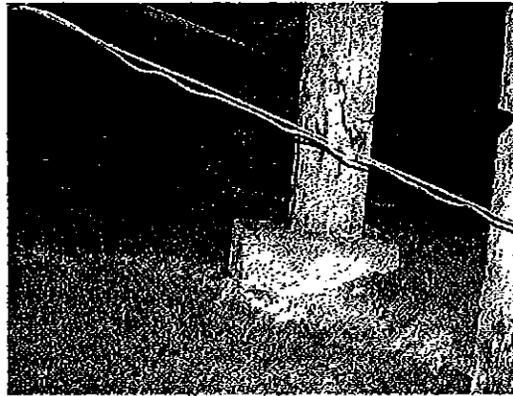
From BEC's observations of the first floor framing, we rate its existing condition a "9". We observed only superficial very minimal marks from old termite activity on only a couple of framing members that in our opinion are structurally negligible. We observed 5 or 6 shoring piers that were probably inserted long ago to reduce deflection (spring, bounce or vibration) of the 1st. floor framing in some areas, although not as proper as the original construction, these shoring piers apparently are performing adequately. BEC did not observe structural member conditions that would indicate a deficiency that would cause an imminent structural failure due to gravity loads. The maximum floor loading in the first floors should not exceed 125psf. in the vaults and 50psf. for all other rooms.

Floor shoring piers
