**FORMER HOSPITAL BUILDING
COMMUNITY SERVICES BUILDING
901 EAST MOODY BOULEVARD
BUNNELL, FLORIDA**

**UNIVERSAL ENGINEERING SCIENCES, INC.
Jacksonville, Florida
PROJECT NUMBER 0940.1300057.0000**

July 17, 2013

Subject: **Report of Professional Consulting Services
Former Hospital Building and Community Services Building
901 East Moody Boulevard
Bunnell, Florida
UES Project No. 0940.1300057.0000, UES Report Number 1051526**

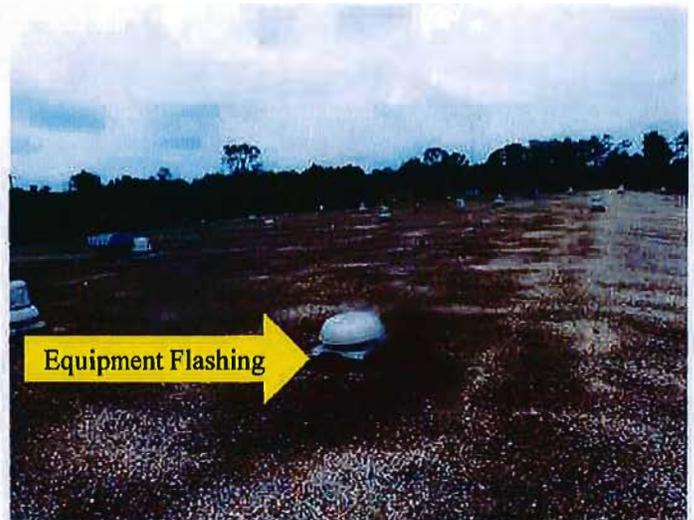
4. Typical view of asbestos-containing equipment flashing area on roof.

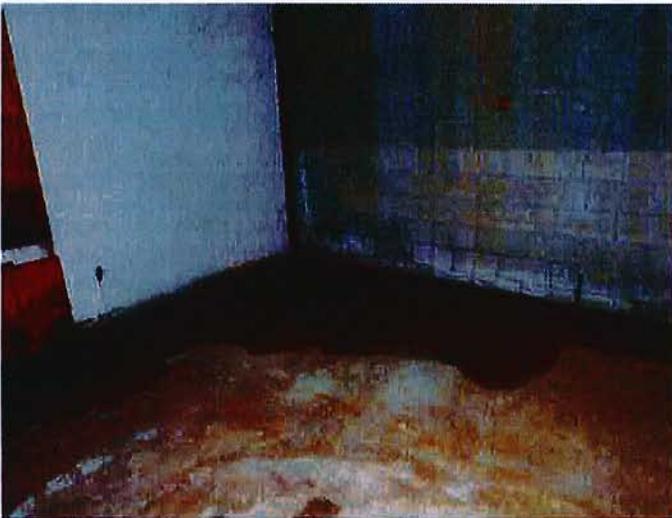
7. Typical view of water intrusion area (observed throughout building)

Visible mold was observed to be present throughout the former hospital building. Based on the results of our visual mold observations, it is recommended that the interior water damaged materials be removed and that any visible mold be removed by a Florida Licensed Mold Remediation company. The Florida Department of Business and Professional Regulation, Construction Industry Board issued a declaratory statement that allows a Certified Division I Contractor to perform the work as part of their services provided they are not representing themselves as a person or entity who specializes as a "Mold Remediator". Wallpaper within areas on the front of the building was observed to have mold growth between the paper and drywall. It appears that the paper is acting as a vapor barrier and allowing moisture and mold to form on the wall surfaces. It is recommended that damaged drywall be removed and remaining materials cleaned or removed. The exterior of the building was observed to have an Exterior Insulation Finish System (EIFS). Many damaged areas were observed and present locations for moisture intrusion and mold growth to occur. It is recommended that this EIFS system be removed and replaced if the building is to be renovated. In addition, damaged areas of roof flashing, guttering systems and downspouts were observed. These items will require repair to prevent future water intrusion.

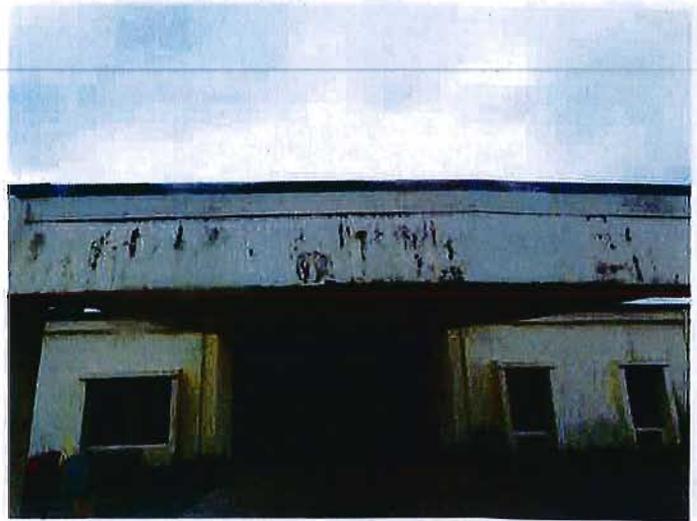
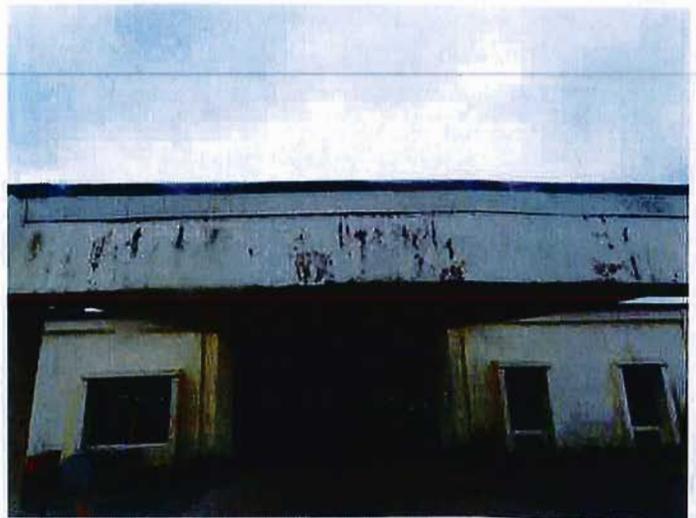
10. Typical view of front of building with damaged Exterior Insulation Finish System (EIFS) exterior.

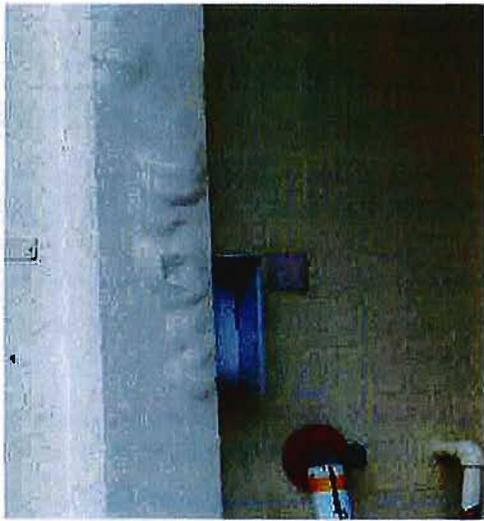
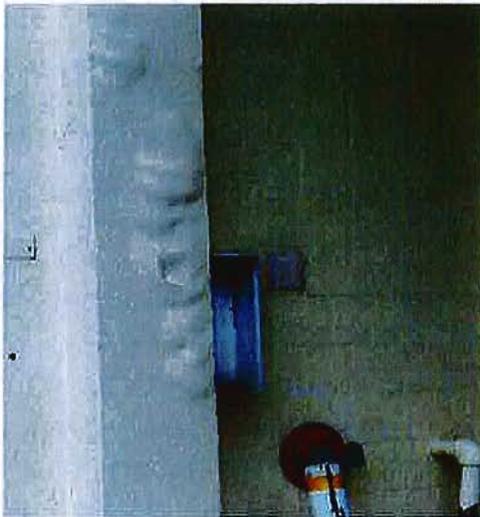
11. Typical view of damaged EIFS system on building exterior.

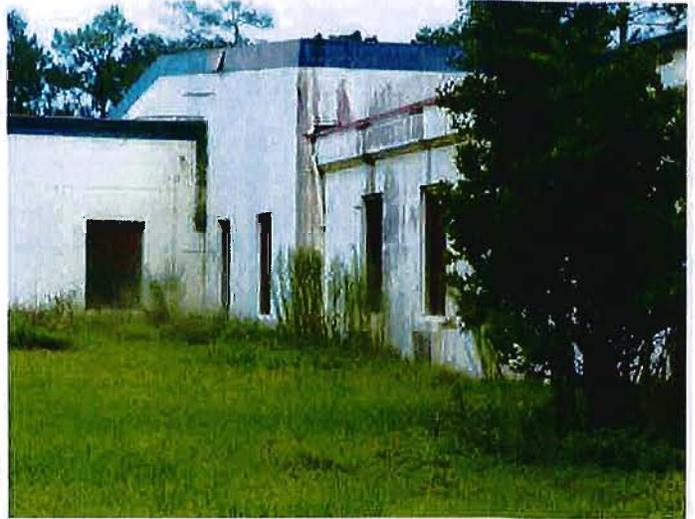
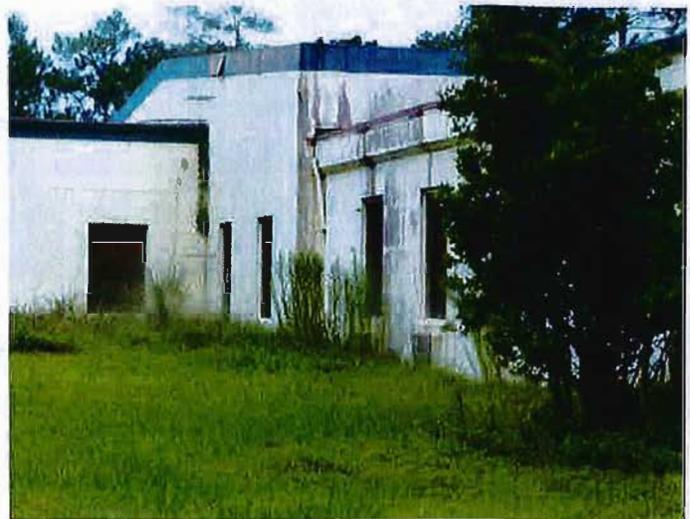
12. Typical view mold growth on exterior wall.

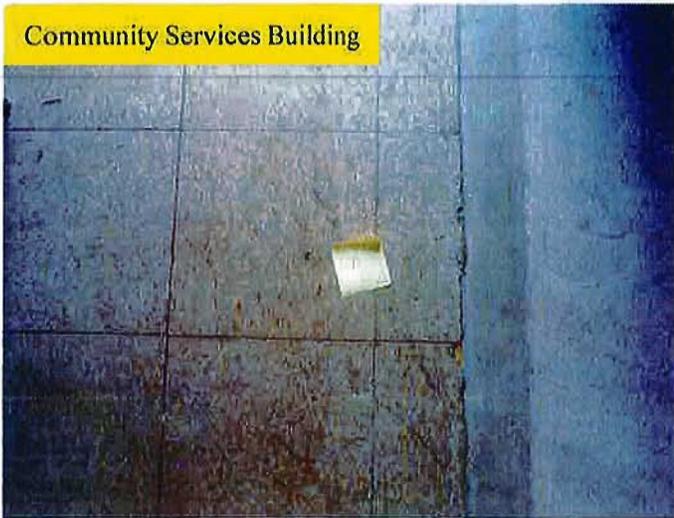
Community Services Building

13. Typical view asbestos-containing floor tile in community services building.

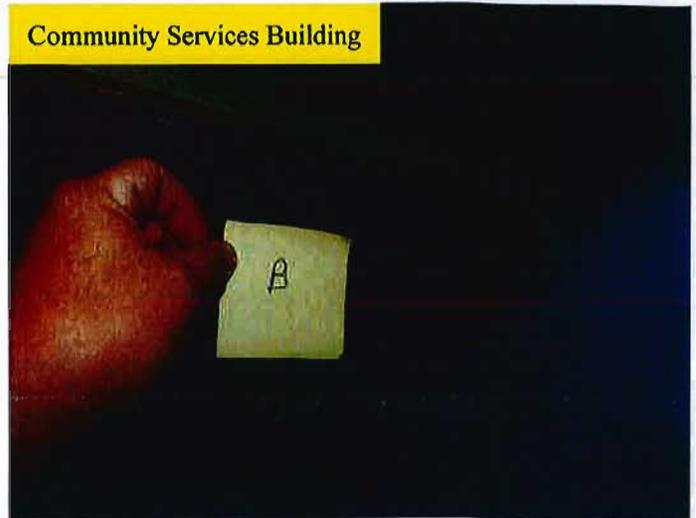
Community Services Building

14. Typical view of asbestos-containing cement board in community services building.

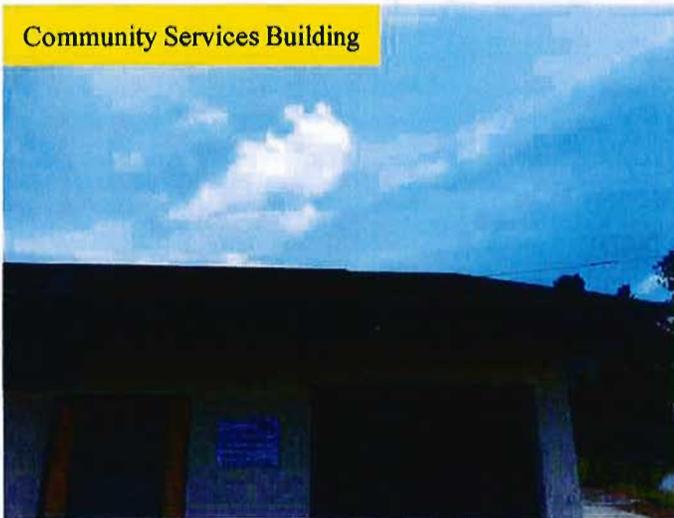
Community Services Building

15. Typical view of roof at community services building. Asbestos-containing mastic was found in roofing felt.

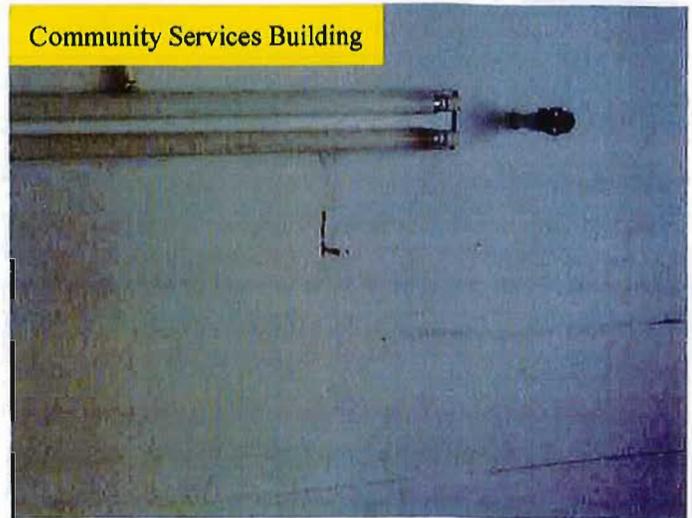
Community Services Building

16. Typical view fluorescent lighting fixture in community services building.

UES recommends that fluorescent lighting tubes and lighting fixtures with ballast be recycled.
