**Report of the Building
Construction/Renovation
Study for Flagler County**

June 2002

Flagler County Building Construction/Renovation Study

8. Memorial Hospital Moody Boulevard, Bunnell

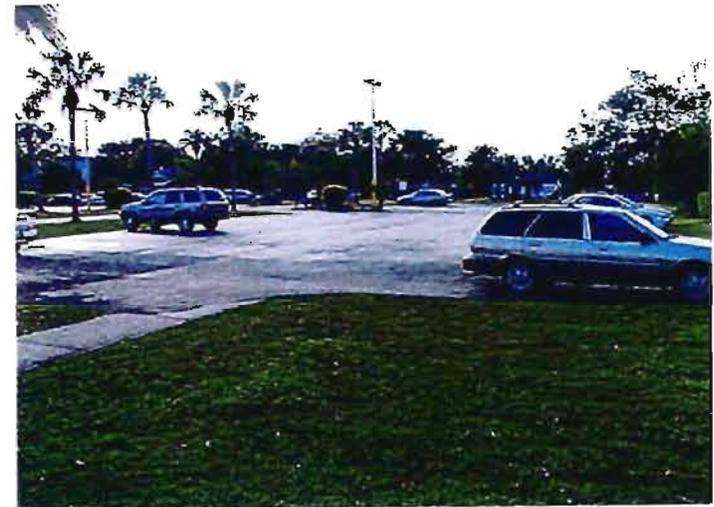
Hospital parking lot

Our firm visited the site on March 22, 2002, and performed a cursory review. The site is in generally good condition. Groundcover, landscaping and trees have been well maintained. We observed a functional sprinkler system currently used by the hospital in the front area of the facility. The aesthetics and functionality of the parking lot could be improved by resurfacing and restriping.

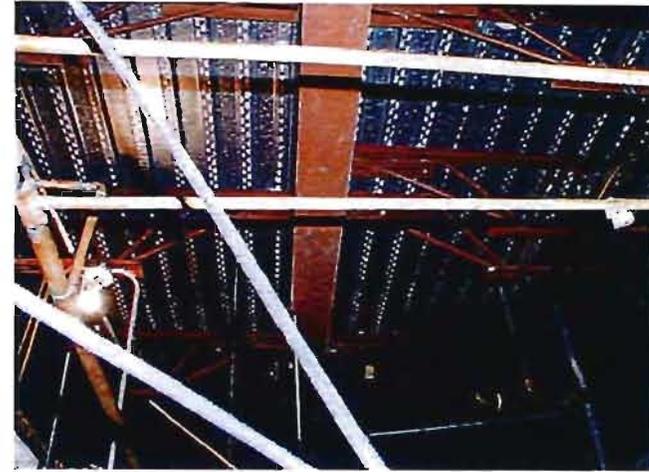
Existing roof structure

The second potential structural deficiency, which we discovered, is the lack of bottom flange bracing of the structural steel beams of the roof. The beams are articulated, or extend over the interior columns. This beam configuration generates a compressive stress in the beams bottom flange near the column when the beam is subjected to downward roof loads. Likewise, when wind uplift is applied to the building's roof, the bottom flange of the beams— between columns—experiences compressive stresses. It is necessary that the bottom flanges of beams in compression be braced. Without these braces there is a possibility that the bottom flanges of these beams would buckle under the compressive stresses experienced. The required spacing of the bracing would vary, depending upon the size of the beam and the load imposed. Our firm typically specifies that a 2x2x1/4 angle be installed at each joist, from the beam bottom chord to the top chord of the joist. I would assume that bracing similar to this would be necessary for several beams of this project.

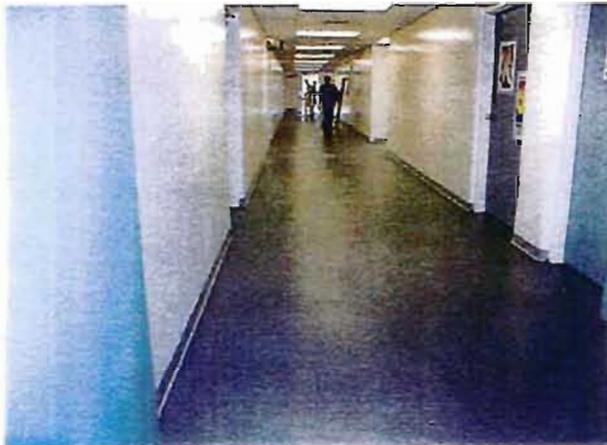
Corridor

- 1) Carpet
 - a) The carpet in some areas appears to be relatively new, and may only require steam cleaning.
 - b) There are several areas of old/worn carpet that should be replaced.
- 2) Doors
 - a) All interior doors and hardware are functional.
 - b) All interior doors are plastic laminate, show signs of use and need repair.

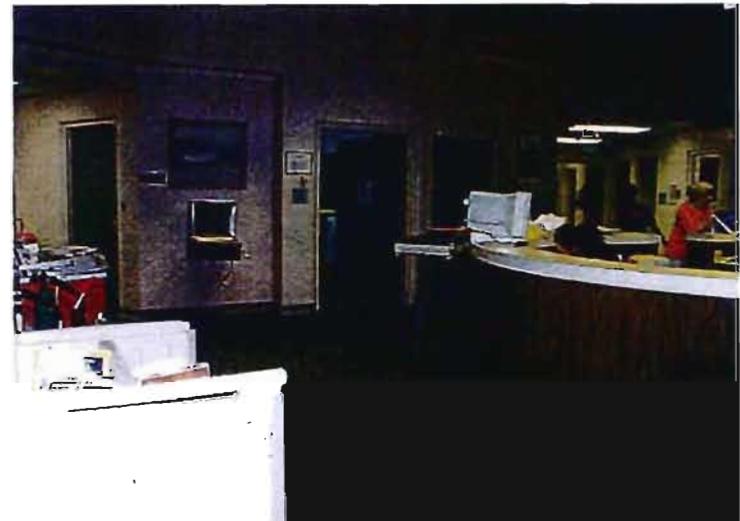
Nurses' Station

- 3) Walls
 - a) All interior walls are in good condition with only minor patchwork required before painting.
 - b) Painting in many areas shows sign of wear. The building should be painted throughout.
 - c) In the administration area, the walls are metal stud with drywall or metal stud with paneling. The paneling is dark in color, which decreases the lighting level. Paneling should be replaced upon renovation of the building.
 - d) The scope of our study did not include research on evidence of lead.

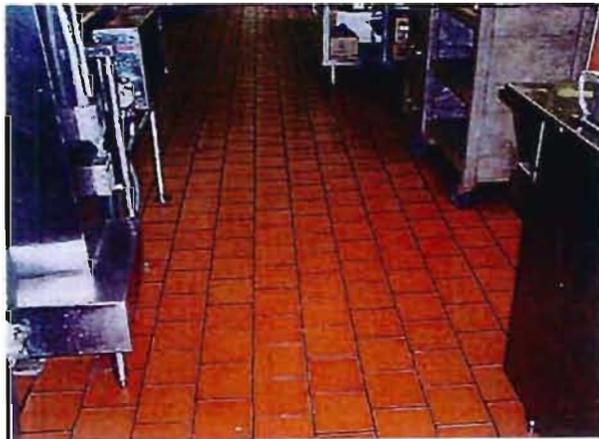
- a) The ceiling is a 2 x 4, lay-in acoustical grid system. All ceiling tiles are in place.
- b) Ceiling grid and tiles are old and discolored throughout the building. Ceiling tiles have been replaced in many areas and do not match. Ceiling grid and tile should be replaced upon renovation of the building.
- c) In the kitchen area, the floor is quarry tile and is in good condition. The ceiling is a plastered ceiling with several water-damaged areas that have been patched.

Kitchen floor

The kitchen ceiling should be removed and replaced with an acoustical grid system.

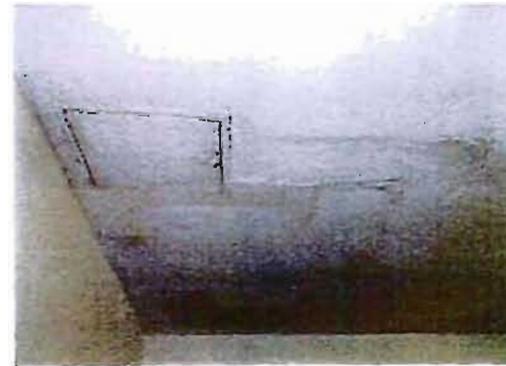
Water stains on ceiling

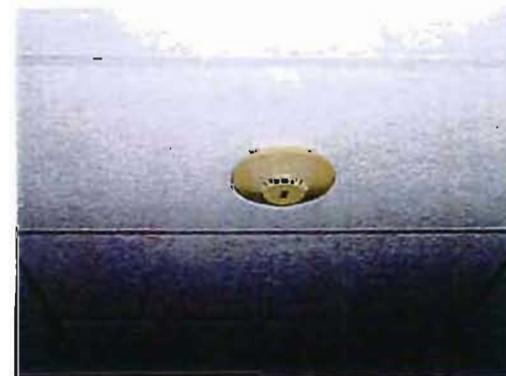
Smoke detector

The fire alarm system is served by a Simplex Time Recorder Company (currently owned by Tyco) control panel believed to be installed under original construction. Smoke detection is provided throughout the facility (though no smoke or heat detectors were observed in the kitchen). Only one wing (TCU or “C” Wing) is provided with full fire sprinkler protection. Other selected areas such as storage closets are provided with fire sprinkler protection. Alarm annunciation is sounded by a chime system. Though this system appears to be serviceable, its age and arrangement make it a likely system for upgrade/renovation by a new owner.

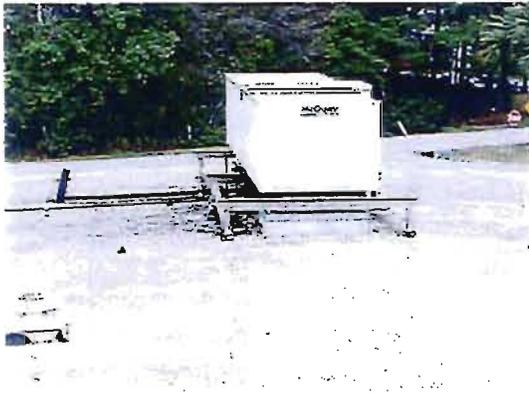
Rooftop AHU

Central station air handling units: The central station air handling units are McQuay Series LSL and appear to be the original equipment installed when the building was initially constructed. Nearly all of the air handling unit coils and condensate drain pans show signs of severe deterioration and appear in poor condition. Many of the air handling units have inadequate traps in the condensate drain lines resulting in inadequate condensate drainage while the units are running. According to the facilities maintenance staff, the air handling unit coils are scheduled to be cleaned in the near future.

As indoor air quality becomes an increasingly significant issue, more attention should be given to the condition and maintenance of air handling equipment. The existing air handling unit coils and drain pans are extremely dirty, rusted and corroded. Also, the inadequate condensate pan drainage mentioned above could result in the growth of bacteria, mold and mildew inside the unit casings. These volatile organic compounds (VOC's) could then migrate into the supply airstreams and be transmitted to the building occupants. The existing central station air handling units are approximately 22 years old, in poor condition and are due to be replaced. New double-walled, central station air handling units with sloped, stainless steel drain pans

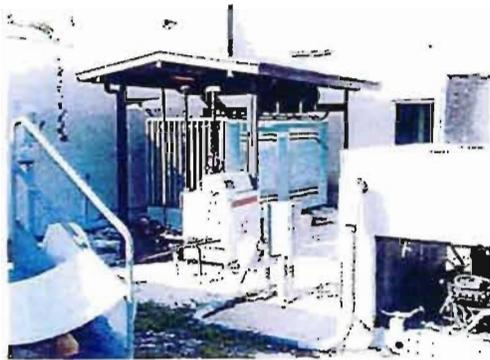
Generator

Emergency power is split into 4 branches: life safety, critical equipment and HVAC. This is typical of hospital design requirements and affords some protection against a fault in one branch causing all emergency power to fail. The generator has been maintained fairly well under a typical service contract and has been

exercised regularly. Accordingly, the system should continue to provide adequate service with normal routine maintenance.
