ConditionAssessmentOldFlaglerHospital, FlaglerCounty

CONFORMING REPORT

DJ Project #02218.02

July 26, 2013

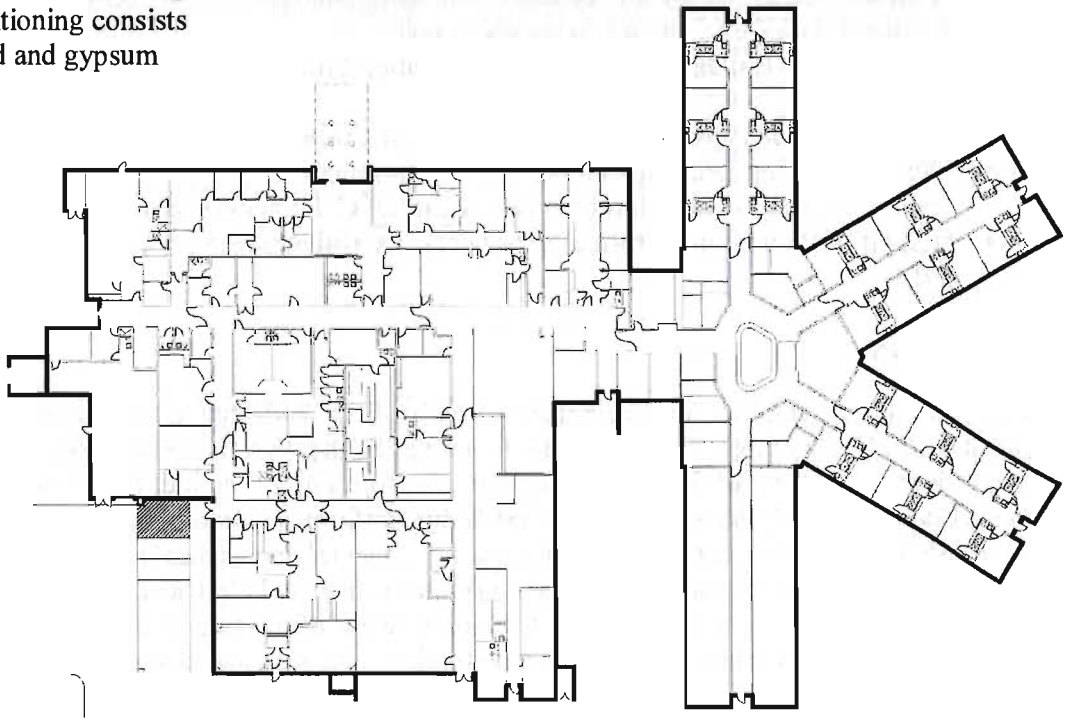
Much of the interior finishes, fixtures and equipment as well as salvageable metals (aluminum, copper, and lead) have been removed over the years. However, the egress corridors and other fire partitions have been retained. While there are numerous holes in the walls, they are largely intact and remained sealed to the structure above and to the exterior walls.

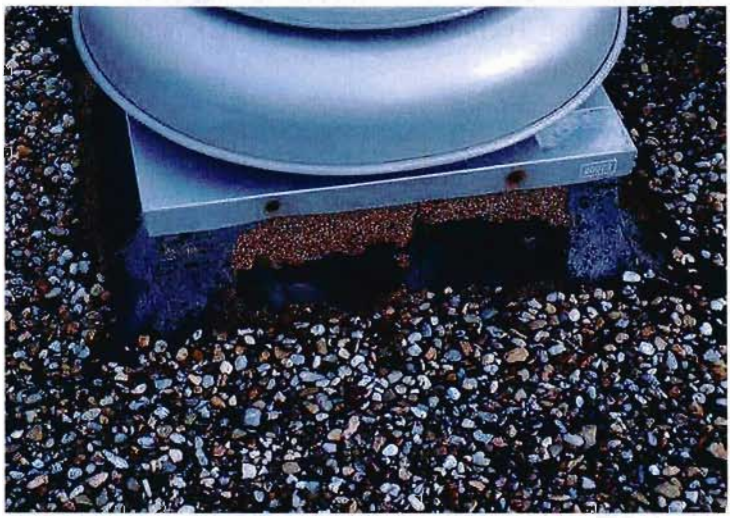
The existing roof is a gravel-ballasted asphalt roof membrane over lightweight insulating concrete poured over a vented deck with polystyrene for the slopes. **R & R Industries** of Daytona Beach inspected the roof on June 12, 2013 and found that the lightweight "seemed in fairly good condition and seemed durable enough to hold fasteners...". Pending a pull-test, **R & R** felt that a **GAF Drill Tek**locking impact nail should provide plenty of holding power against uplift. The roof shows numerous areas of distress although there appear to be few areas of active water penetration below. The existing roof has numerous roof curbs with mechanical equipment (fans and vents) sitting on them and most of these are no longer water-tight. The existing flashing, gravel-stops and gutters are deteriorated and pulling away from roof substrate.

Built-Up Roof with Ballast

We found little evidence of complete roofing failures, but due to its age and condition, we recommend that the entire existing roofed-area be replaced with a new system prior to commencing any interior remodeling. Most of the existing roof penetrations will no longer be necessary, but there may be additional, new penetrations to accommodate a new user/group. There are several re-roofing and budget options offered:

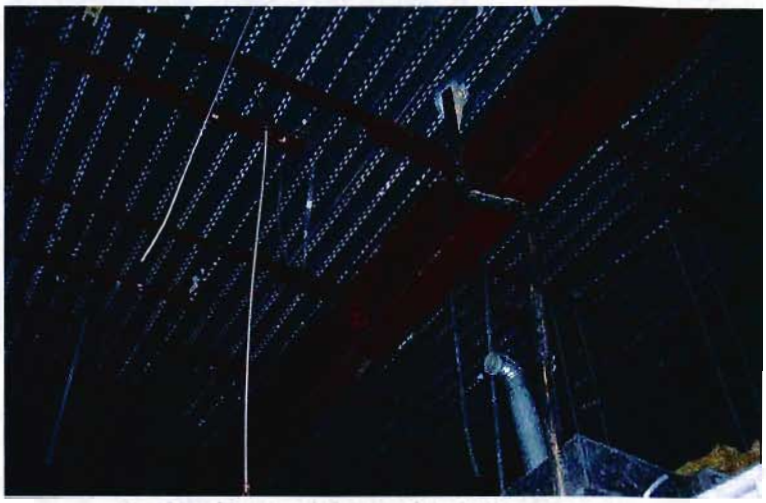
No excessive deterioration or corrosion was observed on the steel framing within the building.

Steel Decking and Joist attached to Steel Beams

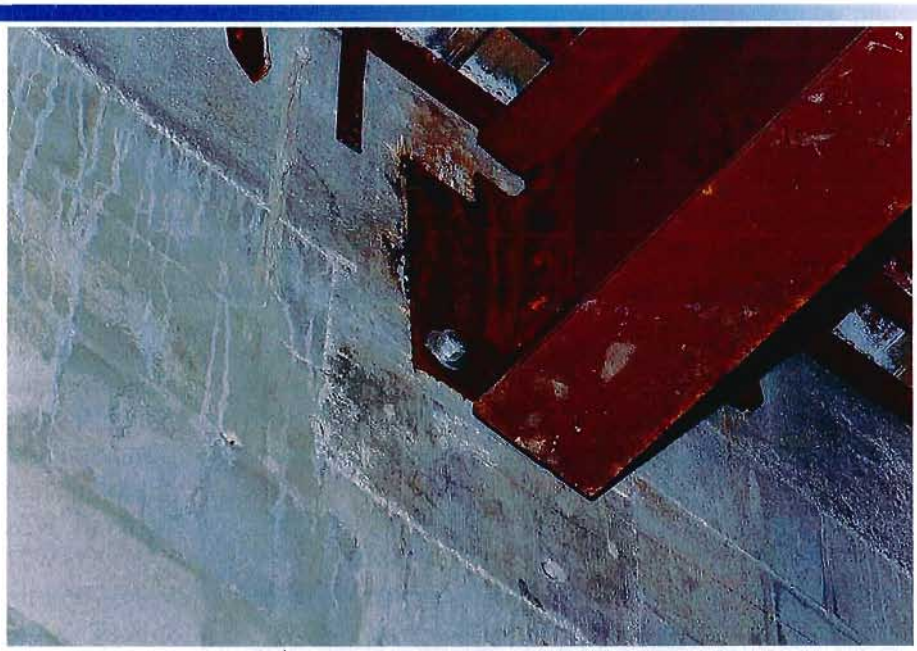
Wide Flange Beam Connection to a Concrete Column

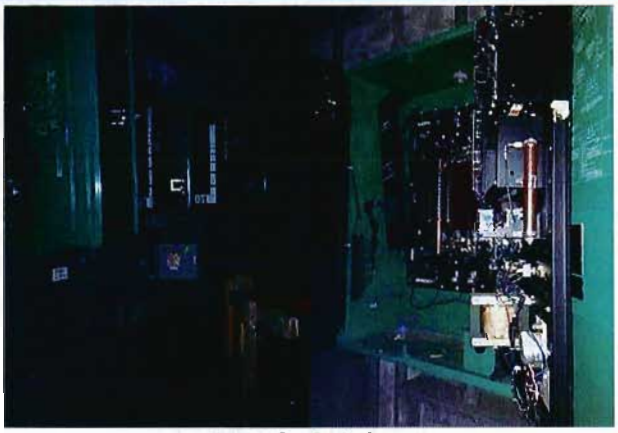
- The building had four (4) automatic transfer switches for the critical and emergency loads commonly found in a hospital building. These transfer switches have been vandalized and most of its major components removed. What remains of these is outdated equipment.

Transfer Switches

As stated in Section 5.1, there is nothing of the existing electrical system that is of any value and/or can be reused. Our recommendation to the new Owner is to install new electrical systems including fire alarm, voice/data cabling, generator, transfer switches, security systems, etc.

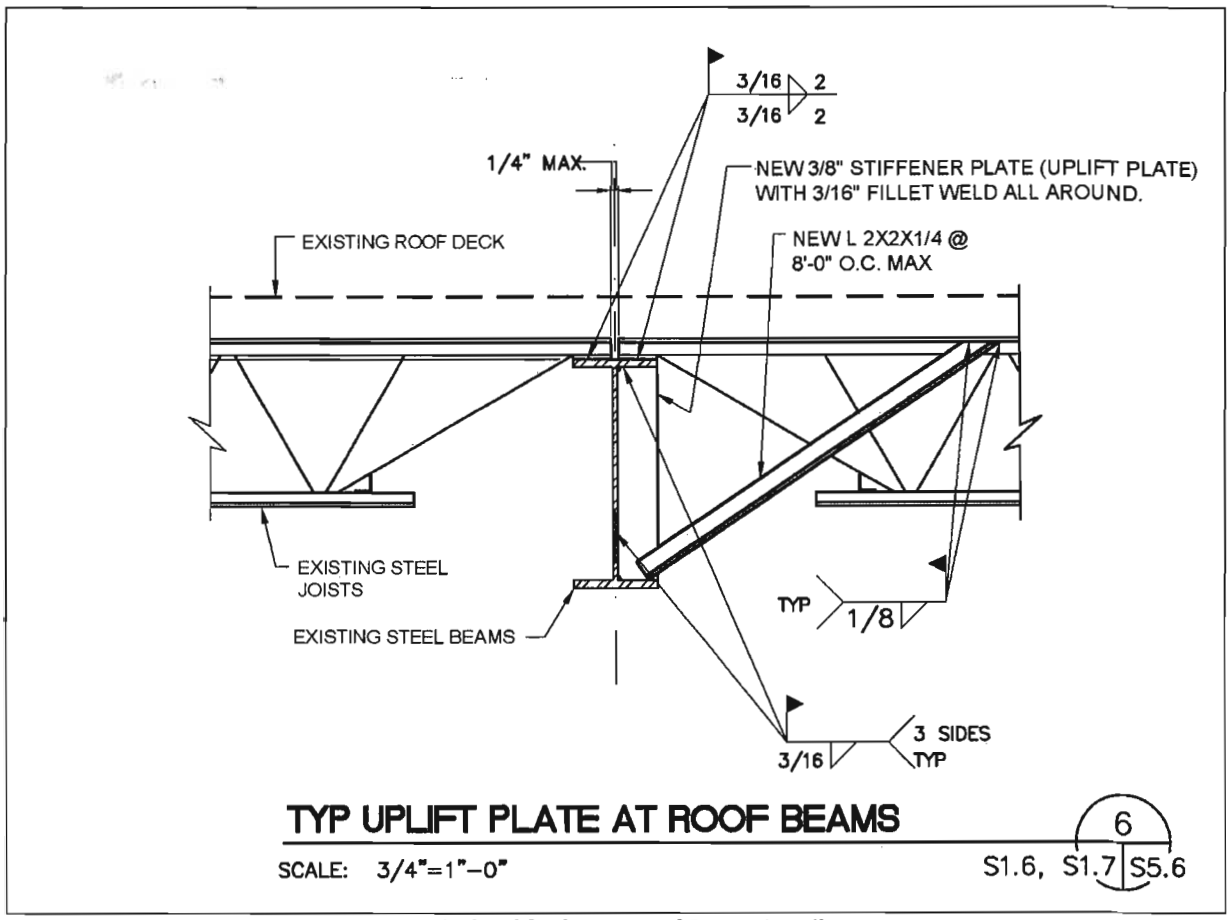
Typical Uplift Plate at Roof Beams Detail

The lack of vertical reinforcement within the perimeter masonry walls reduces the masonry walls' capacity to resist lateral loads due to C&C wind pressures. Roof uplift due to wind load subjects the bottom flange of the steel beams to compressive stress. The lack of bottom flange bracing reduces the steel beams' capacity to support the compressive stresses due to roof wind uplift and may cause the steel beams to buckle if overstressed.

It is required that new L2x2x1/4 angle bracing from the bottom flange of the steel beams to the top chord of the steel joists for roof wind uplift support, as shown in the following figure:
