Mold Assessment-Protocol Report

For Bunnell Courthouse  
200 East Moody Blvd.  
Bunnell FL.

Date: January 12, 2014

Job #: 13-235-2

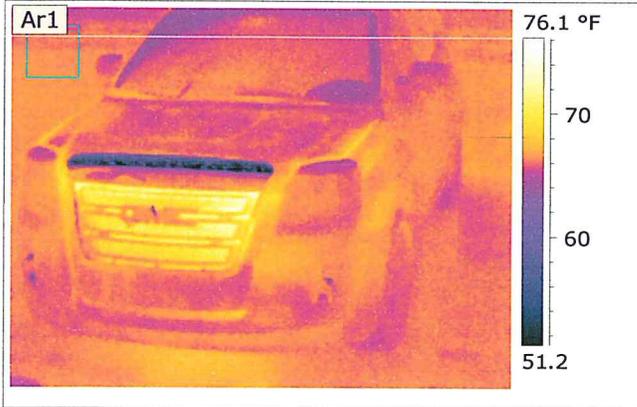
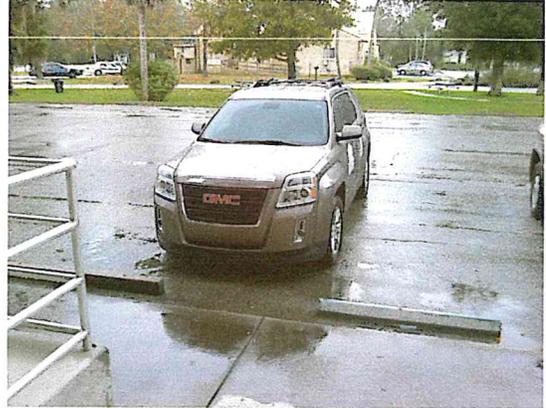
Date	1/2/2014	Location:	Outside
Image Time	3:30:59 PM	<b>Other remarks:</b>	
		Lab Results:	Total spores 3,147 c/m3
		Mold Rating:	Normal readings
Air Temperature 1	68.9 °F	Used as a baseline	
Relative Humidity 1	80.8 %

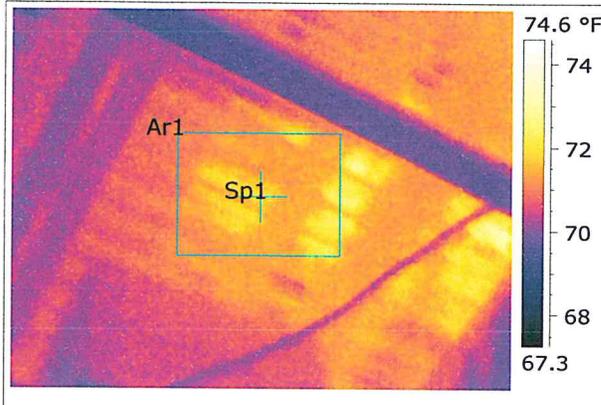
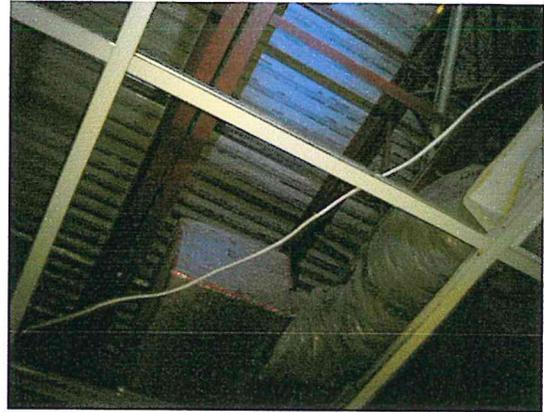
Date	12/30/2013	<table border="1"> <tr> <td>Location:</td> <td>New building-First Floor-Main Hallway</td> </tr> </table> <p><b>Other remarks:</b></p> <p>Wall &amp; Ceilings: Do not have condition 3 mold. Vents were tested for by the use of a swab to see if they contained condition 2 or 3 mold.</p>	Location:	New building-First Floor-Main Hallway
Location:	New building-First Floor-Main Hallway			
Image Time	2:08:32 PM			
Ar1 Max. Temperature	72.6 °F			
Ar1 Min. Temperature	70.6 °F			
Ar1 Average Temperature	71.5 °F			
Sp1 Temperature	72.0 °F			
Air Temperature 1	70.2 °F			
Relative Humidity 1	53.1 %

**Comment:** There were no leaks detected thermally. All decking and trusses visually look acceptable. Please note the average temperatures and relative humidity on the chart on the left. All within acceptable ranges.

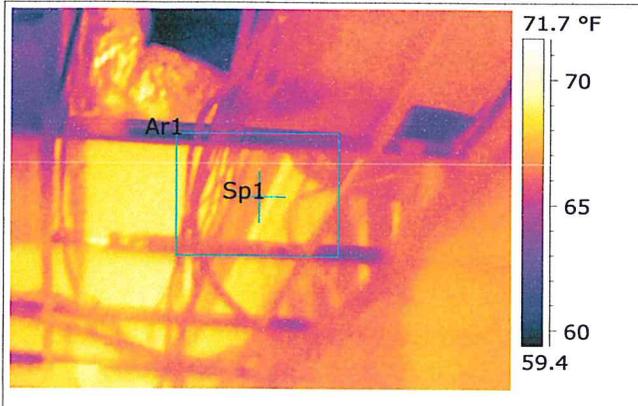
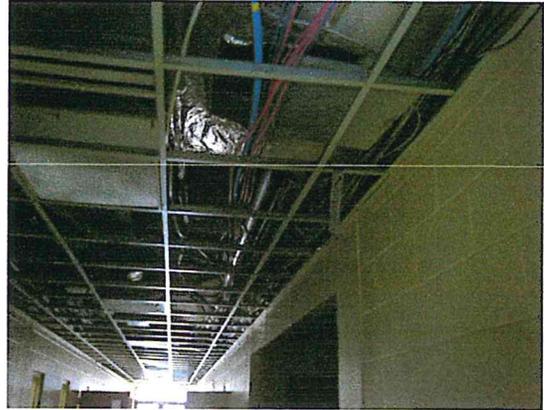
Date	12/30/2013	Location:	Main Hallway
Image Time	2:43:06 PM	<b>Other remarks:</b>	
Ar1 Max. Temperature	69.2 °F	Lab Results:	416,870 c/m3, Swab of duct
Ar1 Min. Temperature	60.9 °F	Mold Rating:	5
Ar1 Average Temperature	66.6 °F	Mold Rating:	1-5 (5 being worst)
Sp1 Temperature	66.8 °F		
Air Temperature 1	68.7 °F		
Relative Humidity 1	55.9 %

**Comment:** Very high readings suggest that the ductwork is compromised. The video taken of a section of the duct suggest condition 3 mold evident.

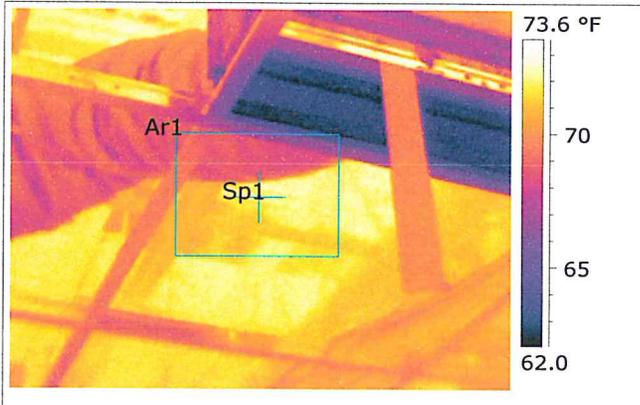
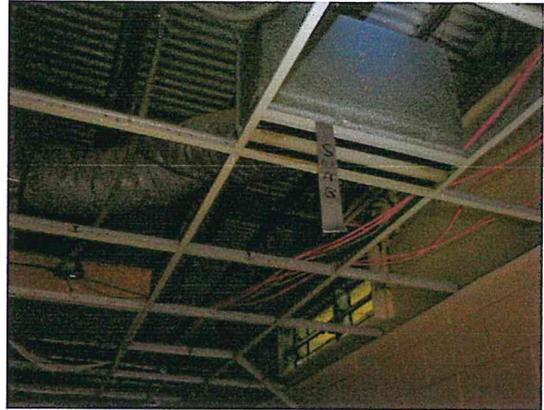
Date	12/30/2013	Location:	Main Hallway
Image Time	2:43:31 PM	<b>Other remarks:</b>	
Ar1 Max. Temperature	72.6 °F	Wall:	
Ar1 Min. Temperature	62.6 °F	Ceilings:	
Ar1 Average Temperature	70.4 °F	Lab Results:	<b>1,550,509 c/m3</b>
Sp1 Temperature	72.1 °F	Mold Rating:	<b>5</b>
Air Temperature 1	68.9 °F	Mold Rating:	1-5 (5 being worst)
Relative Humidity 1	55.0 %

**Comment: See previous comments**

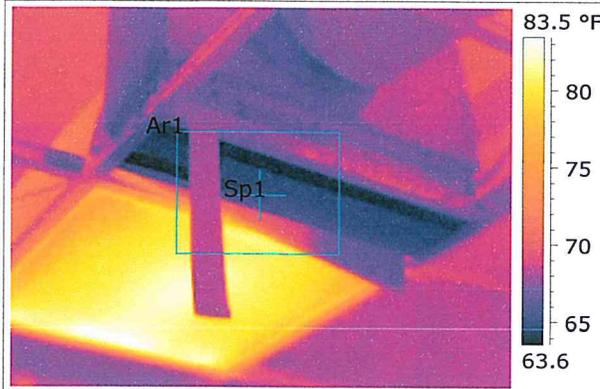
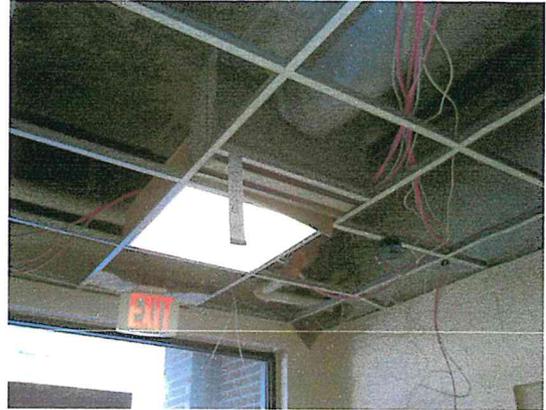
Date	12/30/2013	Location:	Main Hallway
Image Time	2:44:12 PM	<b>Other remarks:</b>	
Ar1 Max. Temperature	81.6 °F	Lab Results:	<b>3,180 c/m3</b>
Ar1 Min. Temperature	63.6 °F	Mold Rating:	<b>4</b>
Ar1 Average Temperature	68.5 °F	Mold Rating:	1-5 ( <b>5 being worst</b> )
Sp1 Temperature	64.9 °F		
Air Temperature 1	68.4 °F		
Relative Humidity 1	55.4 %

**Comment: See previous comments**

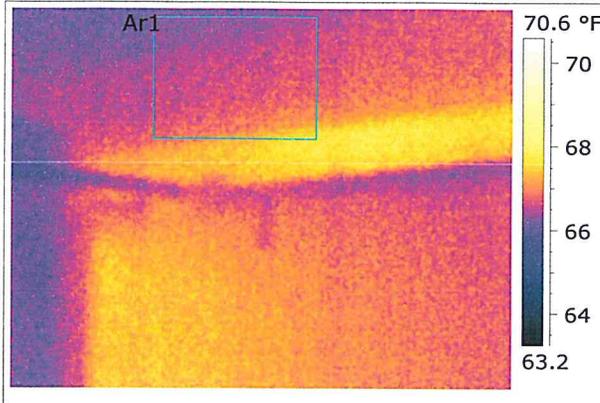
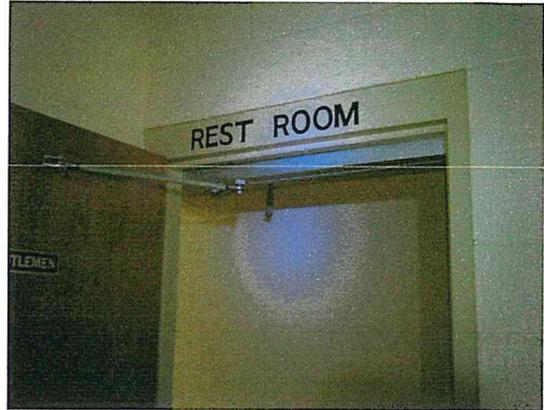
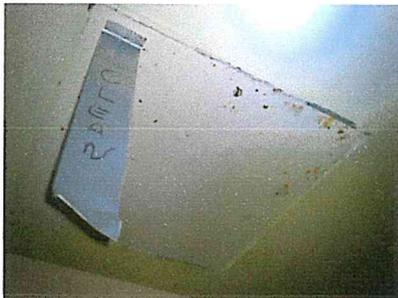
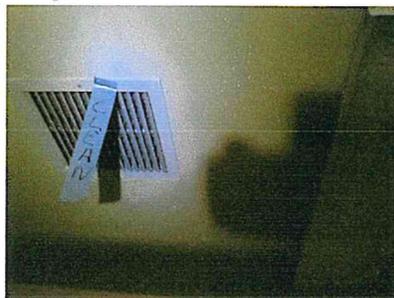
Date	12/30/2013	Location:	New Building-First Floor- Men's Room
Image Time	1:13:17 PM	<b>Other remarks:</b>	
Ar1 Max. Temperature	68.0 °F	Lab Results: <b>Room Air Test: 2,240 c/m3</b>	
Ar1 Min. Temperature	65.9 °F	Mold Rating: 3	
Ar1 Average Temperature	66.6 °F	Mold Rating: 1-5 (5 being worst)	
Air Temperature 1	72.1 °F		
Relative Humidity 1	51.6 %

**Comment:** All external readings in the chart to the upper left are within acceptable ranges. The air test is an acceptable range

**Recommendation:** The room needs cleaning per protocol "B" The supply duct needs cleaning per NADCA standards. (part of remediation "A")

**Remediation Protocol:** "A"

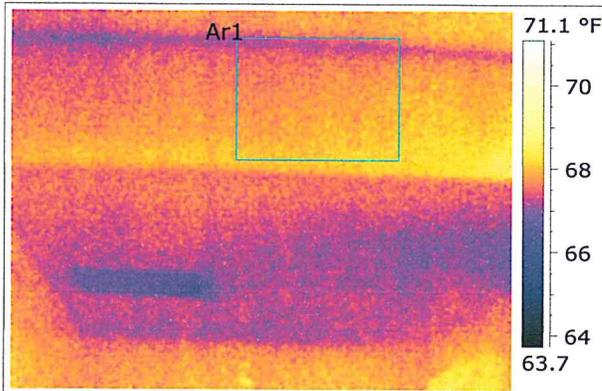
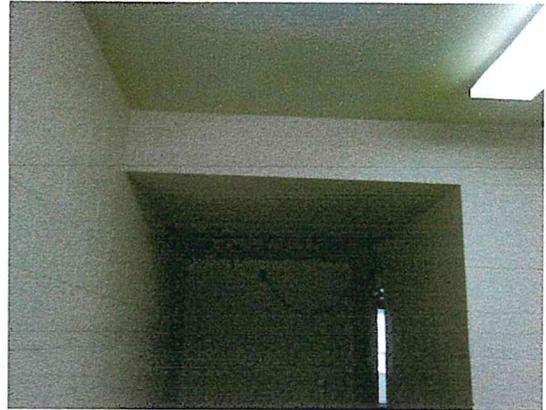
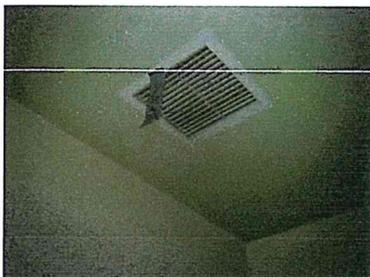
Date	12/30/2013	Location:	New Building-First Floor-Woman's Room
Image Time	1:15:27 PM	<b>Other remarks:</b>	
Ar1 Max. Temperature	68.5 °F	Wall:	
Ar1 Min. Temperature	66.9 °F	Ceilings:	
Ar1 Average Temperature	67.7 °F	Lab Results: <b>Room Air Test- 360c/m3</b>	
Air Temperature 1	71.8 °F	Mold Rating: <b>1</b>	
Relative Humidity 1	52.0 %	Mold Rating: 1- <b>5</b> ( <b>5</b> being worst)

**Comment: All readings are within acceptable range**

**Recommendation: General cleaning per remediation "A" The duct supply needs cleaning**

**Remediation Protocol: Plan "A "**

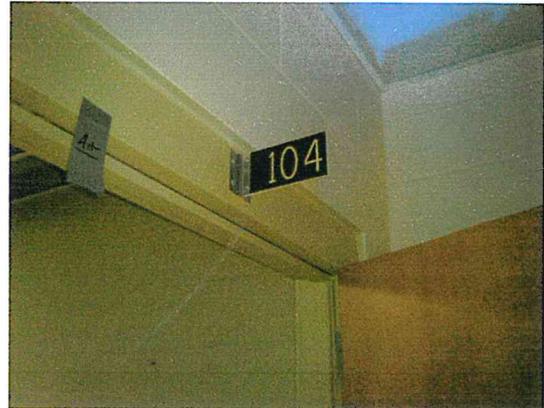
Date	12/30/2013	Location:	<b>New Building- First Floor- Room 104</b>
Image Time	2:06:48 PM	<b>Other remarks:</b>	
Ar1 Max. Temperature	68.0 °F	Wall:	Acceptable
Ar1 Min. Temperature	66.9 °F	Ceilings:	Acceptable
Ar1 Average Temperature	67.4 °F	Lab Results:	<b>Room Air Test-52,560 c/m3</b>
Air Temperature 1	69.8 °F		<b>Supply Vent- 0</b>
Relative Humidity 1	53.9 %	Mold Rating:	<b>5</b>
		Mold Rating:	1-5 (5 being worst)

**Comment: Condition 2 Mold level is high. No visual condition 3. All readings within normal ranges for humidity. No signs of moisture activity in deck or walls.**

**Recommendation: Clean needs to follow plan "B" because of high count.**

**Remediation Protocol: "B"**

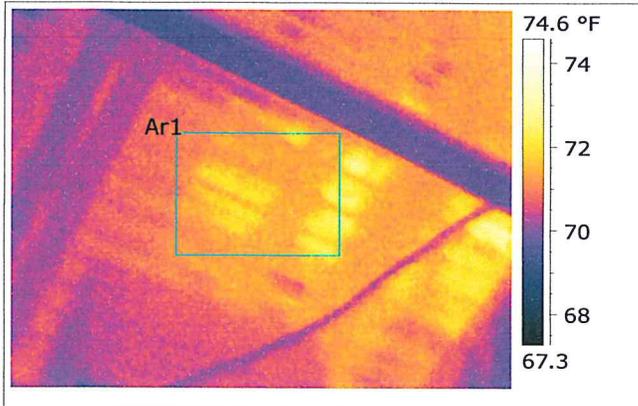
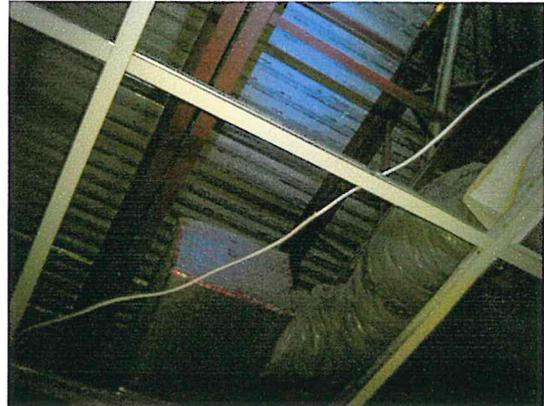
Date	12/30/2013	Location: Room104  <b>Other remarks: See previous comments</b>
Image Time	2:08:32 PM	
Ar1 Max. Temperature	72.6 °F	
Ar1 Min. Temperature	70.6 °F	
Ar1 Average Temperature	71.5 °F	
Air Temperature 1	70.2 °F	
Relative Humidity 1	53.1 %

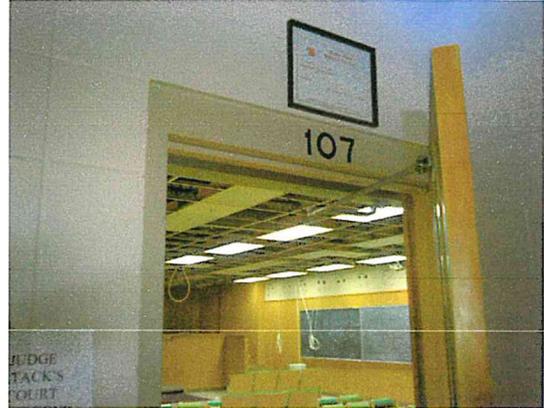
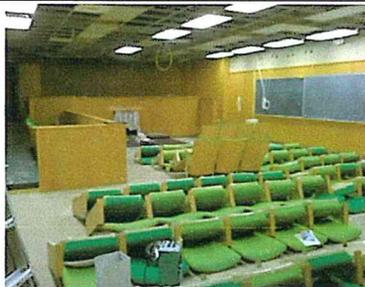
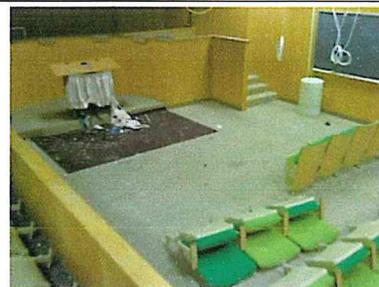
Date	12/30/2013	<b>Location:</b> New Building-First Floor-Room 107 <b>Courtroom</b>
Image Time	3:06:07 PM	
Ar1 Max. Temperature	68.7 °F	
Ar1 Min. Temperature	67.5 °F	
Ar1 Average Temperature	68.1 °F	
Air Temperature 1	70.7 °F	
Relative Humidity 1	52.0 %	
<b>Other remarks:</b> Wall: Acceptable Ceilings: Waste Drain-Leak was visable Lab Results: <b>Room Air Test- 54.960 c/m3</b>  Mold Rating: <b>5</b>  Mold Rating: 1- <b>5</b> ( <b>5</b> being worst)

**Comment:** The air test taken was very elevated with condition 2 mold spores.

**Recommendation:** Seats needs to be removed as well as carpet. All ceiling tiles need to come out. Seats should be cleaned off site in staging area if they are to be reused. Roof deck does not reveal excessive moisture. Trusses and deck need surface cleaning.

**Remediation Protocol:** Plan "B"

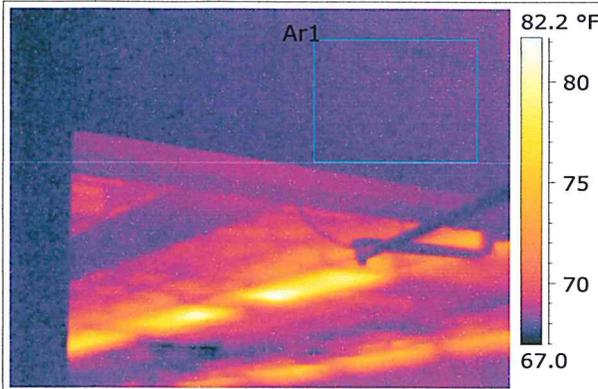
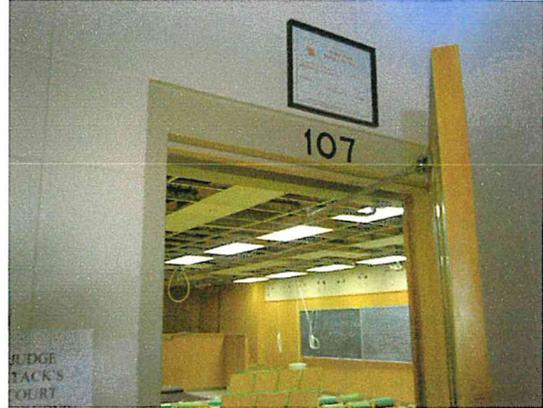
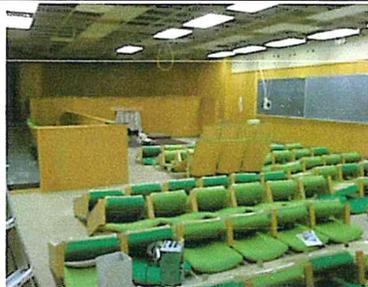
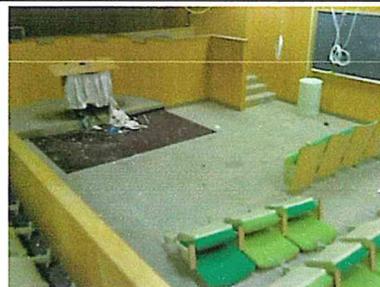
Date	12/30/2013	Location:	New Building-First Floor-Room 107 Courtroom
Image Time	3:06:07 PM	<b>Other remarks:</b>	
Ar1 Max. Temperature	68.7 °F	Wall: Acceptable	
Ar1 Min. Temperature	67.5 °F	Ceilings: Waste Drain-Leak was visible	
Ar1 Average Temperature	68.1 °F	Lab Results: <b>Room Air Test- 54.960 c/m3</b>	
Air Temperature 1	70.7 °F	Mold Rating: <b>5</b>	
Relative Humidity 1	52.0 %	Mold Rating: 1- <b>5</b> ( <b>5</b> being worst)

**Comment:** The air test taken was very elevated with condition 2 mold spores.

**Recommendation:** Seats needs to be removed as well as carpet. All ceiling tiles need to come out. Seats should be cleaned off site in staging area if they are to be reused. Roof deck does not reveal excessive moisture. Trusses and deck need surface cleaning.

**Remediation Protocol: Plan "B"**

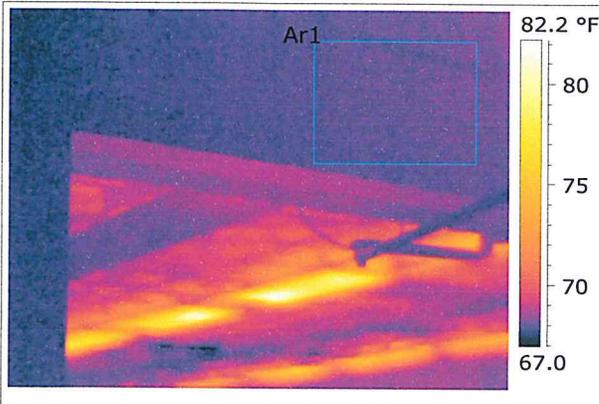
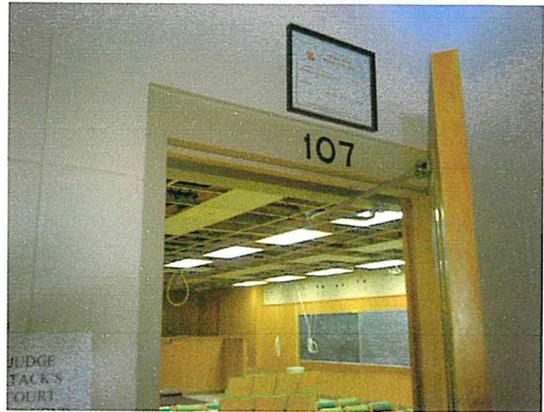
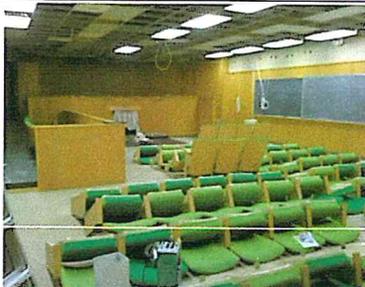
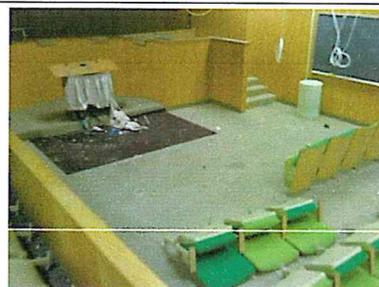
Date	12/30/2013	Location:	New Building-First Floor-Room 107 Courtroom
Image Time	3:06:07 PM	<b>Other remarks:</b>	
Ar1 Max. Temperature	68.7 °F	Wall: Acceptable	
Ar1 Min. Temperature	67.5 °F	Ceilings: Waste Drain-Leak was visable	
Ar1 Average Temperature	68.1 °F	Lab Results: <b>Room Air Test- 54.960 c/m3</b>	
Air Temperature 1	70.7 °F	Mold Rating: <b>5</b>	
Relative Humidity 1	52.0 %	Mold Rating: 1- <b>5</b> ( <b>5</b> being worst)

**Comment:** The air test taken was very elevated with condition 2 mold spores.

**Recommendation:** Seats needs to be removed as well as carpet. All ceiling tiles need to come out. Seats should be cleaned off site in staging area if they are to be reused. Roof deck does not reveal excessive moisture. Trusses and deck need surface cleaning.

**Remediation Protocol:** Plan "B"

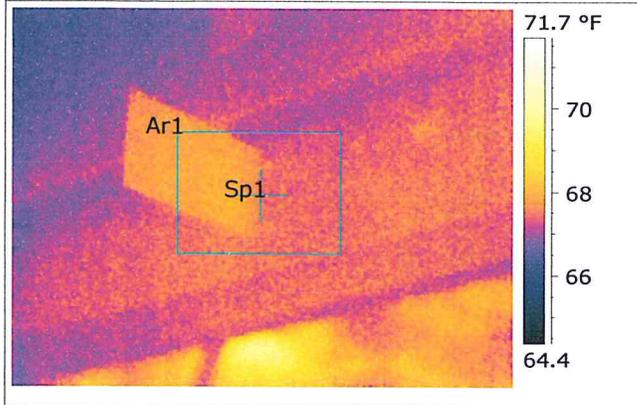
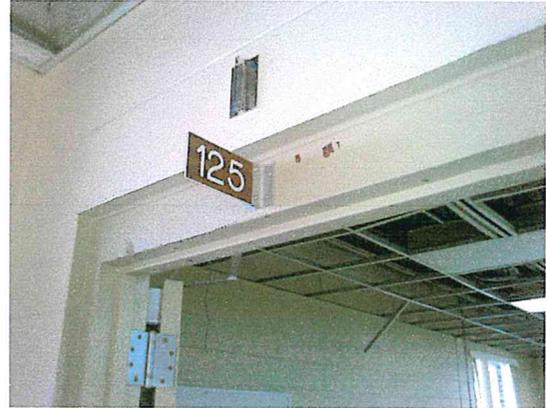
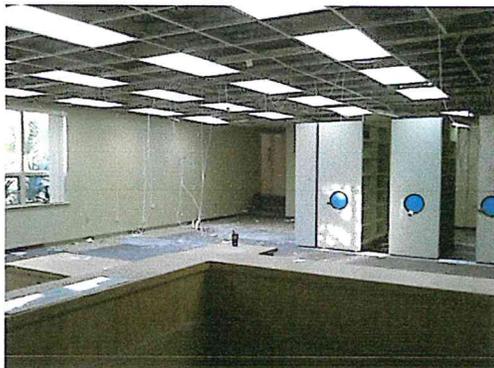
Date	12/30/2013	Location:	<b>New Building-First Floor-Room 125</b>
Image Time	4:54:02 PM	<b>Other remarks:</b>	
Ar1 Max. Temperature	68.3 °F	Wall:	See below
Ar1 Min. Temperature	66.9 °F	Ceilings:	Acceptable
Ar1 Average Temperature	67.6 °F	Lab Results:	<b>Room Air Test- 19,267 c/m3</b>
Sp1 Temperature	67.5 °F	Mold Rating:	<b>5</b>
Air Temperature 1	71.4 °F	Mold Rating:	1- <b>5 (5 being worst)</b>
Relative Humidity 1	55.5 %

**Comment: condition 2 level mold is elevated**

**Recommendation: Walls need to treated with moisture lock and insulated.**

**Remediation Protocol: "B"**

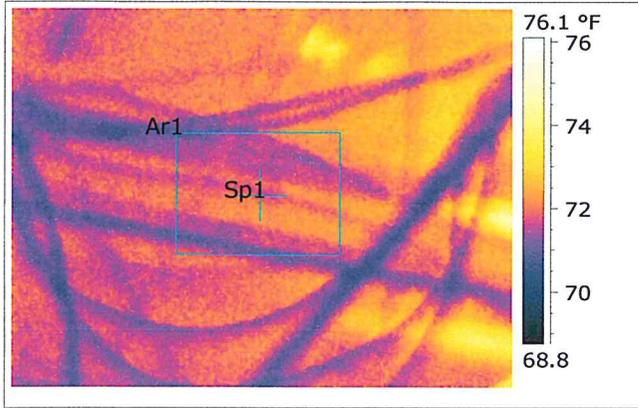
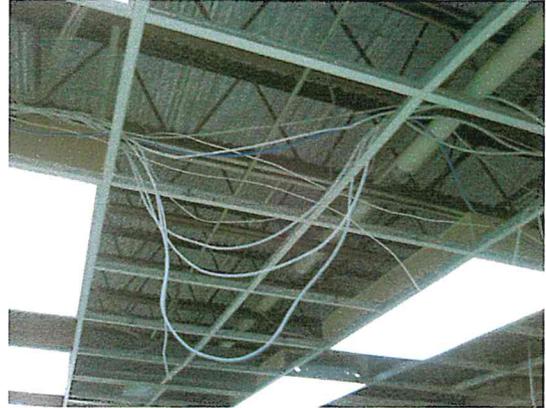
Date	12/30/2013	Location: Room 125  <b>Other remarks:</b>
Image Time	5:07:45 PM	
Ar1 Max. Temperature	72.7 °F	
Ar1 Min. Temperature	70.6 °F	
Ar1 Average Temperature	71.7 °F	
Sp1 Temperature	71.9 °F

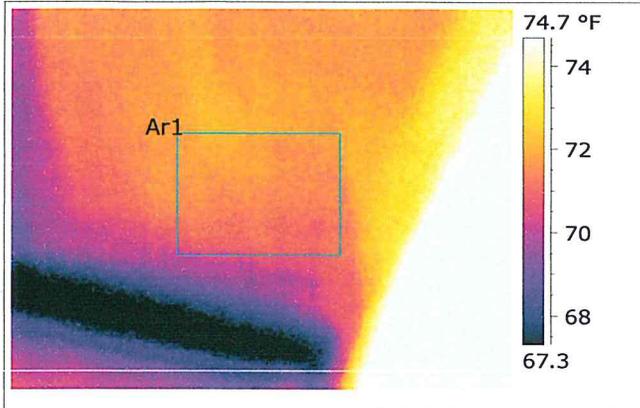
Date	12/30/2013	Location:	Room 125
Image Time	5:08:10 PM	<b>Other remarks:</b>	
Ar1 Max. Temperature	72.3 °F		
Ar1 Min. Temperature	69.8 °F		
Ar1 Average Temperature	71.4 °F

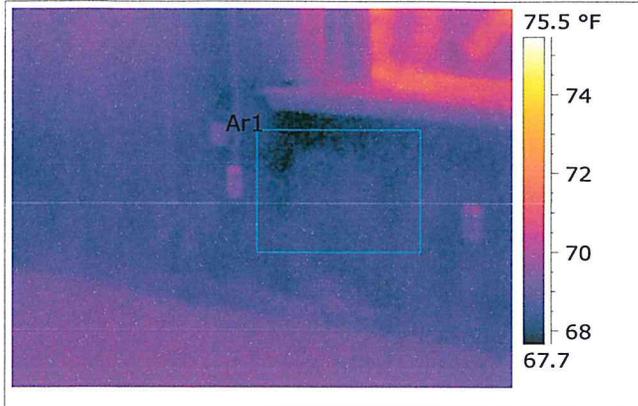
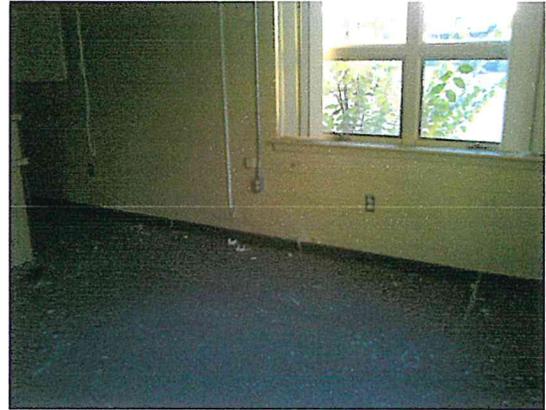
Date	12/30/2013	Location:	Room 125
Image Time	5:09:29 PM	<b>Other remarks: Excessive moisture on block wall. RH in first picture show 55 % RH. Walls are sweating due to no insulation. See protocol for recommendation</b>	
Ar1 Max. Temperature	69.0 °F		
Ar1 Min. Temperature	67.4 °F		
Ar1 Average Temperature	68.3 °F

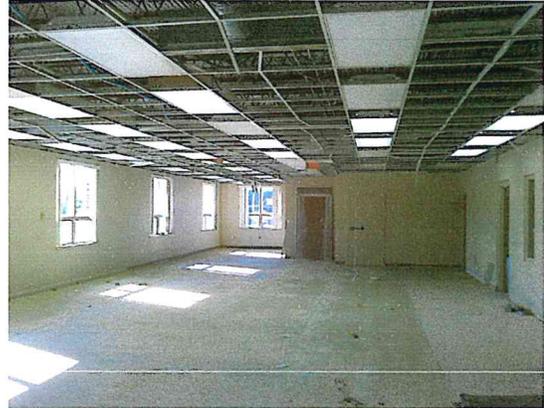
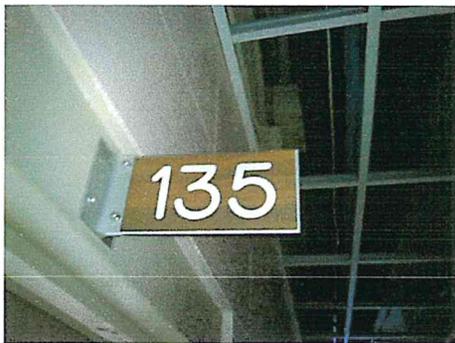
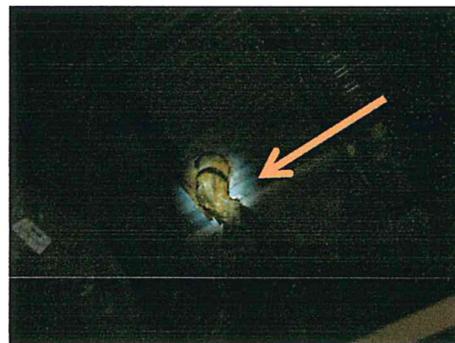
Date	12/30/2013	Location: <b>New Building-First Floor-Room 135</b>
Image Time	10:58:50 AM	
Ar1 Max. Temperature	83.5 °F	<b>Other remarks: Drain in bathroom show previous leaking, noted by orange arrow.</b>  <b>Ceiling in room does not show any evidence of water intrusion.</b>
Ar1 Min. Temperature	66.0 °F	
Ar1 Average Temperature	70.4 °F	
Sp1 Temperature	73.2 °F	
Air Temperature 1	72.1 °F	
Relative Humidity 1	52.7 %

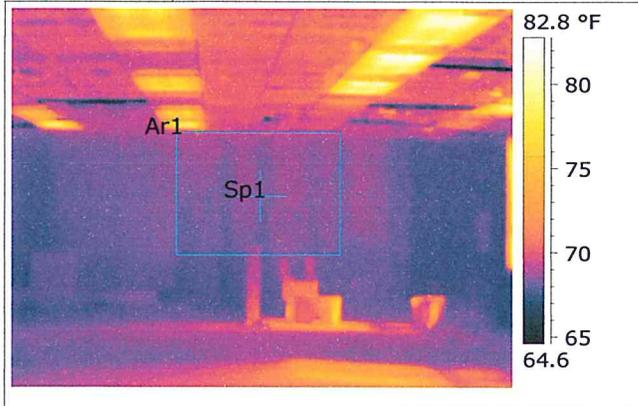
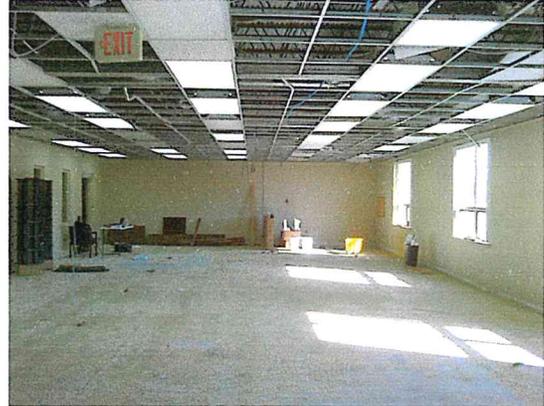
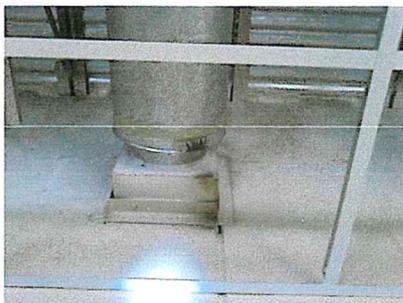
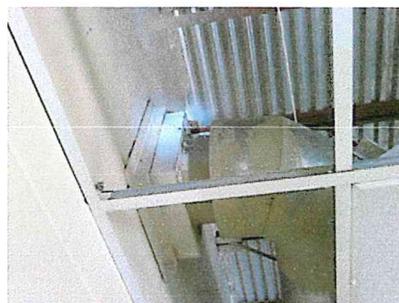
Date	12/30/2013	Location:	<b>Room 135</b>
Image Time	10:59:19 AM	Wall:	Acceptable
Ar1 Max. Temperature	70.5 °F	Ceilings:	Acceptable
Ar1 Min. Temperature	67.7 °F	Lab Results:	<b>Room Air Test: 253 c/m3</b>
Ar1 Average Temperature	68.5 °F		<b>Left Duct Swab: 348 c/m2</b>
Sp1 Temperature	68.4 °F		<b>Right Duct Swab: 59,106 c/m2</b>
Air Temperature 1	72.3 °F		<b>Vent Swab: 0 c/m2</b>
Relative Humidity 1	51.9 %	Mold Rating:	<b>4</b>
		Mold Rating:	<b>1-5 (5 being worst)</b>

**Comment: Room needs general cleaning. Mold air test acceptable**

**Recommendation: The duct show high readings on the exterior. Ducts need full remediation**

**Room Remediation Protocol: "A"**

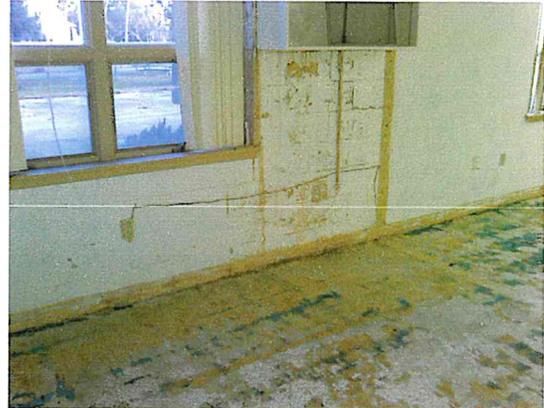
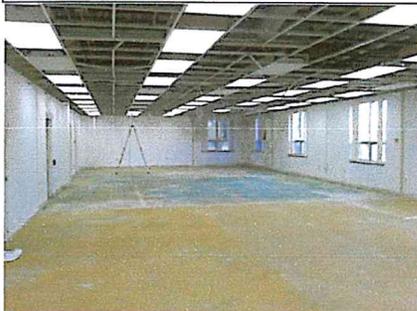
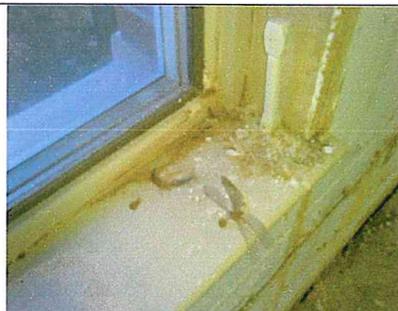
Date	12/30/2013	<b>Location: New building-First Floor-Room 137</b>  Wall: Water intrusion by window, walls high in moisture content Ceilings: Acceptable Lab Results: <b>Room Air Test- 253 c/m3</b>  Mold Rating: 2  Mold Rating: 1-5 (5 being worst)
Image Time	4:06:52 PM	
Ar1 Max. Temperature	68.4 °F	
Ar1 Min. Temperature	64.9 °F	
Ar1 Average Temperature	66.8 °F	
Sp1 Temperature	62.7 °F	
Air Temperature 1	71.6 °F	
Relative Humidity 1	53.8 %

**Comment:** Although the air test came back low the area around the last window on the south side has a major leaking issue. The window also show high moisture build up.

**Recommendation:** The outside brick needs tuck pointing. The window needs replacement. The walls need moisture sealing and insulation per specific protocol.

**Remediation Protocol:** Plan "B "

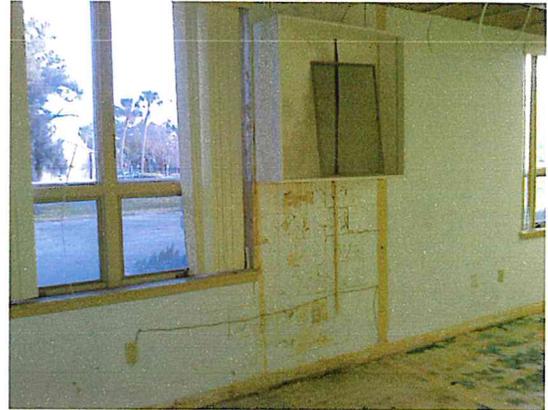
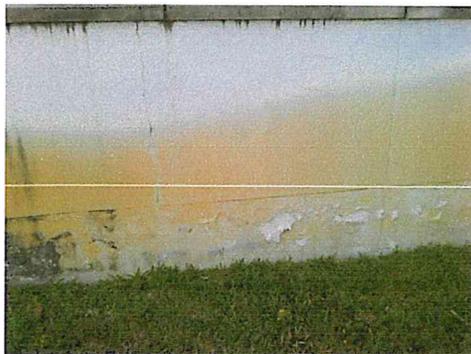
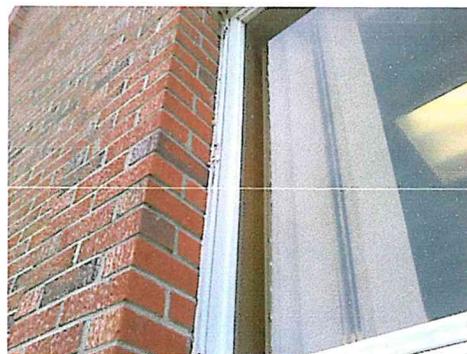
Date	12/30/2013	Location:	Room 137
Image Time	4:07:19 PM	<b>Other remarks:</b>	
Ar1 Max. Temperature	70.4 °F	Wall: Very high moisture readings on outer walls	
Ar1 Min. Temperature	68.0 °F	Lab Results: <b>Wall Swab Test- 2,037 c/m2</b>	
Ar1 Average Temperature	69.3 °F	<b>ATP Test confirmation: 450</b>	
Sp1 Temperature	66.5 °F	Mold Rating: <b>4</b>	
Air Temperature 1	71.6 °F	Mold Rating: 1- <b>5</b> ( <b>5 being worst</b> )	
Relative Humidity 1	53.8 %

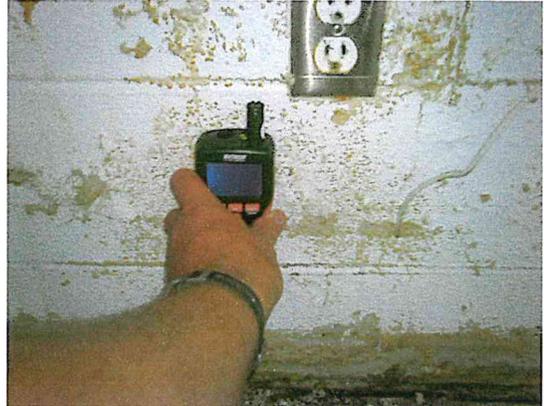
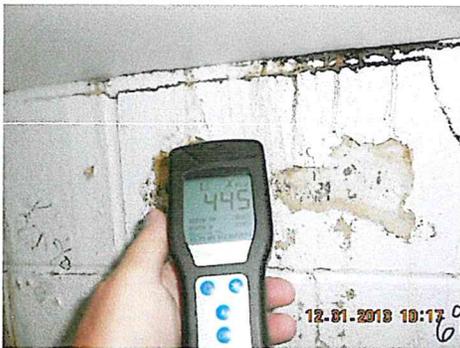
Date	12/30/2013	Location:	Room 137
Image Time	4:12:02 PM	<b>Other remarks:</b>	
Air Temperature 1	70.9 °F	Wall: Internal moisture is high at 37 %	
Internal Moisture 1	33.7 %

ATP on site meter. Showing bacterial or fungal substance

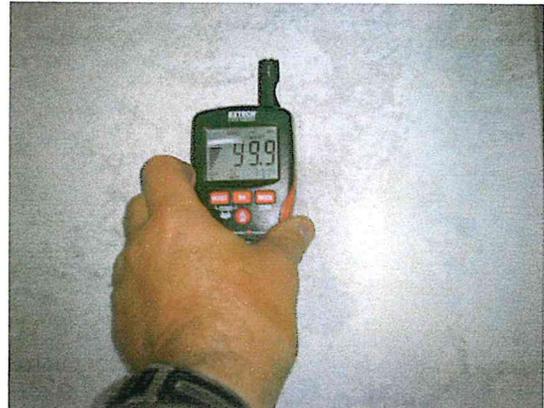
Date	12/30/2013	Location:	Room 137
Image Time	4:12:40 PM	<b>Other remarks:</b>	
Air Temperature 1	71.1 °F	Wall: The meter is showing highest possible reading for moisture	
Internal Moisture 1	99.9 %

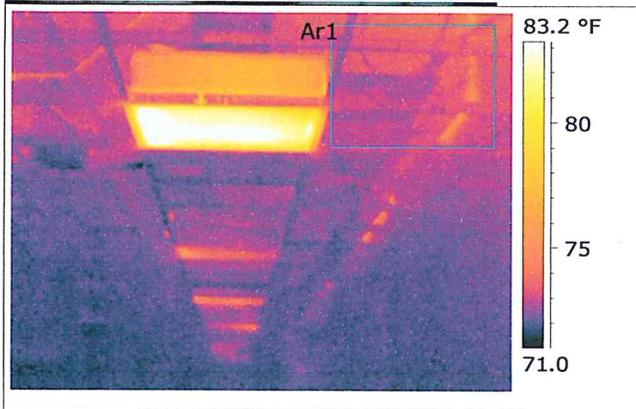
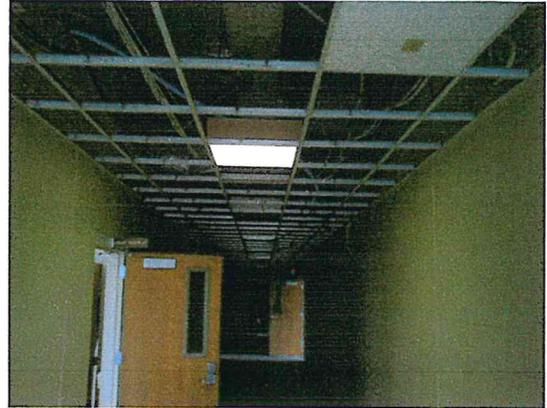
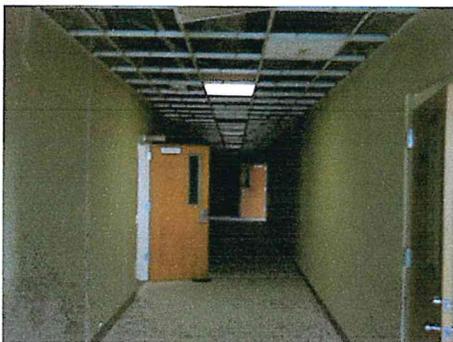
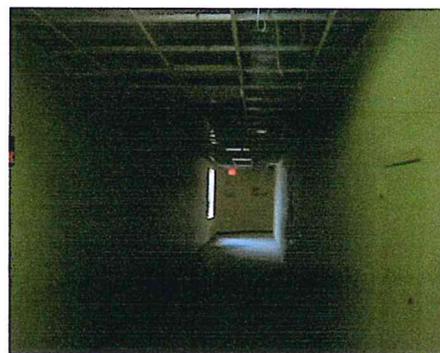
Location: **New Building-2<sup>nd</sup> Floor-Main Hallway**

Date	12/31/2013
Image Time	11:03:17 AM
Ar1 Max. Temperature	75.5 °F
Ar1 Min. Temperature	72.1 °F
Ar1 Average Temperature	73.2 °F
Air Temperature 1	72.9 °F
Relative Humidity 1	51.6 %

Mold Rating: **5**

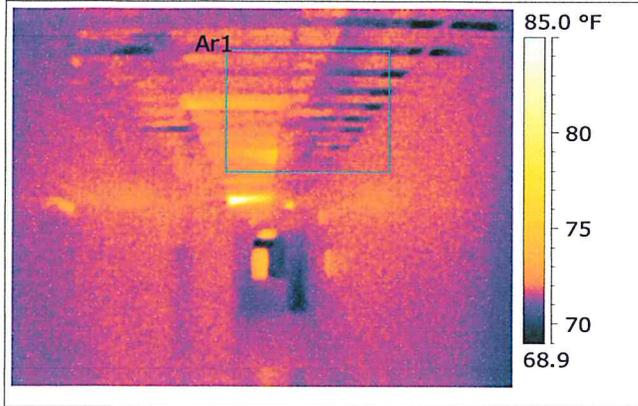
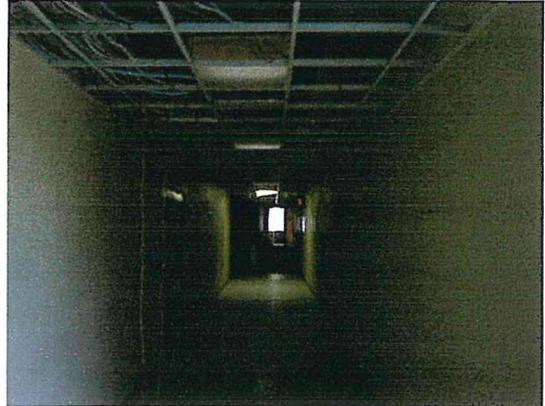
Date	12/31/2013	Location:	Main Hallway
Image Time	11:05:46 AM	Lab Results:	<b>Swab Test- 39,503 c/m3</b>
Ar1 Max. Temperature	76.7 °F	Mold Rating:	<b>5</b>
Ar1 Min. Temperature	69.5 °F	Mold Rating:	1- <b>5</b> ( <b>5</b> being worst)
Ar1 Average Temperature	71.8 °F		
Air Temperature 1	72.0 °F		
Relative Humidity 1	53.2 %

**Comment: See previous comment**

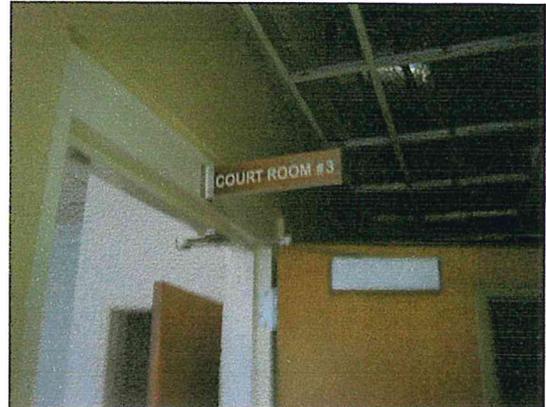
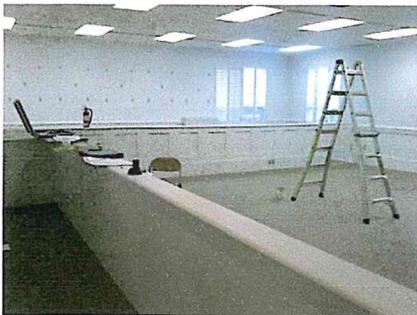
Date	12/31/2013	Location: <b>New Building-1<sup>st</sup>. Floor-Courtroom 3</b>  <b>Other remarks:</b>  <b>Room Air Test: 19,307 c/m3</b>
Image Time	9:59:38 AM	
Ar1 Max. Temperature	71.1 °F	
Ar1 Min. Temperature	70.0 °F	
Ar1 Average Temperature	70.5 °F	
Air Temperature 1	72.3 °F	
Relative Humidity 1	53.8 %

**Comment: An air test revealed a elevated condition 2 spore count. The room humidity is normal. However the otter walls show high moisture (se below)**

**Recommendation: Because of the elevated count the ceiling tiles need to be removed. The carpet is in good condition therefore if it is to be kept it needs to be steam cleaned.**

**Remediation Protocol: Plan " B "**

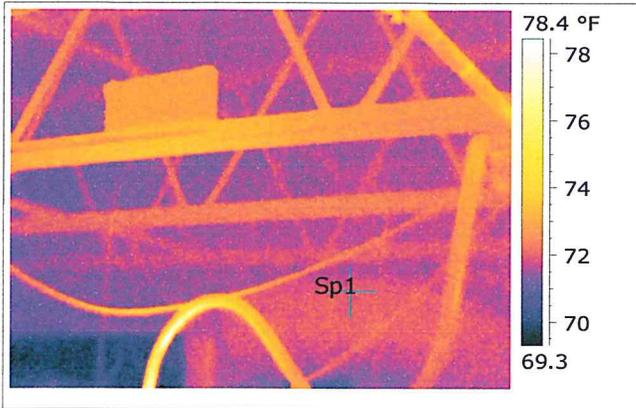
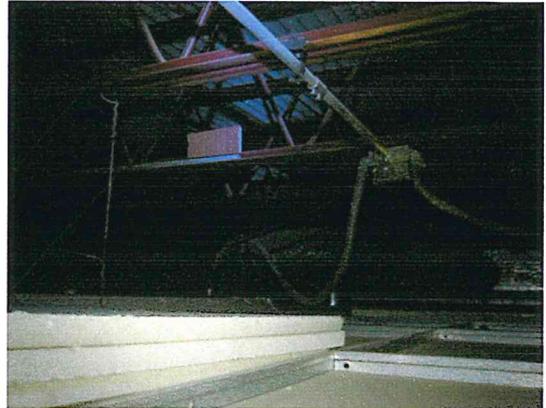
Wall:  
Ceilings: Acceptable

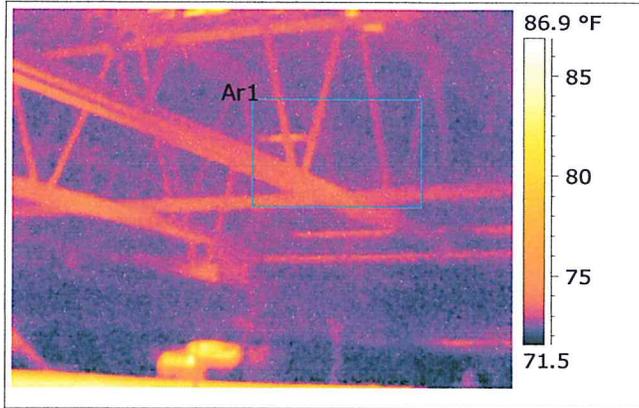
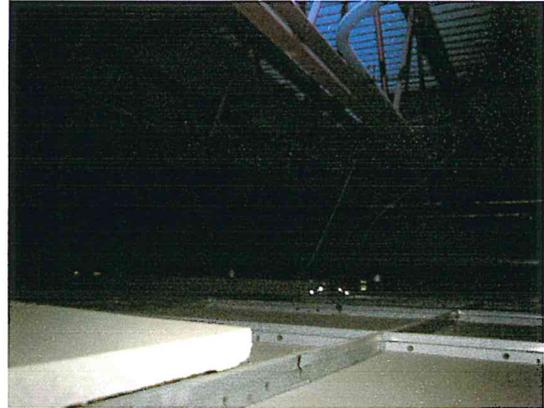
Ceilings: Acceptable

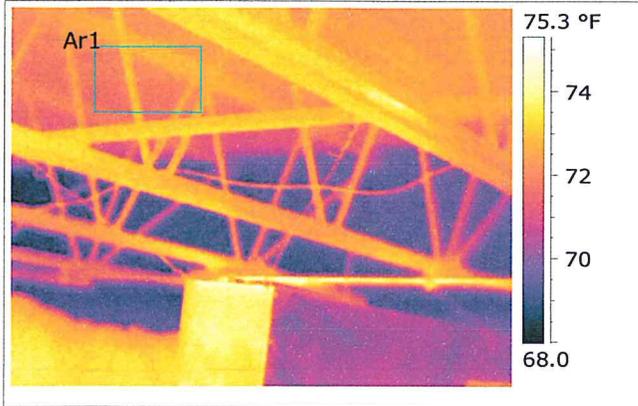
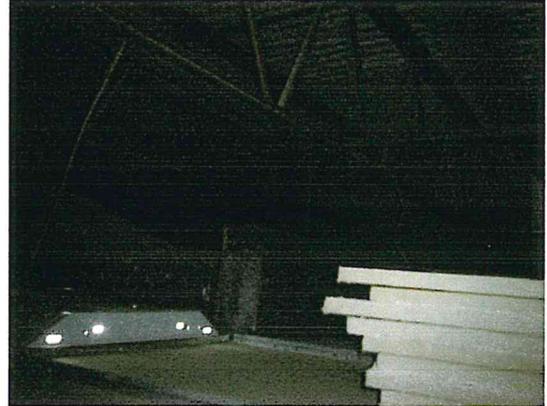
Ceilings: Acceptable. Purple color is reflective imaging.

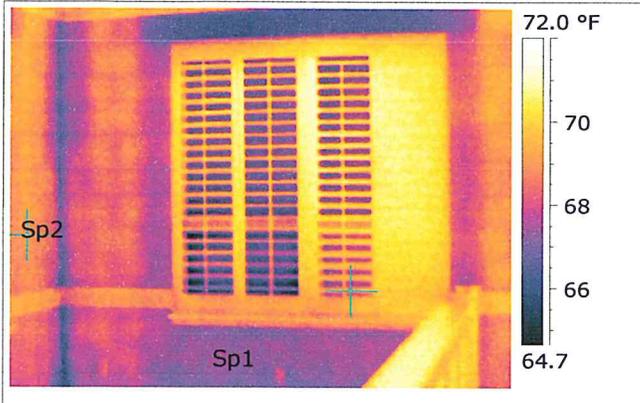
Date	12/31/2013	Location: (Where)
Image Time	10:03:26 AM	
Sp1 Temperature	68.5 °F	
Sp2 Temperature	69.1 °F	
		<b>Other remarks:</b>
		Wall: The thermal image shows cold spots in block wall which is contributing to high moisture.

**Recommendation: Walls need to be contained by applying moisture resistant coating and applying insulation.**

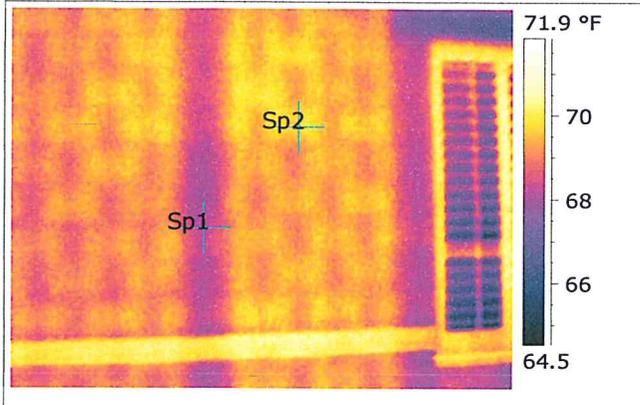
Date	12/31/2013	Location: (Where)
Image Time	10:04:03 AM	
Sp1 Temperature	68.4 °F	
Sp2 Temperature	69.6 °F	
		<b>Other remarks:</b> Wall: High moisture readings on the outer walls. Interior walls are acceptable.

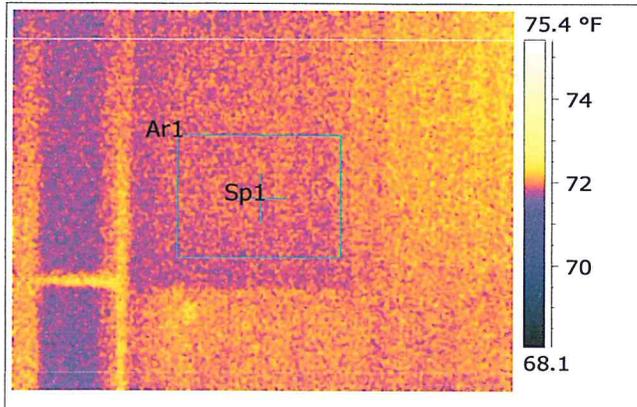
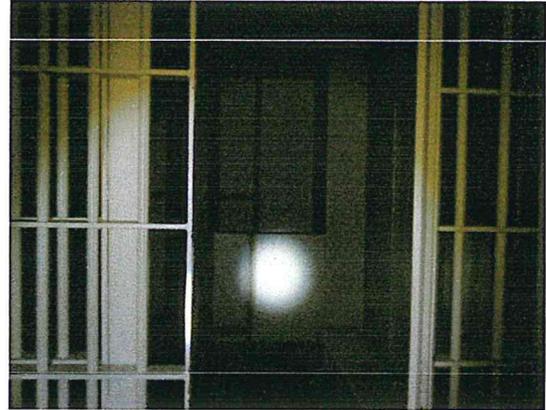
Date	12/31/2013	Location:	<b>Holding Cell 231- Left side</b>
Image Time	1:36:05 PM	Wall:	Metal
Ar1 Max. Temperature	72.4 °F	Ceilings:	Metal
Ar1 Min. Temperature	71.4 °F	Lab Results:	<b>Room Air Test- 6,587 c/m3</b>
Ar1 Average Temperature	71.9 °F	Mold Rating:	<b>5</b>
Sp1 Temperature	71.9 °F	Mold Rating:	1-5 ( <b>5 being worst</b> )
Air Temperature 1	74.5 °F		
Relative Humidity 1	48.0 %

**Comment: The cells are all metal walls. The air sample is elevated suggesting Plan "B"**

**Recommendation: The only option for these rooms is cleaning due to the construction**

**Remediation Protocol: Plan "B"**

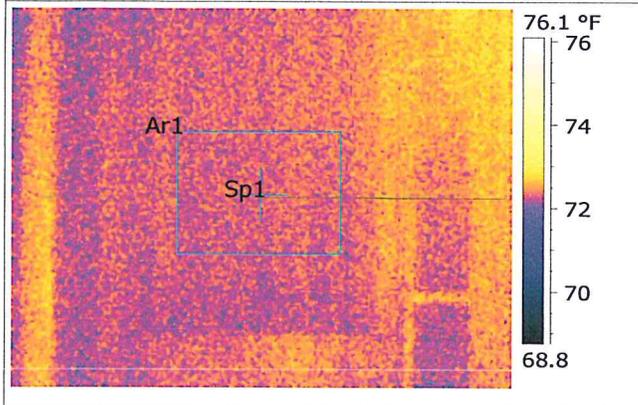
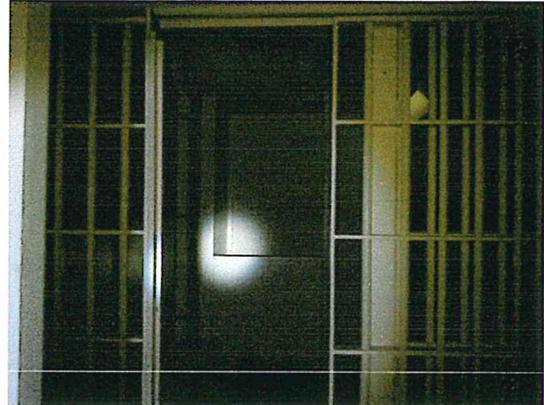
Date	12/31/2013	Location:	New Building-2 <sup>nd</sup> Floor-Holding Cell 228-Right
Image Time	1:36:35 PM	<b>Other remarks:</b>	
Ar1 Max. Temperature	72.8 °F	Wall: Metal	
Ar1 Min. Temperature	71.8 °F	Ceilings: Metal	
Ar1 Average Temperature	72.3 °F	Lab Results: <b>Room Air Test- 43,267 c/m3</b>	
Sp1 Temperature	72.4 °F	Mold Rating: <b>5</b>	
Air Temperature 1	74.5 °F	Mold Rating: 1-5 (5 being worst)	
Relative Humidity 1	47.7 %

**Comment: All walls and ceiling are metal.**

**Recommendation: Because of high readings the cell area need negative containment**

**Remediation Protocol: Plan "B "**

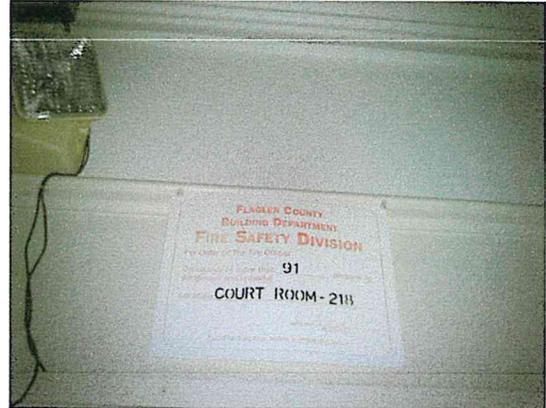
Date	12/31/2013	<table border="1"> <tr> <td>Location:</td> <td><b>New Building-2<sup>nd</sup> Floor- Courtroom 218</b></td> </tr> </table> <p><b>Other remarks:</b></p> <p>Wall: Acceptable Ceilings: Acceptable</p> <p>Lab Results: <b>Room Air Test- 36,387 c/m3</b></p> <p>Mold Rating: <b>5</b></p> <p>Mold Rating: 1-<b>5</b> (<b>5</b> being worst)</p>	Location:	<b>New Building-2<sup>nd</sup> Floor- Courtroom 218</b>
Location:	<b>New Building-2<sup>nd</sup> Floor- Courtroom 218</b>			
Image Time	1:37:28 PM			
Ar1 Max. Temperature	73.5 °F			
Ar1 Min. Temperature	72.3 °F			
Ar1 Average Temperature	72.9 °F			
Sp1 Temperature	72.7 °F			
Air Temperature 1	74.3 °F			
Relative Humidity 1	48.4 %

**Comment: The room's humidity is at an acceptable level. However elevated condition spore count**

**Recommendation: Full cleaning required. Recommend removing carpet& ceiling tiles**

**Remediation Protocol: Plan "B "**

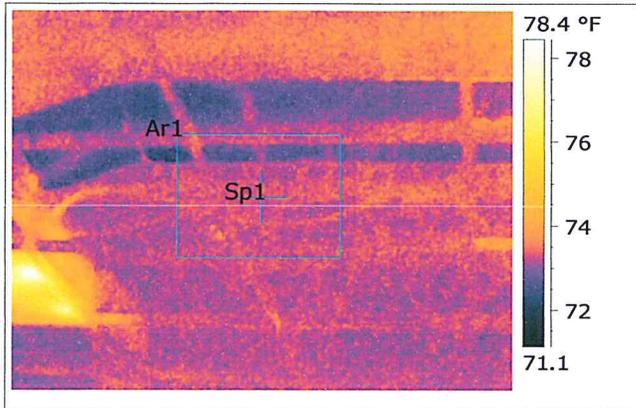
Location: (Where)

Wall: Acceptable. No moisture detected  
Ceilings: Acceptable. No moisture detected

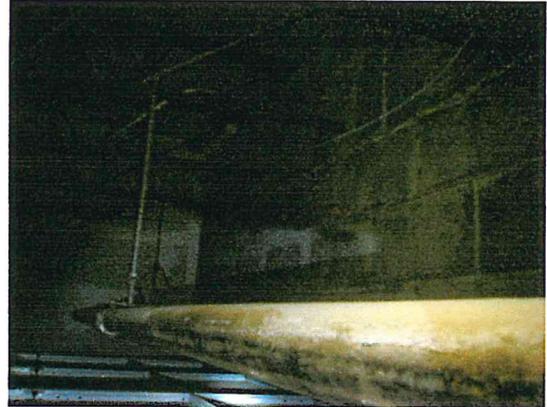
Date	12/31/2013	Location:	(Where)
Image Time	1:45:32 PM	<b>Other remarks:</b>	
Air Temperature 1	74.3 °F	Wall: Paneling	
Relative Humidity 1	48.1 %	Ceilings: Acceptable	
		Lab Results: <b>Room Air Test- 23,547 c/m3</b>	
		Mold Rating: <b>5</b>	
		Mold Rating: 1-5 (5 being worst)

**Comment: The mold count is elevated.**

**Recommendation: The paneling, ceiling tiles and the carpet need to be removed before remediation. Evaluate the outer walls once paneling is removed.**

**Remediation Protocol: Plan " B "**

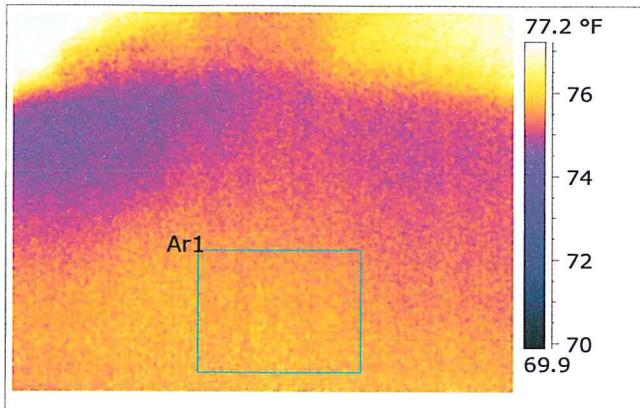
Location: Jury room

**Other remarks: The outer walls above the drop ceiling show moisture**

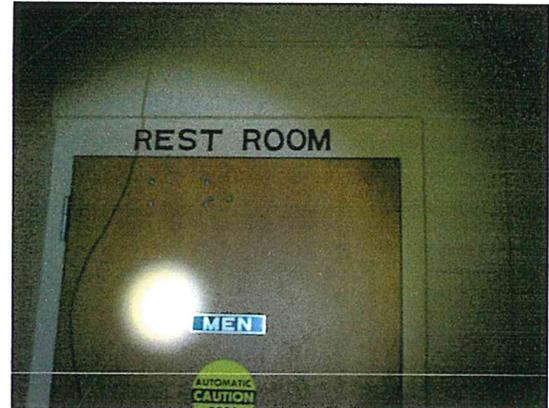
Date	12/31/2013	Location:	New Building-2 <sup>nd</sup> Floor- Men's Room
Image Time	1:09:10 PM	<b>Other remarks:</b>	
Ar1 Max. Temperature	71.1 °F	Wall:	Acceptable
Ar1 Min. Temperature	70.0 °F	Ceilings:	Acceptable
Ar1 Average Temperature	70.6 °F	Lab Results:	<b>Room Air Test- 270,893 c/m3</b>
Sp1 Temperature	70.5 °F	Mold Rating:	<b>5</b>
Air Temperature 1	72.9 °F	Mold Rating:	1- <b>5 (5 being worst)</b>
Relative Humidity 1	53.5 %

**Comment: Mold spore count is very elevated in this room.**

**Recommendation: Clean duct system and provide full "B" remediation**

**Remediation Protocol: Plan "B" "**

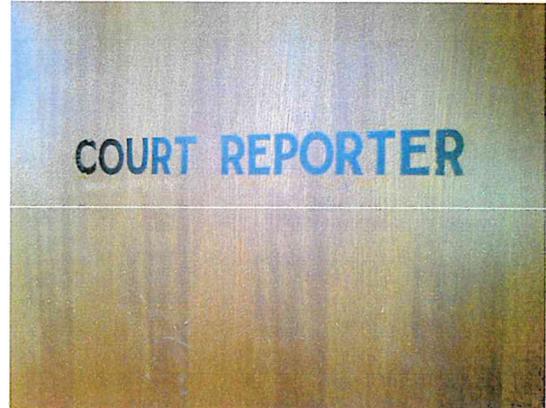
Date	12/31/2013	Location: <b>New Building- 2<sup>nd</sup> Floor-Court Reporter room</b>
Image Time	1:17:26 PM	
Ar1 Max. Temperature	70.8 °F	
Ar1 Min. Temperature	68.5 °F	
Ar1 Average Temperature	70.2 °F	
Sp1 Temperature	70.1 °F	
Air Temperature 1	71.8 °F	
Relative Humidity 1	52.8 %	
<b>Other remarks:</b>		
Wall: Excessive moisture on outer block wall. Readings well exceed normal. RH% is normal		
Ceilings: Acceptable		
Lab Results: <b>Room Air Test- 37,240 c/m3</b>		
Mold Rating: <b>5</b>		
Mold Rating: 1- <b>5</b> ( <b>5</b> being worst)

**Comment: The RH % is within normal range however the walls are showing high moisture readings. The spore count is elevated.**

**Recommendation: The outer walls need to be sealed and insulated**

**Remediation Protocol: Plan "B "**

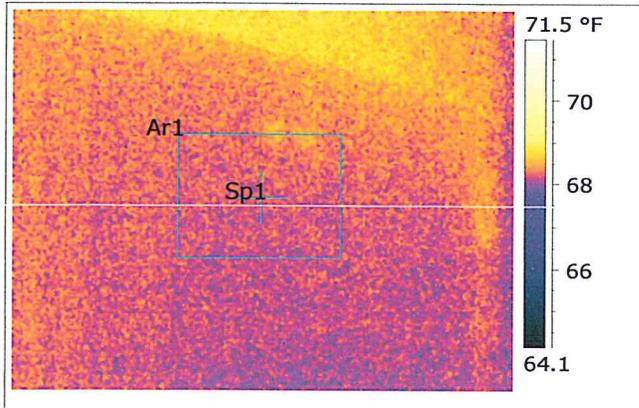
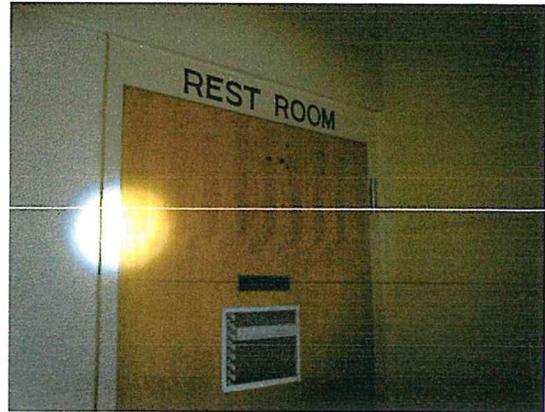
Location: **New Building-2<sup>nd</sup> Floor-Woman's Room**

**Comment: Condition 2 mold spores are elevated in this room.**

**Recommendation: Full cleaning of room and duct system**

**Remediation Protocol: Plan " B "**

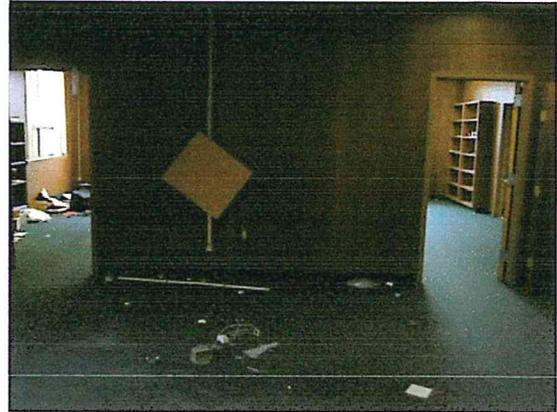
Date	12/31/2013	Location:	New Building-2 <sup>nd</sup> Floor- 206-Front Room
Image Time	1:46:06 PM	<b>Other remarks:</b>	
Air Temperature 1	74.3 °F	Lab Results:	<b>Room Air Test- 2,667 c/m3</b>
Relative Humidity 1	48.1 %	Mold Rating:	2
		Mold Rating:	1-5 (5 being worst)

**Comment:** Air test is in an acceptable range, however back two offices that a adjacent to it. Those rooms have elevated counts. The ceiling above the tile appears to be dry at the time of this inspection.

**Recommendation:** Remove all paneling, carpets and ceiling tiles. Remediate the 3 spaces as one.

**Remediation Protocol:** Plan "B "
