Mold Assessment-Protocol Report

For Bunnell Courthouse  
200 East Moody Blvd.  
Bunnell FL.

Date: January 12, 2014

Job #: 13-235-2

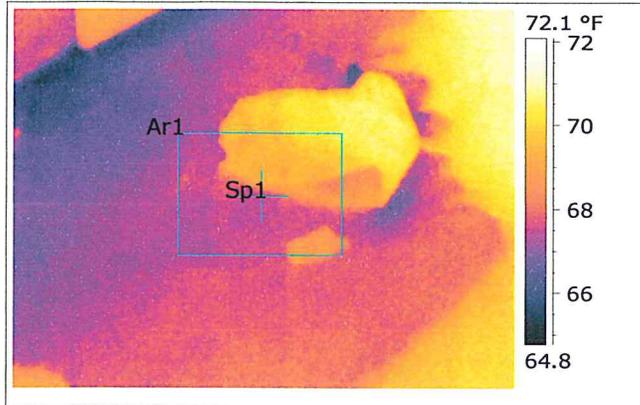
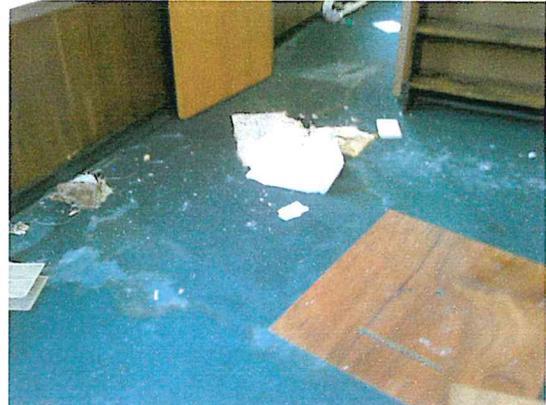
Date	12/31/2013	Location:	New Building-2 <sup>nd</sup> Floor-Left office of 206
Image Time	2:08:14 PM	Wall:	Excessive moisture
Ar1 Max. Temperature	70.7 °F	Floor:	Wet Carpet
Ar1 Min. Temperature	66.8 °F	Ceilings:	No leaks evident
Ar1 Average Temperature	68.3 °F	Lab Results:	<b>Room Air Test- 5,067 c/m3</b>
Sp1 Temperature	67.6 °F	Mold Rating:	<b>4</b>
Air Temperature 1	74.3 °F	Mold Rating:	1-5 ( <b>5</b> being worst)
Relative Humidity 1	48.6 %

**Comment:** The spore count is elevated. The wet carpet suggests wall leak as the ceiling did not show evidence of leak. Humidity was in acceptable range.

**Recommendation:** All paneling, ceiling tiles and carpet to be removed in conjunction with the front room and the right office. Once paneling is off the outer wall needs to be evaluated.

**Remediation Protocol:** Plan " B "

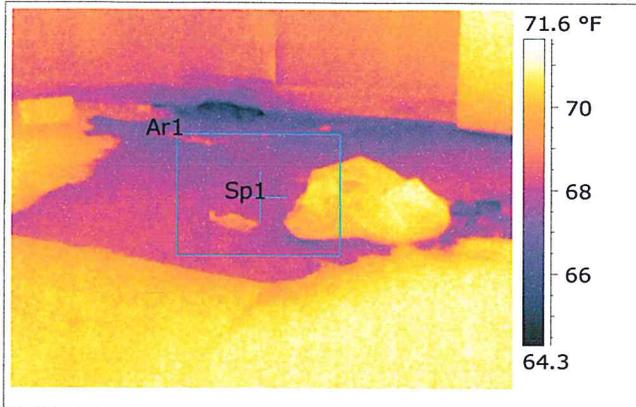
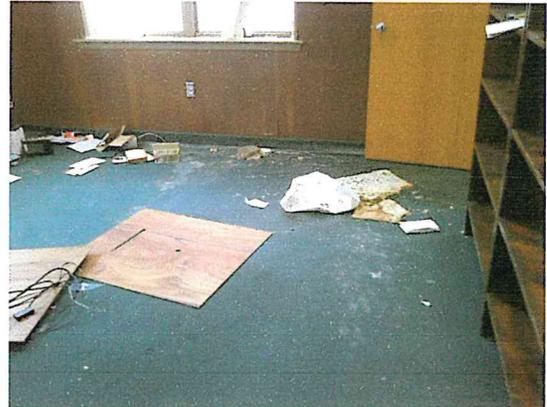
Location: Left Office-206

Floor: Actively wet at the time of inspection

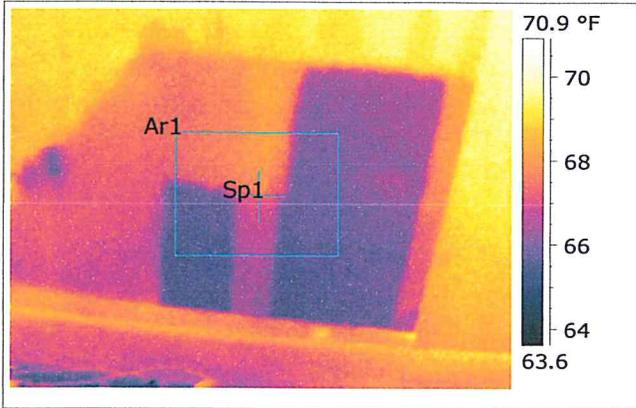
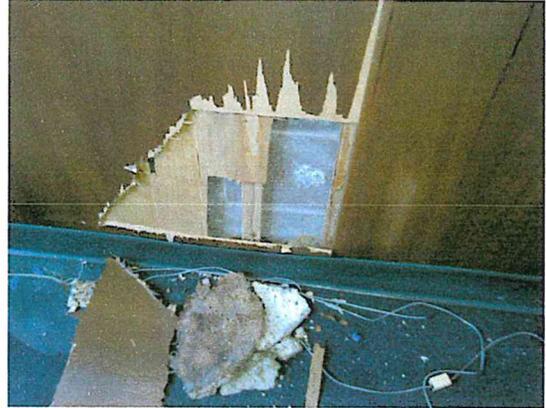
Location: 206 Left Office

Wall: Space behind paneling has excessive moisture.

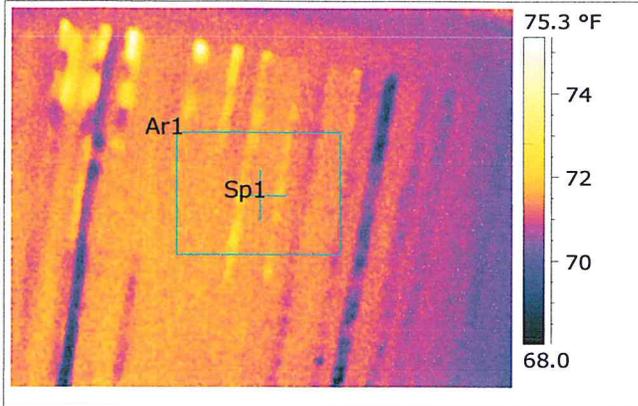
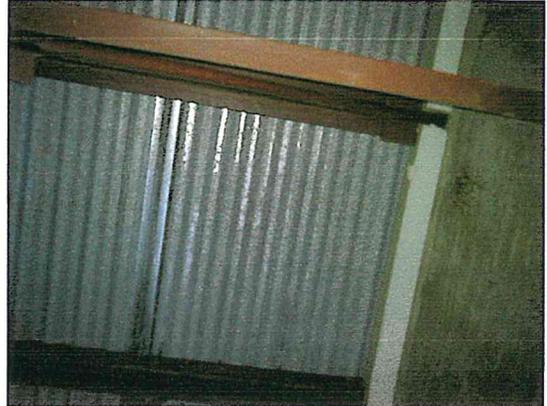
Date	12/31/2013	Location: 206 Left Office  <b>Other remarks:</b>  Ceilings: No signs of active leak
Image Time	2:21:11 PM	
Ar1 Max. Temperature	72.7 °F	
Ar1 Min. Temperature	70.6 °F	
Ar1 Average Temperature	71.5 °F	
Sp1 Temperature	71.5 °F

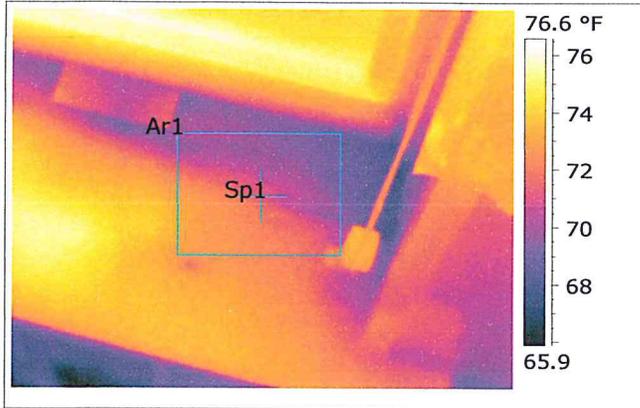
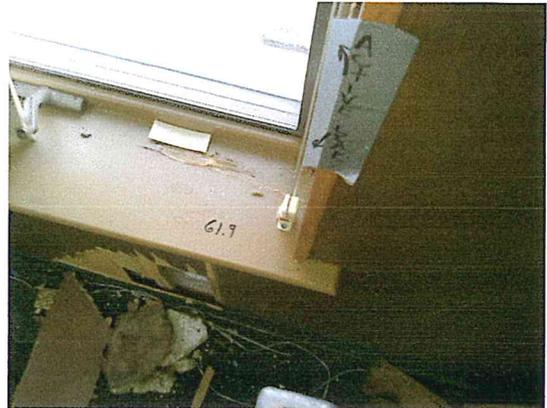
Location: 206 Left Office

Wall: Wet around windows. Paneling is high on the surface by the window-30%  
Window: Sill has high moisture count of 62%

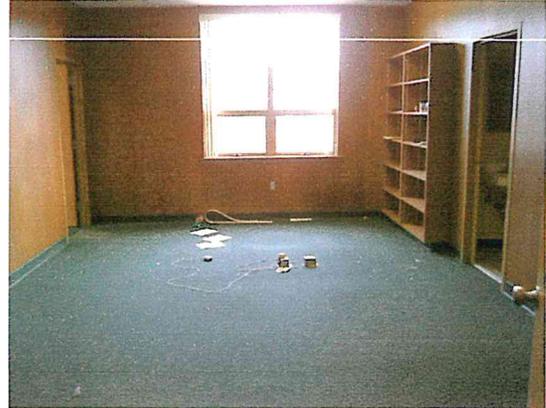
Date	12/30/2013	Location:	<b>New Building-2<sup>nd</sup> Floor-206 Right Office</b>
Image Time	2:08:32 PM	<b>Other remarks:</b>	
Ar1 Max. Temperature	72.6 °F	Wall: Paneling was acceptable	
Ar1 Min. Temperature	70.6 °F	Ceilings: Acceptable	
Ar1 Average Temperature	71.5 °F	Lab Results: No test taken	
Sp1 Temperature	72.0 °F		
Air Temperature 1	70.2 °F		
Relative Humidity 1	53.1 %

**Comment: No tests were taken in this room. This room should be remediated like the other two rooms of 206 even though excessive moisture did not appear.**

**Remediation Protocol: Plan "B"**

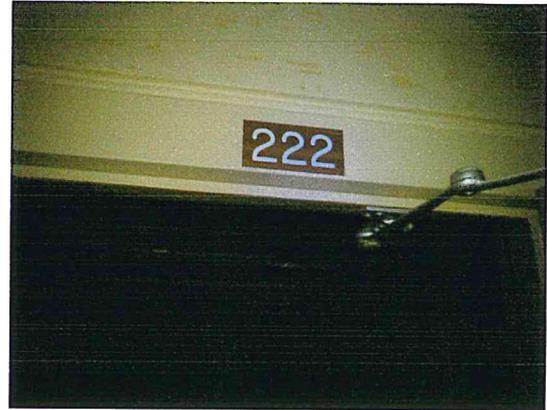
Date	12/31/2013	Location:	New building-2 <sup>nd</sup> Floor-Room 222
Image Time	10:32:43 AM	<b>Other remarks:</b>	
Sp1 Temperature	72.8 °F	Wall: Surface readings are dry	
Sp2 Temperature	72.2 °F	Ceilings: Acceptable	
Air Temperature 1	72.7 °F	Lab Results: <b>Room Air Test- 34,333 c/m3</b>	
Relative Humidity 1	59.3 %	Mold Rating: <b>5</b>	
		Mold Rating: 1-5 (5 being worst)

**Comment: The mold spore count is elevated**

**Recommendation: Remove paneling, carpet and ceiling tiles**

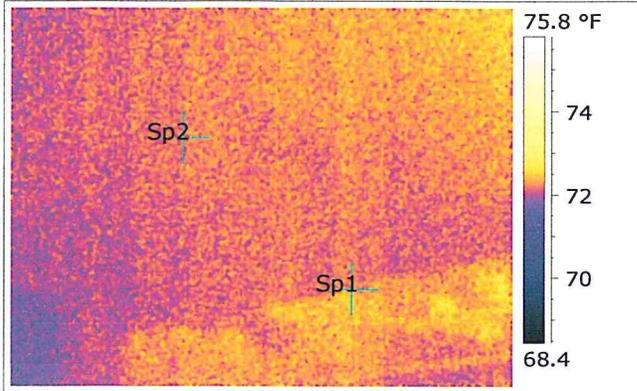
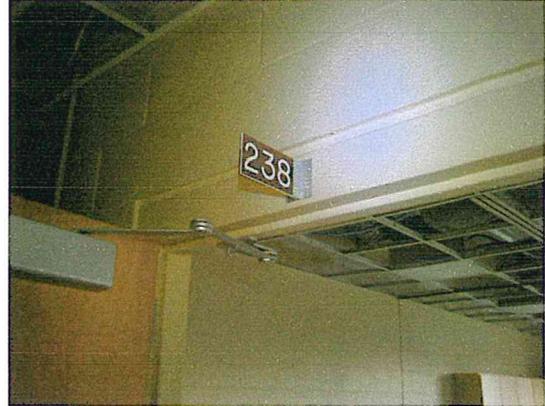
Location: **New building-2<sup>nd</sup> Floor-Room 238**

Date	12/31/2013
Image Time	10:18:36 AM
Sp1 Temperature	72.3 °F
Sp2 Temperature	72.2 °F
Air Temperature 1	73.4 °F
Relative Humidity 1	52.5 %

Wall: Elevated moisture readings on outer block walls  
 Ceilings: Acceptable  
 Lab Results: **Room Air Test- 36,067 c/m3**  
 Mold Rating: 5  
 Mold Rating: 1-5 (5 being worst)

**Comment: The outer wall readings noted in pictures below were excessive in areas. These readings are mark on the block walls. The ceiling deck was dry. Elevated mold spores in the room**

**Recommendation: All outer walls need to have moisture block and insulation installed. All windows need sealing.**

**Remediation Protocol: Plan " B "**

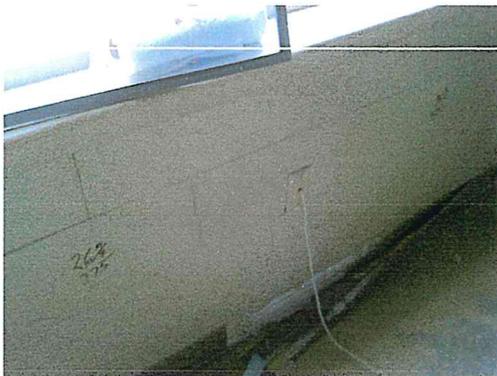
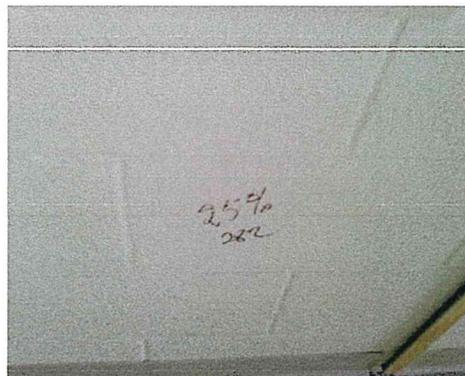
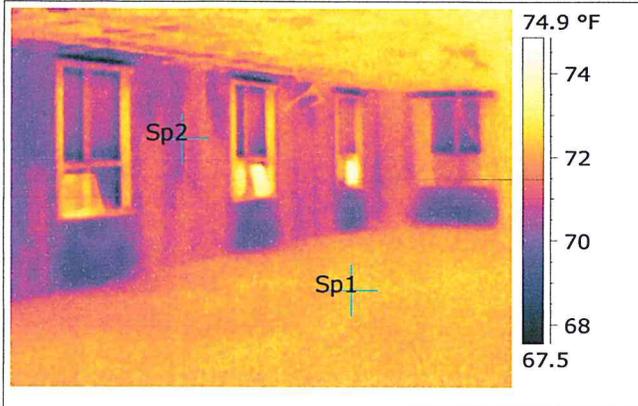
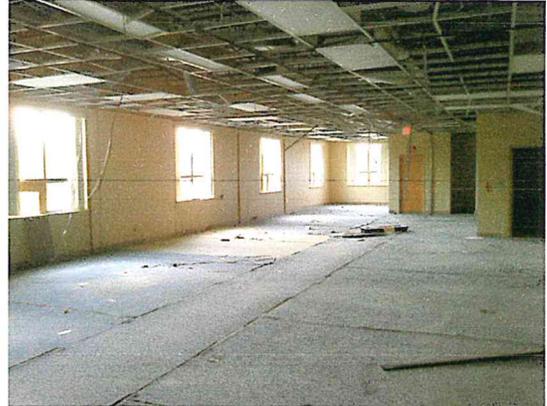
Date	12/31/2013	Location: Room 238  <b>Other remarks:</b>  Wall: Thermal shows cold areas around and below windows. Ceilings:
Image Time	10:19:21 AM	
Sp1 Temperature	72.3 °F	
Sp2 Temperature	70.8 °F	
Air Temperature 1	73.4 °F	
Relative Humidity 1	51.9 %

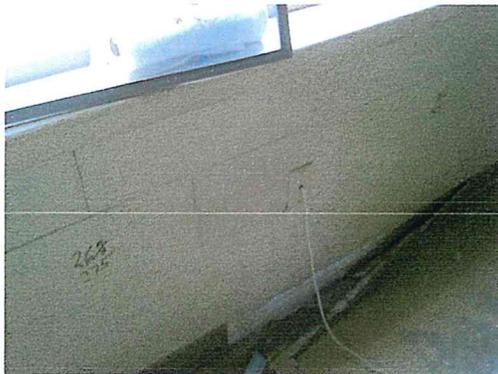
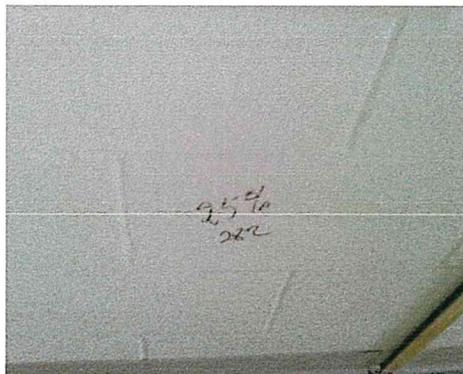
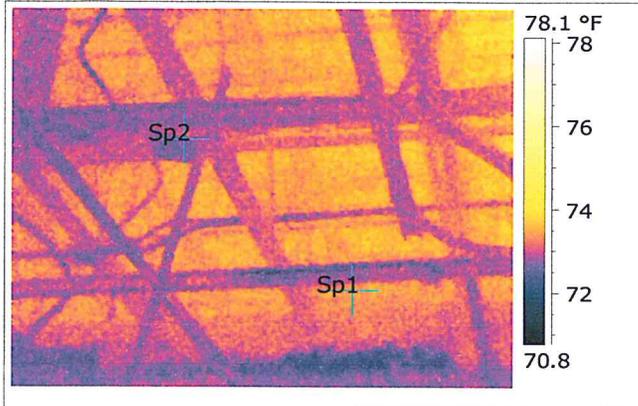
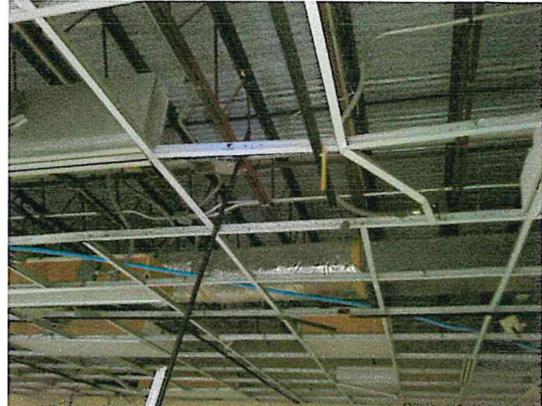
**Wall readings below show high moisture content.**

Date	12/31/2013	Location: Room 238  <b>Other remarks:</b>  Ceilings: Acceptable
Image Time	10:22:29 AM	
Sp1 Temperature	73.4 °F	
Sp2 Temperature	72.7 °F	
Air Temperature 1	73.4 °F	
Air Temperature 2	73.4 °F	
Air Temperature 3	73.2 °F	
Relative Humidity 1	52.1 %	
Relative Humidity 2	51.9 %	
Relative Humidity 3	51.9 %

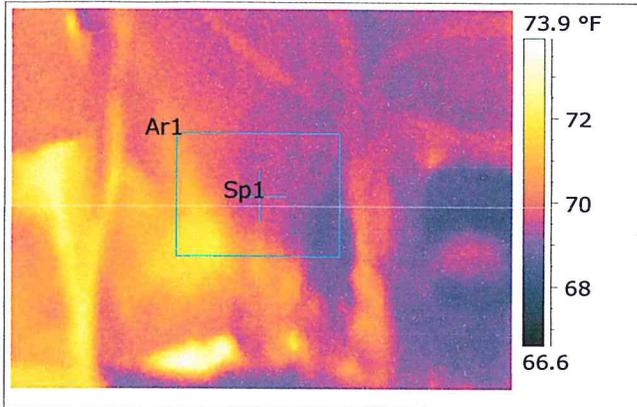
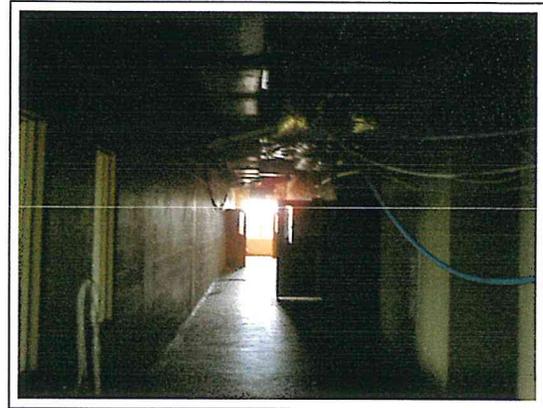
Date	1/10/2014	Location:	<b>New Building-3<sup>rd</sup> Floor-Main Hallway</b>
Image Time	11:57:56 AM	<b>Other remarks:</b>	
Ar1 Max. Temperature	73.4 °F	Wall:	Acceptable
Ar1 Min. Temperature	69.5 °F	Ceilings:	Acceptable
Ar1 Average Temperature	71.3 °F	Lab Results:	Swab of duct in hallway
Sp1 Temperature	71.3 °F	Mold Rating:	119,000 c/m2
Air Temperature 1	71.2 °F	Mold Rating:	1-5 (5 being worst)
Relative Humidity 1	72.6 %

**Comment: The 3<sup>rd</sup> floor hallway needs to have ductwork removed in areas.**

**Recommendation: All ductwork needs to be cleaned per NADCA. Ceiling and wall need general cleaning**

**Remediation Protocol: Plan "A "**

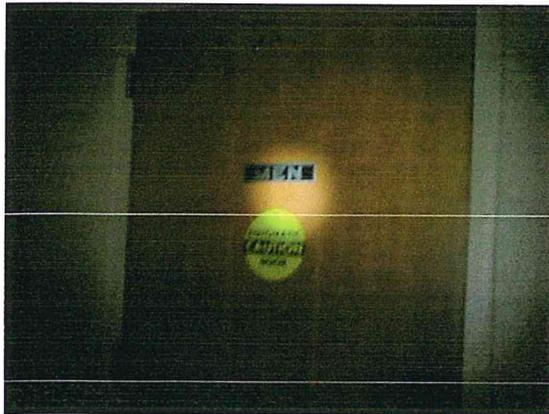
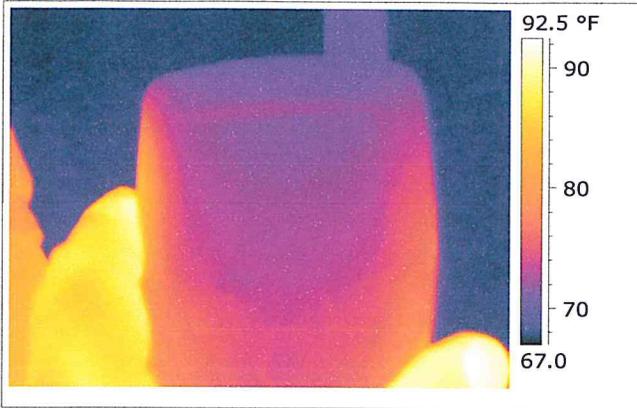
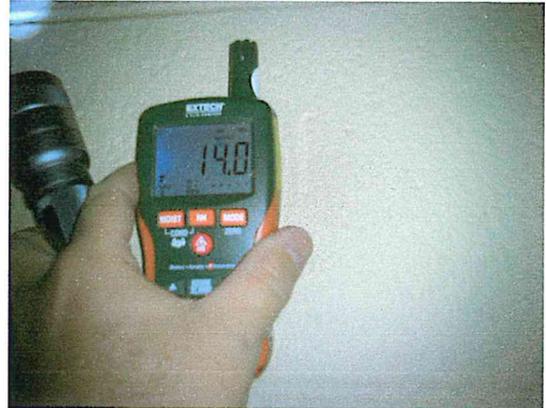
Date	1/10/2014	Location: <b>New building-3<sup>rd</sup> Floor-Men's Room</b>  <b>Other remarks:</b>  Wall: Acceptable Ceilings: Acceptable Lab Results: Air Test: 2,827 c/m3 Mold Rating: 2  Mold Rating: 1-5 (5 being worst)
Image Time	11:40:19 AM	
Ar1 Max. Temperature	67.8 °F	
Ar1 Min. Temperature	66.7 °F	
Ar1 Average Temperature	67.3 °F	
Sp1 Temperature	67.3 °F	
Air Temperature 1	70.2 °F	
Relative Humidity 1	69.6 %

**Comment: Bathroom has acceptable mold spore level.**

**Recommendation: Clean duct system**

**Remediation Protocol: Plan " A "**

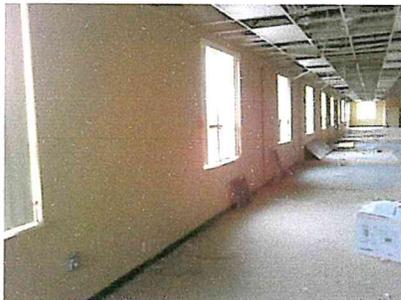
Date	12/31/2013	<b>Location:</b> <b>New building-3<sup>rd</sup> Floor-Room 312</b>  <b>Other remarks:</b>  Wall: Wall shows excessive moisture on the outer block walls Ceilings: Lab Results: 733 spores per c/m3 Mold Rating: 1  Mold Rating: 1-5 (5 being worst)
Image Time	3:11:52 PM	
Ar1 Max. Temperature	72.3 °F	
Ar1 Min. Temperature	69.5 °F	
Ar1 Average Temperature	71.5 °F	
Air Temperature 1	75.6 °F	
Relative Humidity 1	46.6 %

**Comment: RH % is within range**

**Recommendation: Seal all outer walls and provide internal insulation. Bricks surface needs to be tuck pointed.**

**Remediation Protocol: Plan "A "**

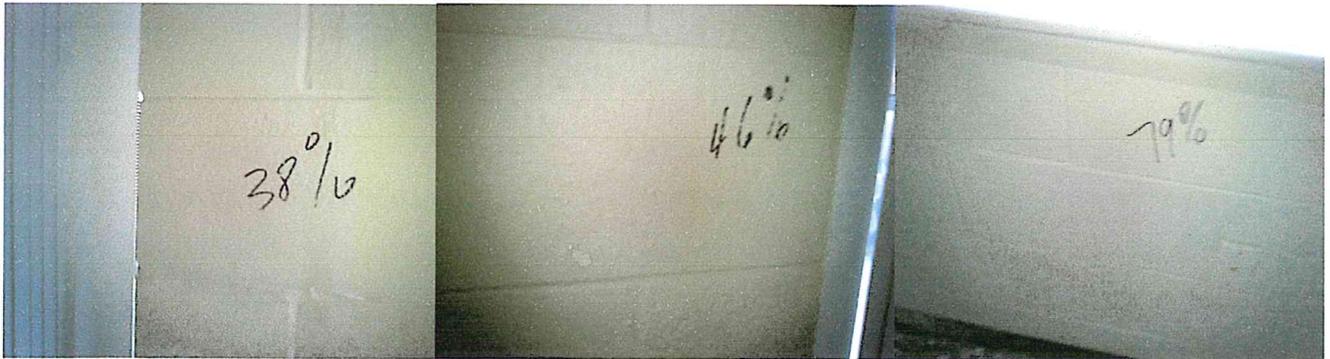
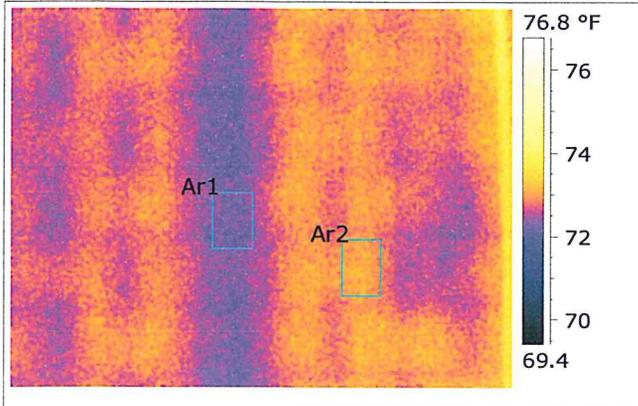
Date	12/31/2013	Location:	(Where)
Image Time	3:12:05 PM	<b>Other remarks:</b>	
Air Temperature 1	75.7 °F	Wall: Excessive wall moisture	
Relative Humidity 1	46.6 %

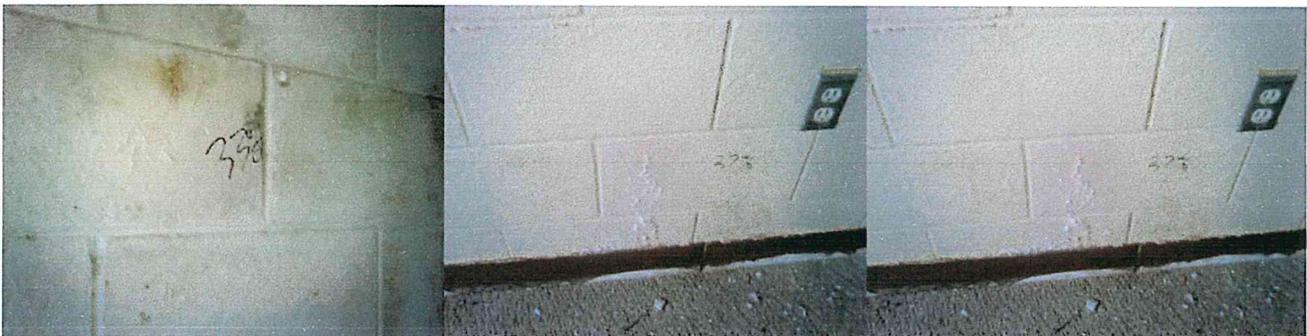
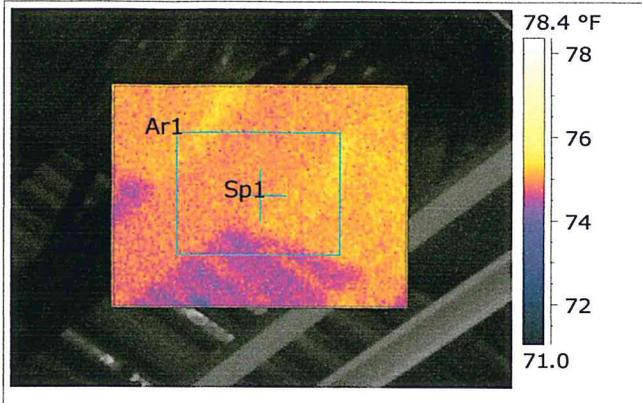
Date	12/31/2013	Location: (Where)  <b>Other remarks:</b>  Wall: Excessive moisture
Image Time	3:25:20 PM	
Ar1 Max. Temperature	72.7 °F	
Ar2 Max. Temperature	73.4 °F	
Ar1 Min. Temperature	71.8 °F	
Ar2 Min. Temperature	72.6 °F	
Ar1 Average Temperature	72.3 °F	
Ar2 Average Temperature	73.0 °F

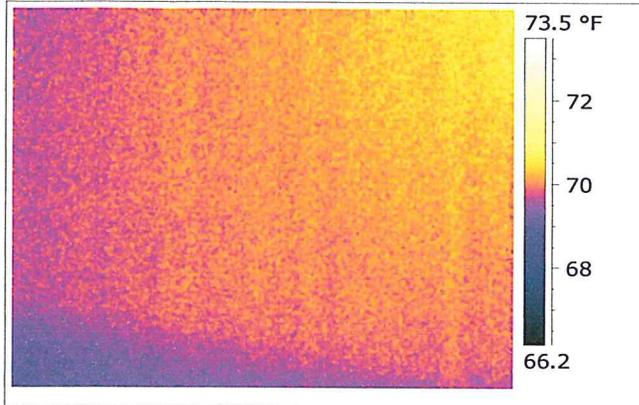
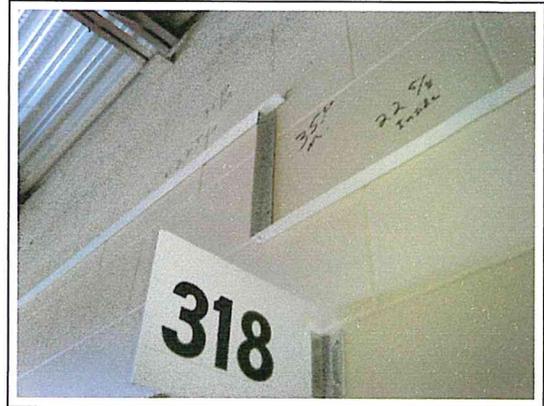
Date	1/10/2014	Location:	New Building-3 <sup>rd</sup> Floor- Room 318
Image Time	11:51:28 AM	<b>Other remarks:</b>	
Air Temperature 1	72.7 °F	Wall:	Outer walls have excessive moisture
Relative Humidity 1	68.8 %	Ceilings:	Acceptable
		Lab Results:	1,667 spores c/m3
		Mold Rating:	1
		Mold Rating:	1-5 (5 being worst)

<b>Comment: Mold spore count is low.</b>
<b>Recommendation: Seal and insulate outer walls</b>
<b>Remediation Protocol: Plan " A "</b>

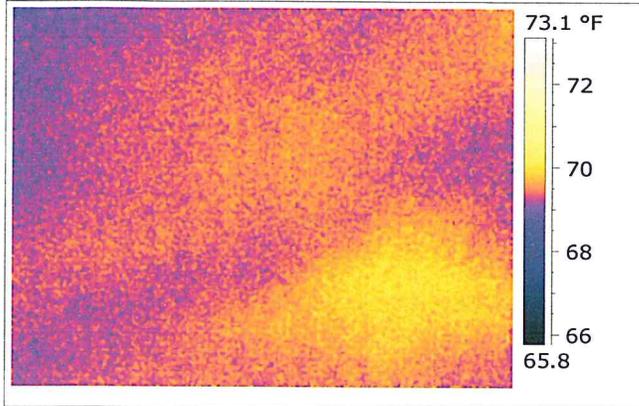
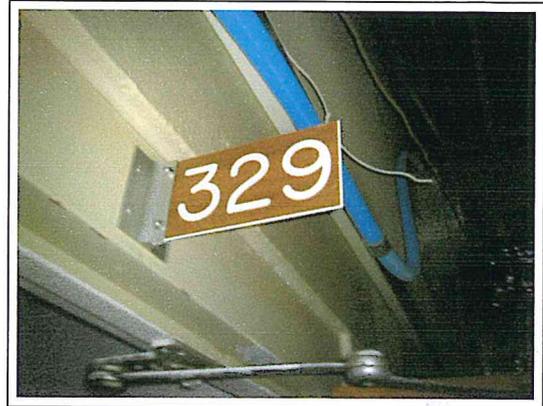
Date	1/10/2014	Location:	
Image Time	11:46:50 AM	<b>Other remarks:</b>	
Air Temperature 1	70.9 °F	Wall: Outer walls have moisture	
Relative Humidity 1	72.6 %	Ceilings: Acceptable	
		Lab Results: 1,880 spores per c/m3	
		Mold Rating: 1	
		Mold Rating: 1-5 (5 being worst)

<b>Comment: All readings within normal range other than outer walls.</b>
<b>Recommendation: Seal outer block walls and insulate</b>
<b>Remediation Protocol: Plan "A "</b>

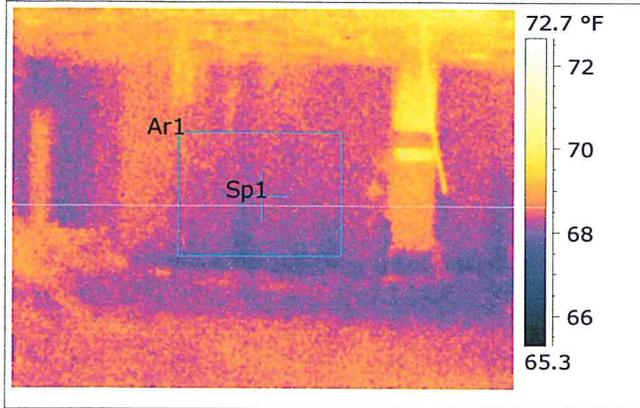
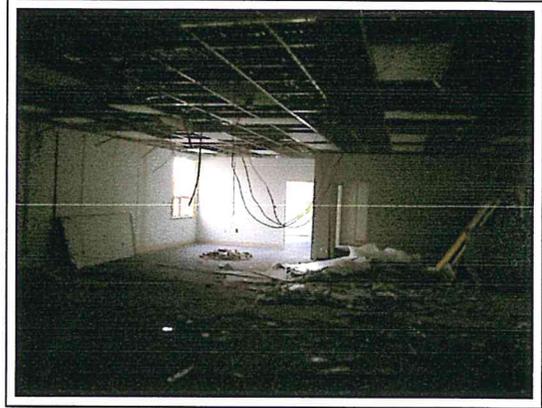
Date	1/10/2014	Location:	New Building-3 <sup>rd</sup> Floor-Room 330
Image Time	11:54:01 AM	<b>Other remarks:</b>	
Ar1 Max. Temperature	69.1 °F	Wall: Se pictures below	
Ar1 Min. Temperature	67.9 °F	Ceilings: Acceptable	
Ar1 Average Temperature	68.6 °F	Lab Results: 1,213	
Sp1 Temperature	68.6 °F	Mold Rating: 1	
Air Temperature 1	72.7 °F	Mold Rating: 1-5 (5 being worst)	
Relative Humidity 1	69.9 %

**Comment: All readings within normal ranges**

**Remediation Protocol: Plan " A "**

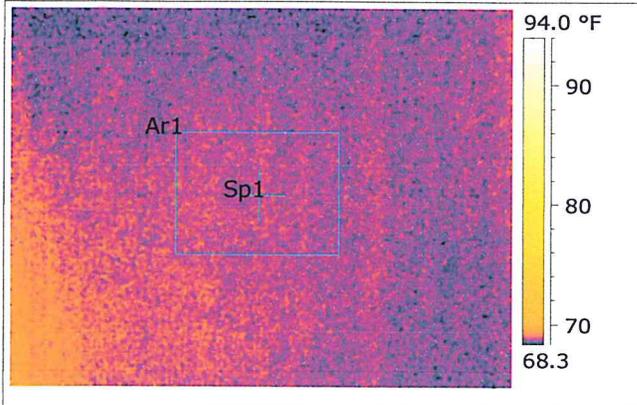
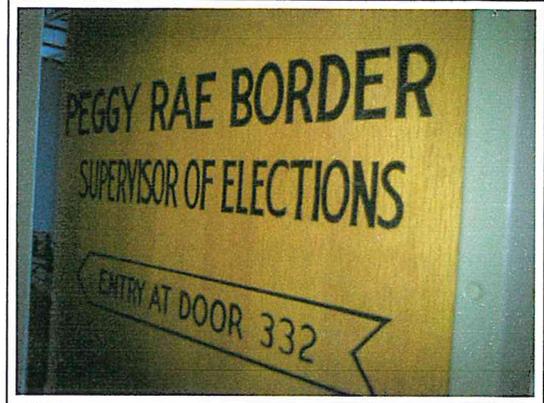
Date	1/10/2014
Image Time	11:54:17 AM
Ar1 Max. Temperature	69.0 °F
Ar1 Min. Temperature	67.3 °F
Ar1 Average Temperature	68.2 °F
Sp1 Temperature	68.2 °F
Air Temperature 1	71.6 °F
Relative Humidity 1	69.6 %

Walls: Have excessive moisture

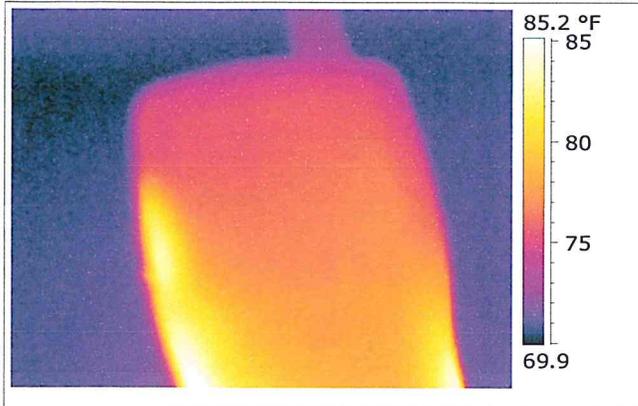
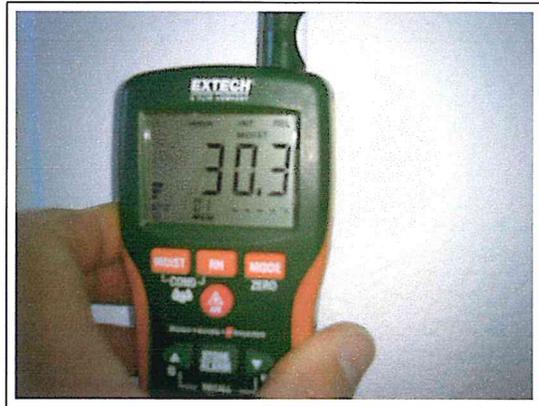
Date	1/10/2014	Location:	Room 332 (off of 330)
Image Time	11:54:52 AM	<b>Other remarks:</b>	
Ar1 Max. Temperature	69.3 °F	Wall:	Interior walls acceptable
Ar1 Min. Temperature	68.3 °F	Ceilings:	Acceptable
Ar1 Average Temperature	68.8 °F		
Sp1 Temperature	68.9 °F		
Air Temperature 1	-0.0 °F		
Internal Moisture 1	17.7 %

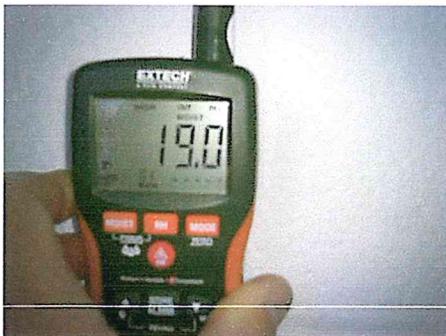
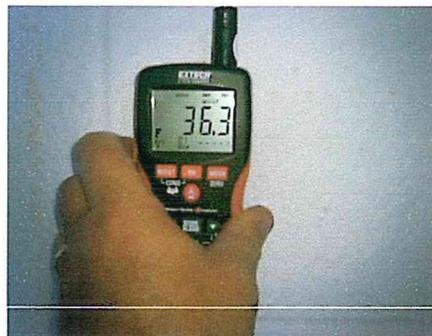
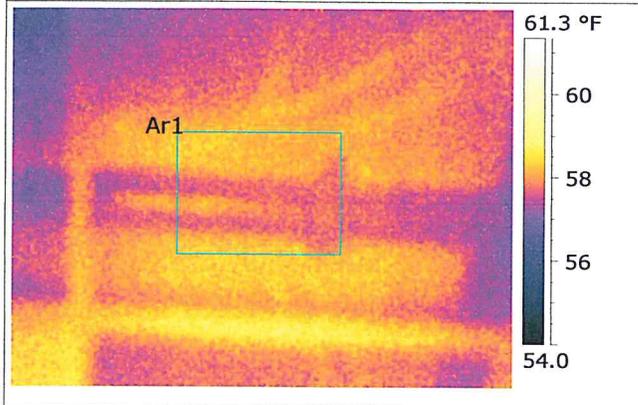
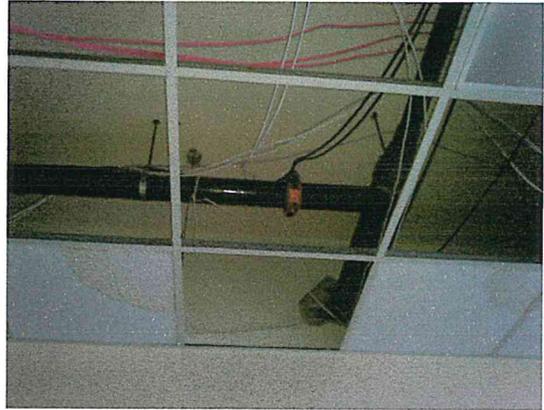
Date	1/10/2014	Location: Outer walls of 330
Image Time	11:55:08 AM	
Air Temperature 1	-0.0 °F	<b>Other remarks:</b>  Wall: Excessive moisture
Air Temperature 2	-0.0 °F	
Air Temperature 3	-0.0 °F

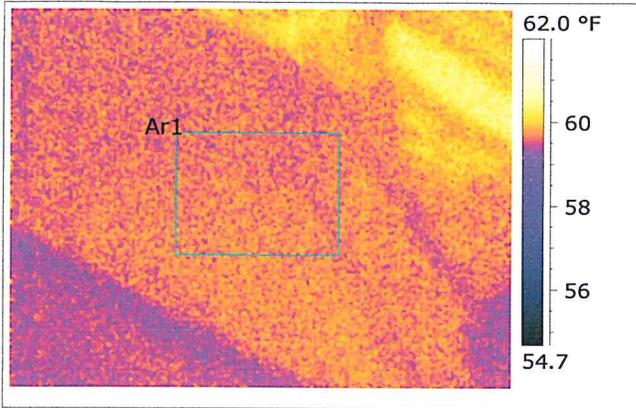
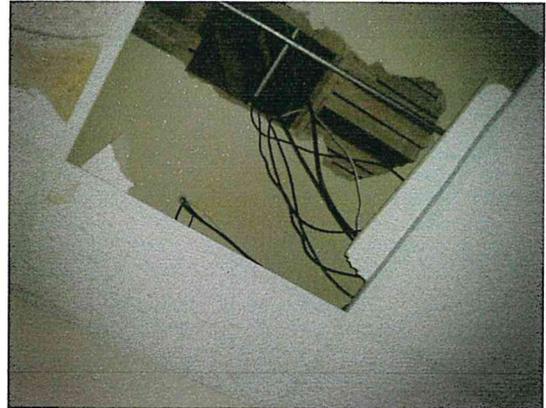
Date	1/10/2014	Location: <b>Old building-1<sup>st</sup>. floor-Main Hallway</b>  <b>Other remarks:</b>
Image Time	11:08:52 AM	
Ar1 Max. Temperature	58.8 °F	
Ar1 Min. Temperature	57.3 °F	
Ar1 Average Temperature	58.0 °F	
Air Temperature 1	65.1 °F	
Relative Humidity 1	76.5 %

**Comment: The hallway was not tested for spores counts. However due to the lathe in the ceilings full remediation is recommended..**

**Remediation Protocol: Plan "C "**

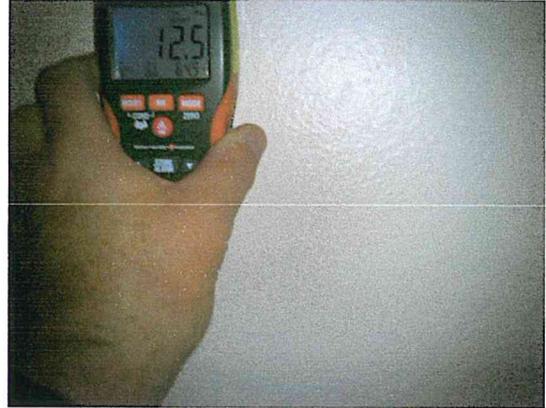
Date	1/10/2014	Location: Hallway)
Image Time	11:09:26 AM	
Ar1 Max. Temperature	60.2 °F	
Ar1 Min. Temperature	59.1 °F	
Ar1 Average Temperature	59.7 °F	
Air Temperature 1	64.4 °F	
Relative Humidity 1	78.1 %

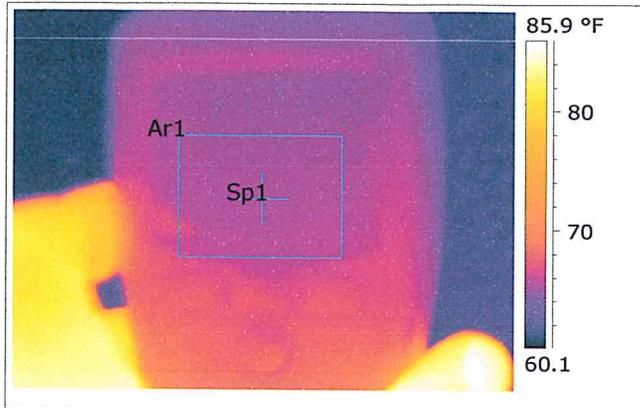
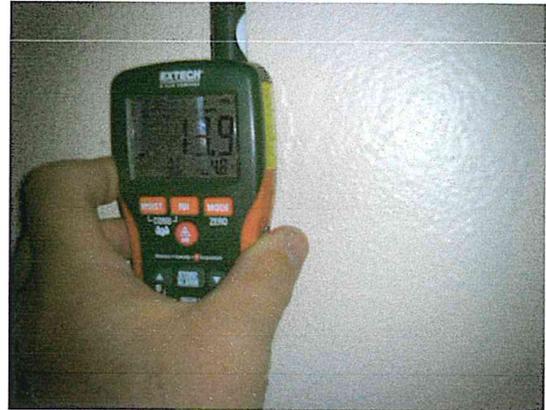
Date	1/10/2014	Location: (Where)  <b>Other remarks:</b>  Wall: Acceptable Ceilings: Acceptable
Image Time	11:12:57 AM	
Ar1 Max. Temperature	89.1 °F	
Ar1 Min. Temperature	65.8 °F	
Ar1 Average Temperature	77.3 °F	
Sp1 Temperature	73.3 °F	
Air Temperature 1	64.9 °F	
Air Temperature 2	64.9 °F	
Internal Moisture 1	12.5 %	
Internal Moisture 2	12.7 %

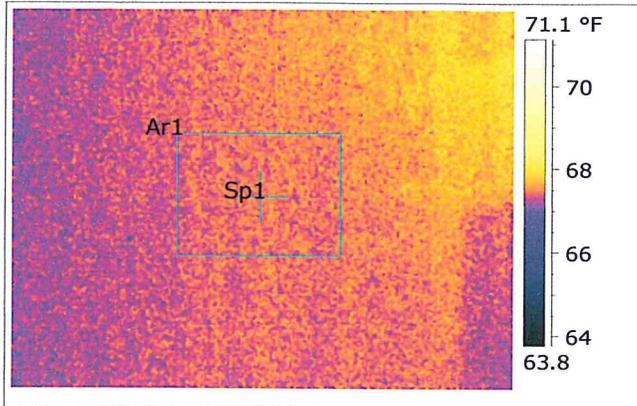
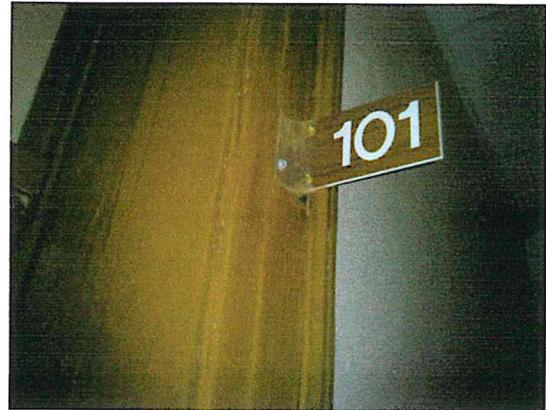
Date	1/10/2014
Image Time	11:13:34 AM
Ar1 Max. Temperature	67.0 °F
Ar1 Min. Temperature	64.8 °F
Ar1 Average Temperature	65.5 °F
Sp1 Temperature	65.4 °F
Air Temperature 1	64.8 °F
Internal Moisture 1	13.9 %

Wall: Acceptable

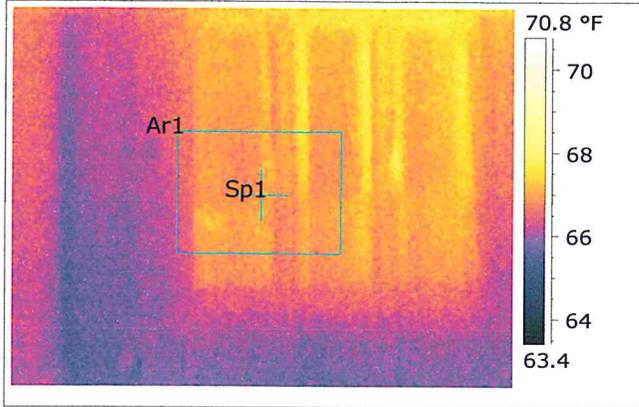
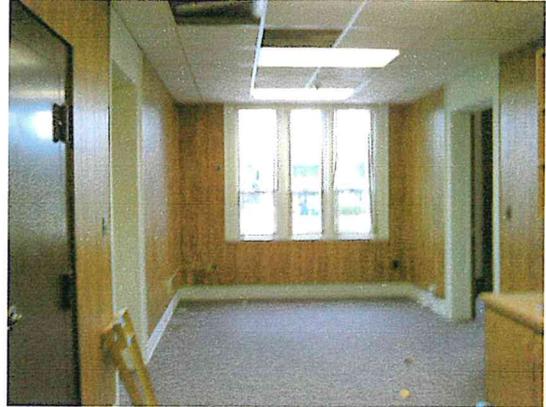
Date	1/2/2014	Location:	Old Building-1 <sup>st</sup> Floor-Room 101
Image Time	3:53:47 PM	<b>Other remarks:</b>	
Ar1 Max. Temperature	67.9 °F	Wall: Paneling	
Ar1 Min. Temperature	66.9 °F	Ceilings: Acceptable	
Ar1 Average Temperature	67.4 °F	Lab Results: 667	
Sp1 Temperature	67.5 °F	Mold Rating: 1	
Air Temperature 1	68.4 °F		
Air Temperature 2	68.7 °F		
Relative Humidity 1	73.2 %		
Relative Humidity 2	72.3 %		
			Mold Rating: 1-5 (5 being worst)

**Comment: This room has a low mold rating.**

**Recommendation: It still would be prudent to remove the paneling to see the condition of the outer wall.**

**Remediation Protocol: Plan " A "**

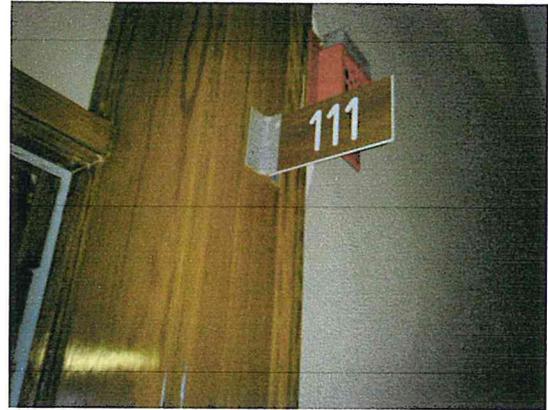
Date	1/2/2014	Location:	Old Building-Room 111
Image Time	3:32:03 PM	<b>Other remarks:</b>	
Ar1 Max. Temperature	67.7 °F	Wall:	
Ar1 Min. Temperature	64.6 °F	Ceilings:	
Ar1 Average Temperature	65.9 °F	Lab Results:	1,907 c/m3
Air Temperature 1	68.4 °F	Mold Rating:	1
Relative Humidity 1	73.1 %	Mold Rating:	1-5 (5 being worst)

**Comment: Spore count is low but RH% is very high**

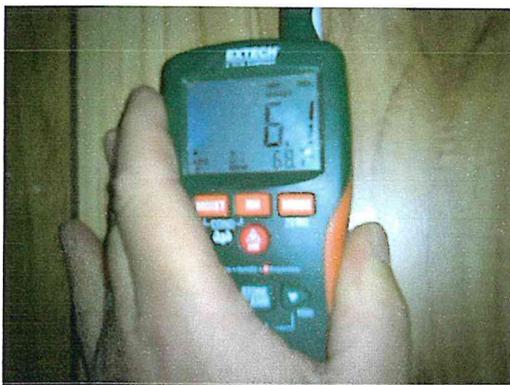
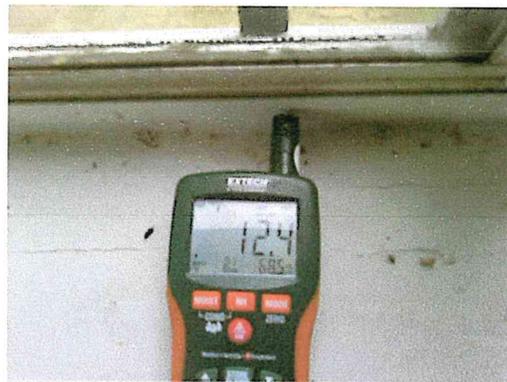
Date	1/2/2014	Location:	Room 11
Image Time	3:33:53 PM		
Air Temperature 1	68.7 °F		
Relative Humidity 1	70.7 %

**Comment: Window sill dry at the time of inspection except water droplets shown in next picture.**

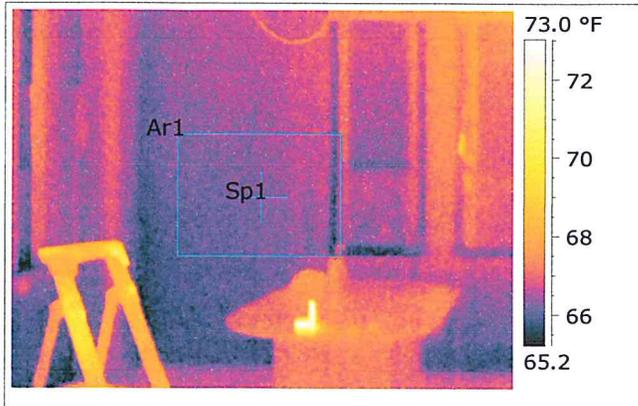
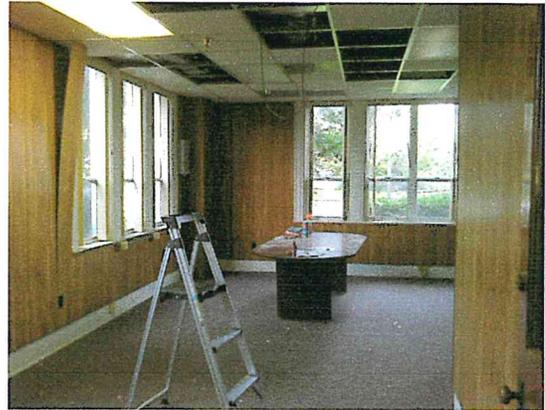
Date	1/2/2014
Image Time	3:34:24 PM
Ar1 Max. Temperature	67.3 °F
Ar1 Min. Temperature	65.4 °F
Ar1 Average Temperature	66.3 °F
Sp1 Temperature	66.4 °F
Air Temperature 1	68.7 °F
Relative Humidity 1	70.5 %

**Recommendation:** All outer walls need to be exposed, sealed and insulated.

**Remediation Protocol:** Plan " C "

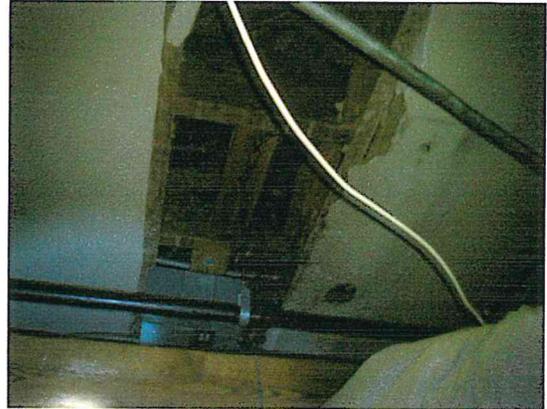
Date	1/2/2014	<table border="1"> <tr> <td>Location:</td> <td>Room 111</td> </tr> </table> <p><b>Other remarks:</b></p> <p>Ceilings: Previous water damaged noted. Appears to be fixed.</p>	Location:	Room 111
Location:	Room 111			
Image Time	3:36:23 PM			
Ar1 Max. Temperature	70.0 °F			
Ar1 Min. Temperature	68.7 °F			
Ar1 Average Temperature	69.3 °F			
Air Temperature 1	68.9 °F			
Relative Humidity 1	70.0 %

**Recommendation: Although the mold readings are low the potential for future problems due to the high RH% are probable. Recommend full remediation. Remove all lathe and previous ceiling materials.**

**Remediation Protocol: Plan " C "**

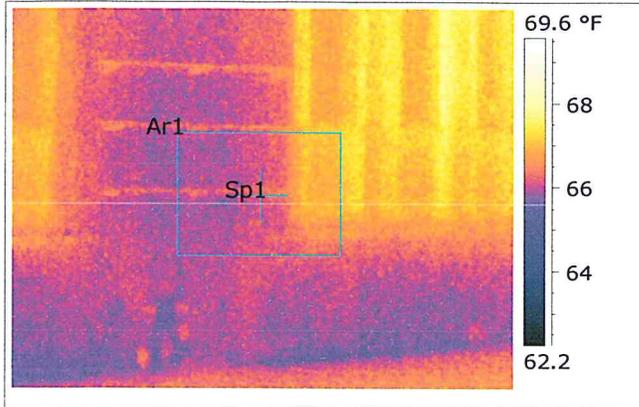
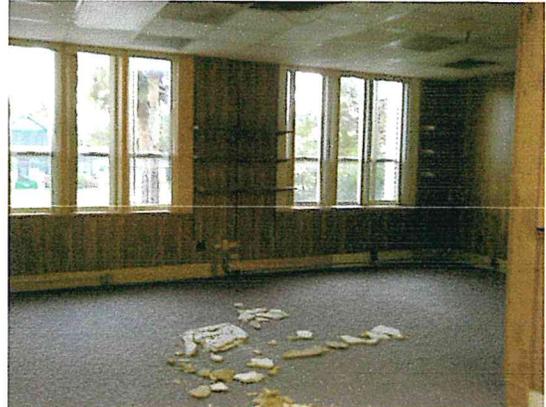
Date	1/2/2014	Location:	Old Building-Room 114
Image Time	3:56:09 PM	<b>Other remarks:</b>	
Ar1 Max. Temperature	67.3 °F	Lab Results: 2,760	
Ar1 Min. Temperature	66.2 °F	Mold Rating: 1	
Ar1 Average Temperature	66.8 °F	Mold Rating: 1-5 (5 being worst)	
Air Temperature 1	68.2 °F		
Relative Humidity 1	72.1 %

**Comment: Spore Count is low. However the room conditions will lend itself to additional growth based on the humidity levels.**

**Recommendation: Full removal of paneling, ceiling tiles, and all lathe material is suggested. Sealing & insulation is required for exterior walls.**

**Remediation Protocol: Plan " C "**

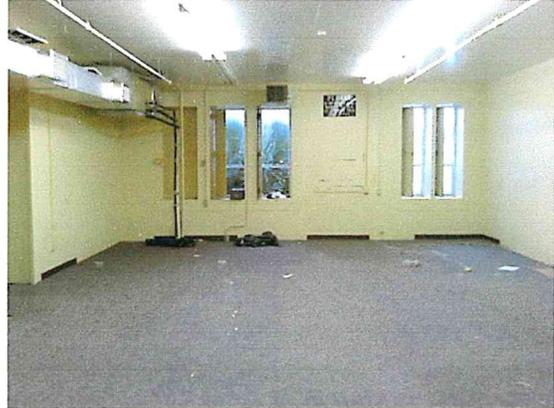
Date	1/2/2014	Location: (Where)  <b>Other remarks:</b>
Image Time	3:56:44 PM	
Ar1 Max. Temperature	67.4 °F	
Ar1 Min. Temperature	65.3 °F	
Ar1 Average Temperature	66.3 °F	
Sp1 Temperature	66.1 °F	
Air Temperature 1	68.4 °F	
Relative Humidity 1	72.6 %

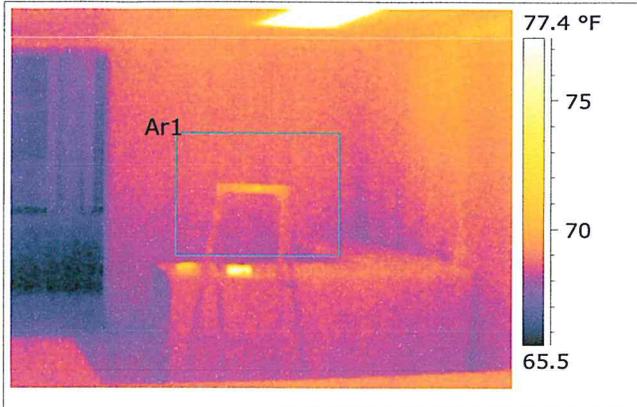
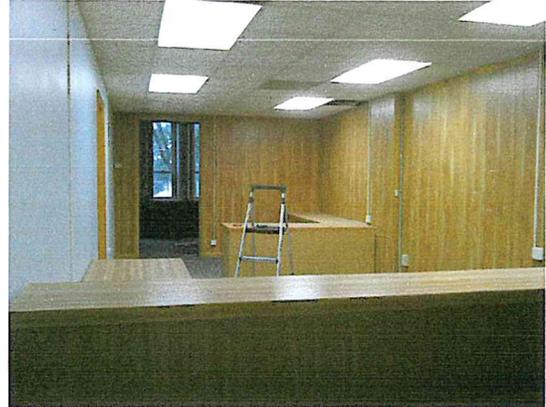
Date	1/2/2014	Location:	Old building-1 <sup>st</sup> Floor-Front and back Rooms of 117
Image Time	4:19:16 PM	Other remarks:	
Air Temperature 1	69.8 °F	Lab Results:	30,267 c/m3
Relative Humidity 1	69.9 %	Mold Rating:	5
		Mold Rating:	1-5 (5 being worst)

**Comment: Elevated spore count due to excessive moisture and humidity.**

**Recommendation: The ceiling plenum is shared with the break room. All ceiling tiles should be removed, carpet, lathe removed, plaster and metal reinforcement (above drop ceiling) & paneling removed. RH% is very high due to a lack of insulation. Plenum and outer walls need insulation and sealing.**

**Remediation Protocol: Plan " C "**

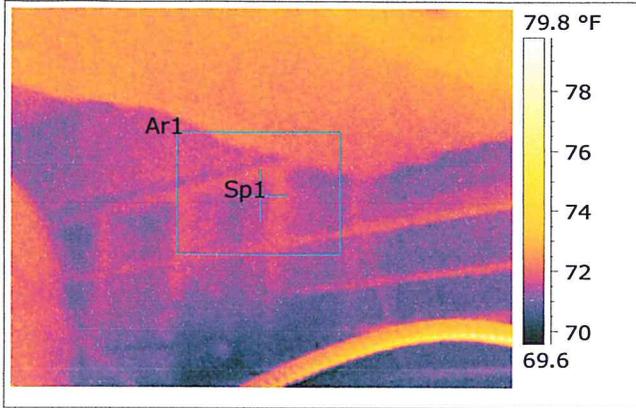
Date	1/2/2014	Location: <input type="text" value="(Where)"/>  <b>Other remarks:</b>
Image Time	4:19:43 PM	
Ar1 Max. Temperature	72.3 °F	
Ar1 Min. Temperature	67.7 °F	
Ar1 Average Temperature	68.6 °F	
Air Temperature 1	69.8 °F	
Relative Humidity 1	70.0 %

**Comment: RH % very high**

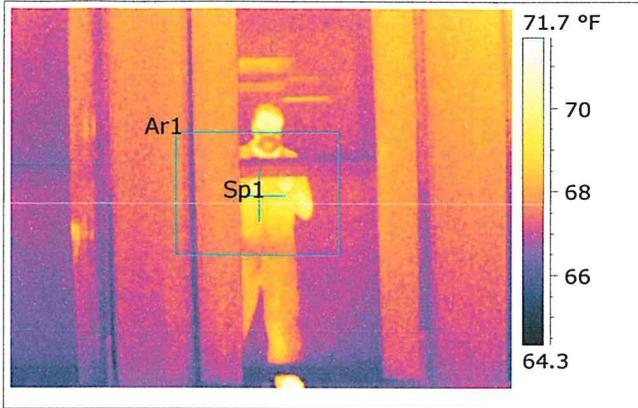
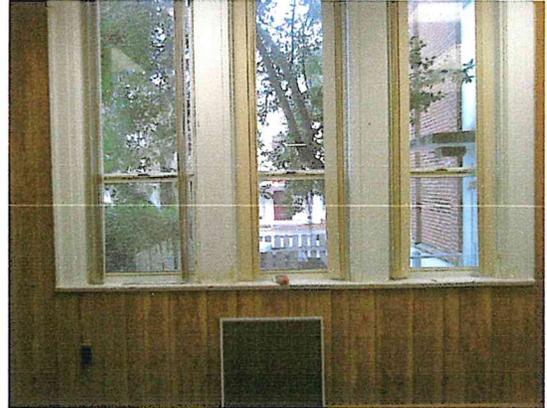
Date	1/2/2014	Location: (Plenum above dropped ceiling- Room 117)  <b>Other remarks:</b>
Image Time	4:21:09 PM	
Ar1 Max. Temperature	72.7 °F	
Ar1 Min. Temperature	70.9 °F	
Ar1 Average Temperature	71.7 °F	
Sp1 Temperature	71.5 °F	
Air Temperature 1	69.8 °F	
Relative Humidity 1	70.0 %

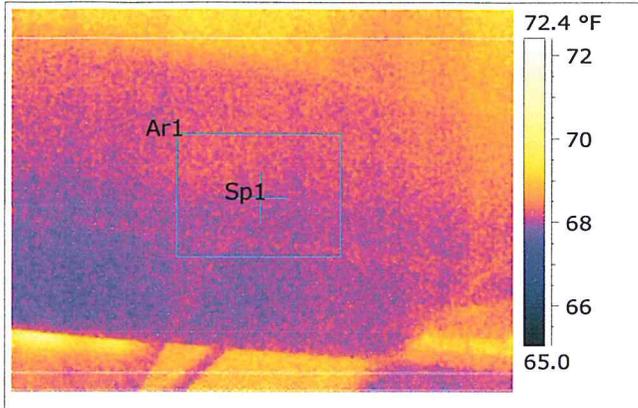
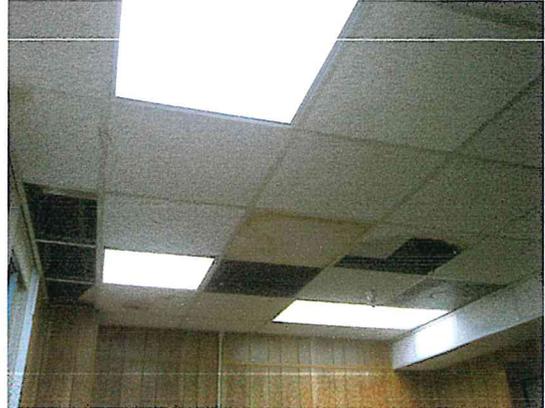
Date	1/2/2014	Location: (Room 117)
Image Time	4:23:15 PM	
Ar1 Max. Temperature	70.5 °F	
Ar1 Min. Temperature	66.1 °F	
Ar1 Average Temperature	67.8 °F	
Sp1 Temperature	69.0 °F	
Air Temperature 1	70.2 °F	
Relative Humidity 1	69.8 %

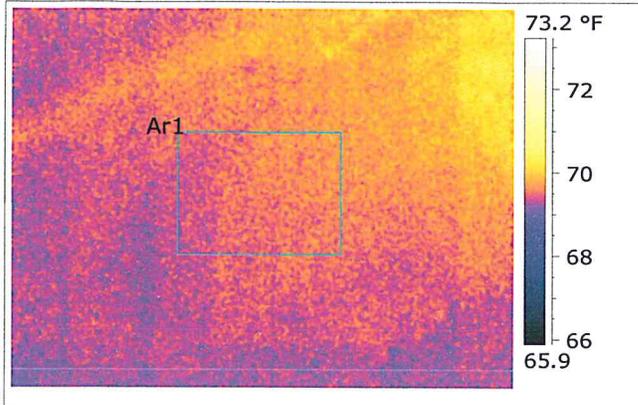
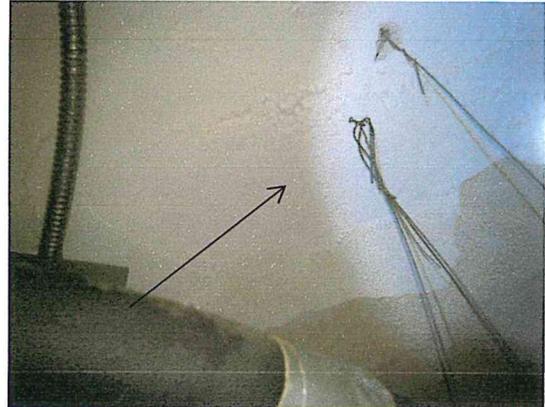
Date	1/2/2014	Location:	Room 117
Image Time	4:23:49 PM	<b>Other remarks:</b>	
Ar1 Max. Temperature	68.7 °F		
Ar1 Min. Temperature	67.5 °F		
Ar1 Average Temperature	68.1 °F		
Sp1 Temperature	68.0 °F		
Air Temperature 1	69.8 °F		
Relative Humidity 1	70.2 %

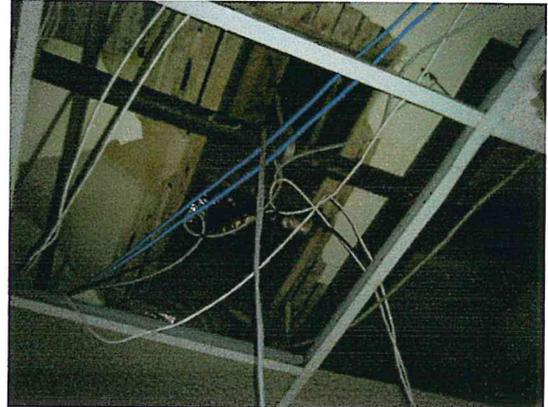
Date	1/10/2014	Location:	Old Building-2 <sup>nd</sup> floor-Main Hallway
Image Time	11:19:01 AM	<b>Other remarks:</b>	
Ar1 Max. Temperature	66.9 °F	Wall:	Acceptable
Ar1 Min. Temperature	64.8 °F	Ceilings:	See comment
Ar1 Average Temperature	65.6 °F	Lab Results:	
Air Temperature 1	64.4 °F	Mold Rating:	
Relative Humidity 1	80.8 %	Mold Rating:	1-5 (5 being worst)

**Comment: Very high humidity in this portion of the building. All ceilings need to be removed. Plaster and lathe of old ceiling needs to come down. The underside of the decking needs to be sealed and spray insulated.**

**Remediation Protocol: Plan " C "**

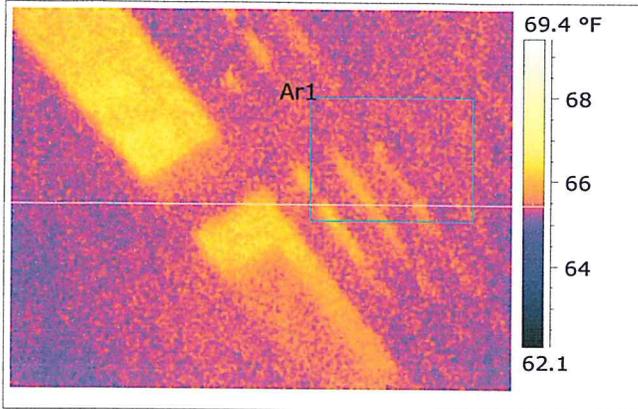
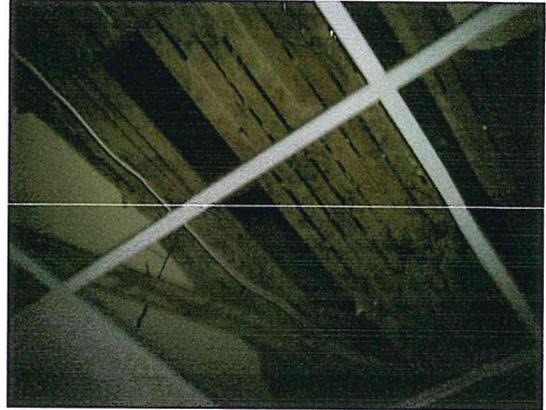
Date	1/10/2014	Location: (Where)  <b>Other remarks:</b>
Image Time	11:19:36 AM	
Ar1 Max. Temperature	66.4 °F	
Ar1 Min. Temperature	64.9 °F	
Ar1 Average Temperature	65.4 °F	
Air Temperature 1	64.9 °F	
Air Temperature 2	64.9 °F	
Relative Humidity 1	80.6 %	
Relative Humidity 2	80.1 %

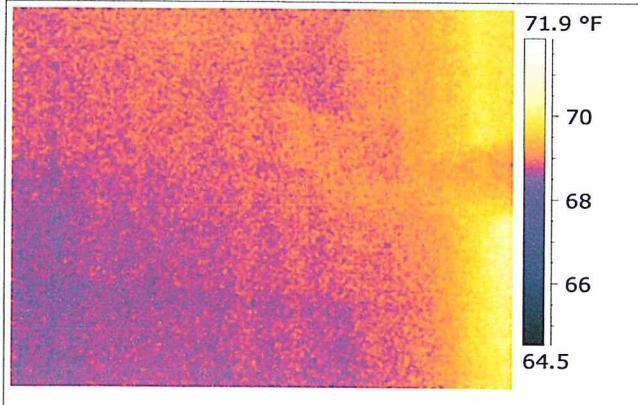
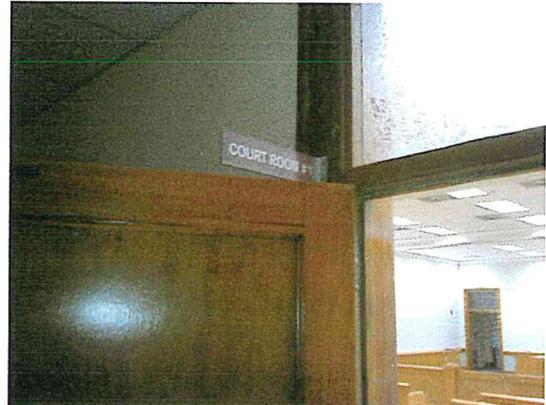
Date	1/2/2014	Location: (Where)
Image Time	9:24:39 AM	
Air Temperature 1	73.6 °F	
Relative Humidity 1	61.0 %	
		<b>Other remarks:</b>
		Wall: Walls are acceptaable
		Lab Results: 3,293 (Stachybotrus was found)
		Mold Rating: 2
		Mold Rating: 1-5 (5 being worst)

**Comment: This room is an interior room and appears to be in good condition.**

**Remediation Protocol: Plan " A "**
