Mold Assessment-Protocol Report

For Bunnell Courthouse  
200 East Moody Blvd.  
Bunnell FL.

Date: January 12, 2014

Job #: 13-235-2

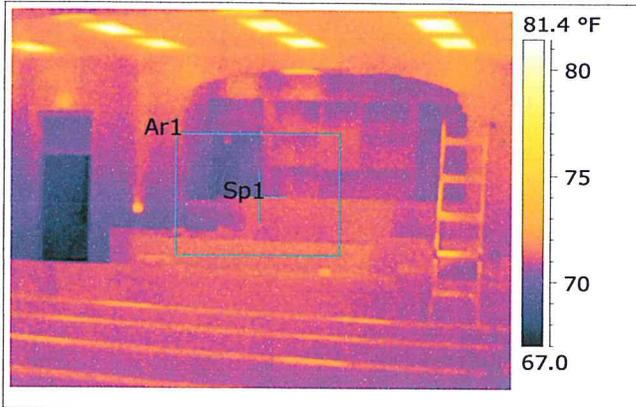
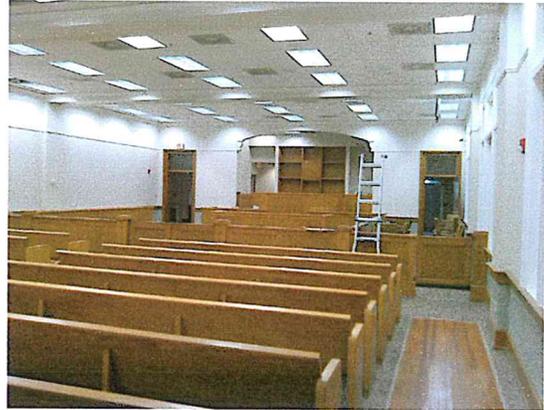
Date	1/2/2014	Location: (Where)  <b>Other remarks:</b>
Image Time	9:25:11 AM	
Ar1 Max. Temperature	72.0 °F	
Ar1 Min. Temperature	68.5 °F	
Ar1 Average Temperature	70.8 °F	
Sp1 Temperature	71.1 °F	
Air Temperature 1	73.6 °F	
Relative Humidity 1	61.0 %

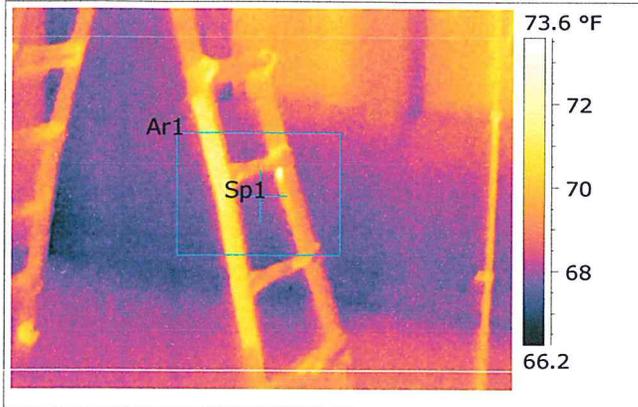
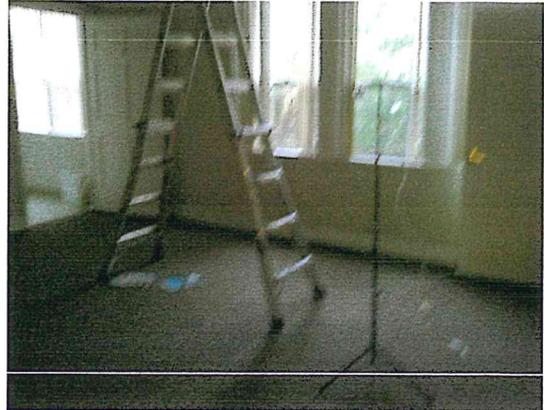
Date	1/2/2014	Location:	Judges room off of courtroom
Image Time	9:55:42 AM	<b>Other remarks:</b>	
Ar1 Max. Temperature	73.3 °F	Wall:	
Ar1 Min. Temperature	67.0 °F	Ceilings:	
Ar1 Average Temperature	68.6 °F	Lab Results:	1,560 spores c/m3
Sp1 Temperature	68.0 °F	Mold Rating:	1
		Mold Rating:	1-5 (5 being worst)

**Comment: Although spore count is low the room is subject to issues due to the lack of insulation.**

**Recommendation: Remove lathe, seal with fog and seal (see specific protocol) and isnyualte ceiling and outer wall**

**Remediation Protocol: Plan " C "**

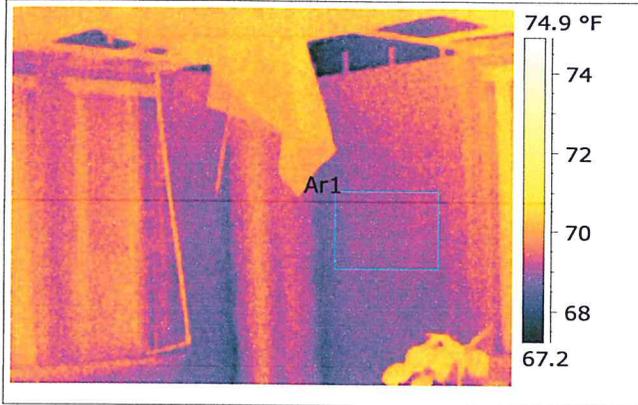
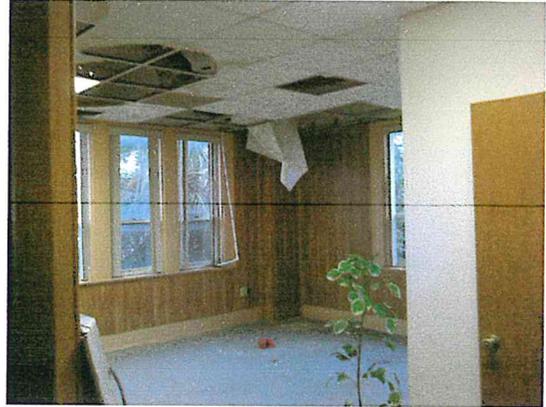
Date	1/2/2014	Location:	Old Building-2 <sup>nd</sup> Floor-Room 219 & side room
Image Time	10:53:02 AM	<b>Other remarks:</b>	
Ar1 Max. Temperature	69.6 °F	Wall: Wet	
Ar1 Min. Temperature	68.4 °F	Ceilings: Wet, Current water leak	
Ar1 Average Temperature	69.0 °F	Lab Results: 6,627	
Air Temperature 1	70.5 °F	Mold Rating: 4	
Relative Humidity 1	76.3 %	Mold Rating: 1-5 (5 being worst)

**Comment:** The outer room had a previous leak from the drain pipe in the northwest corner of the building. It appears this has been fixed. The small side room has an active leak from the middle drain on the roof (see roof). The wall and floor is wet.

**Recommendation:** Remove all paneling, ceiling tiles and grid, plaster and lathe and carpet. Fix water leak. Full clean up is required with deck sealing and spray foam insulation.

**Remediation Protocol:** Plan " C "

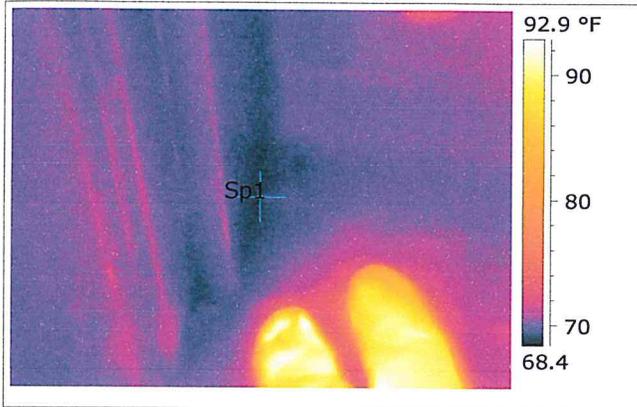
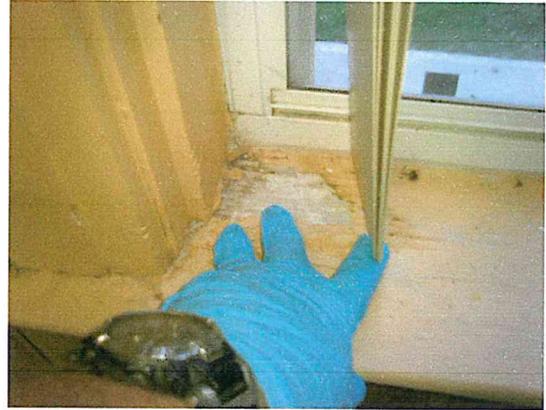
Date	1/2/2014	Location:	Small Room
Image Time	10:54:20 AM	<b>Other remarks:</b>	
Sp1 Temperature	69.1 °F	Window Frame: Needs replacing and sealing	
Air Temperature 1	70.5 °F		
Relative Humidity 1	76.1 %

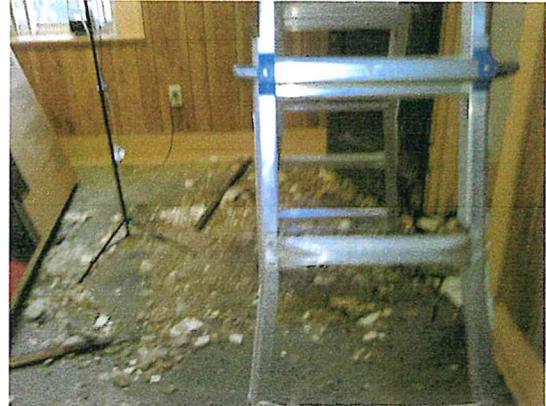
Date	1/2/2014	Location:	Small Room
Image Time	10:55:01 AM	<b>Other remarks:</b>	
Sp1 Temperature	66.9 °F	Ceilings:	Room where leak is occurring
Sp2 Temperature	69.1 °F	Lab Results:	
Air Temperature 1	70.5 °F	Mold Rating:	
Relative Humidity 1	75.9 %	Mold Rating:	1-5 (5 being worst)

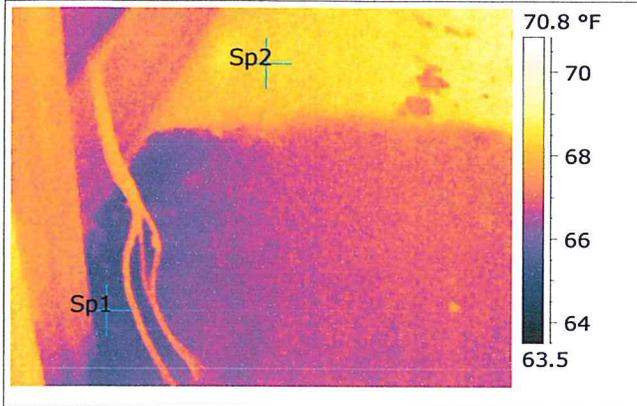
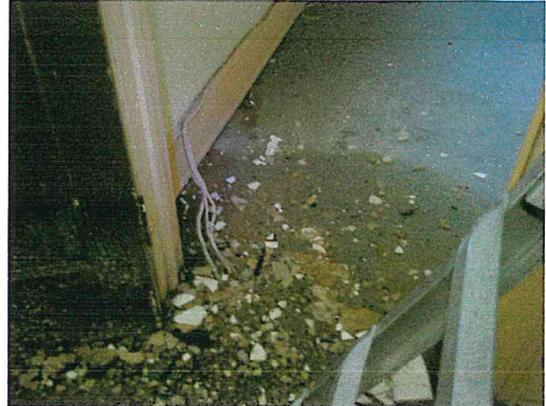
Date	1/2/2014	Location: (Where)  <b>Other remarks:</b>  Floor: Carpet needs to be removed in both rooms
Image Time	10:55:56 AM	
Sp1 Temperature	65.5 °F	
Sp2 Temperature	68.5 °F	
Air Temperature 1	70.5 °F	
Relative Humidity 1	75.9 %

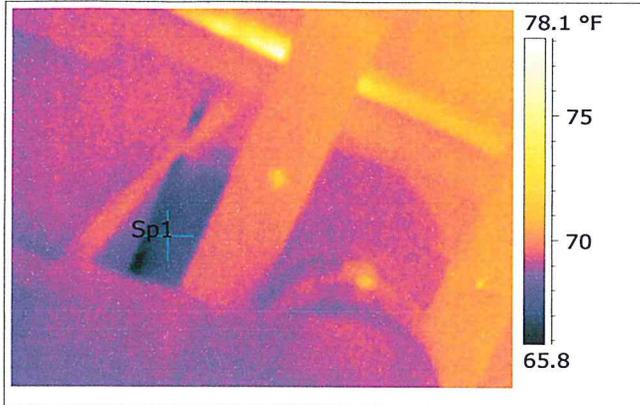
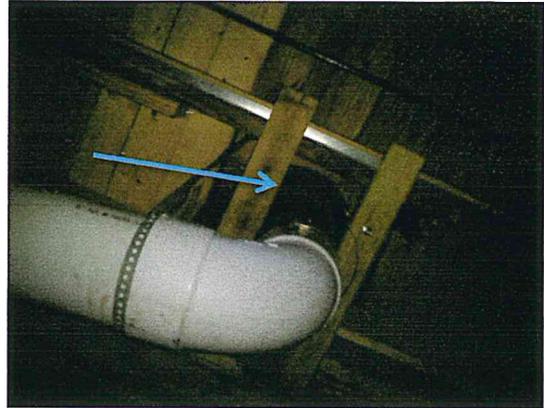
Date	1/2/2014	Location:	Small room
Image Time	10:58:12 AM	<b>Other remarks:</b>	
Sp1 Temperature	67.3 °F	Ceilings: Source of leak at blue arrow	
Air Temperature 1	70.3 °F		
Relative Humidity 1	76.4 %

**Comment: See roof info. This needs to be fixed before any remediation can take place.**

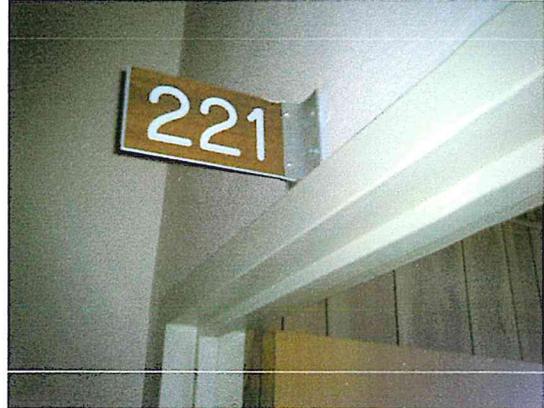
Date	1/2/2014	Location:	Old Building-2 <sup>nd</sup> Floor-Room 221
Image Time	2:01:56 PM	<b>Other remarks:</b>	
Air Temperature 1	70.5 °F	Wall:	Panel is dry on surface
Relative Humidity 1	71.3 %	Ceilings:	Acceptable
		Lab Results:	6,627
		Mold Rating:	4
		Mold Rating:	1-5 (5 being worst)

**Comment:** Although this room show dry it is still recommended because of the high humidity to fully remediate

**Recommendation:** Remove all paneling, carpet ceiling tiles, lathe and plaster, insdie window trim and sill. Reseal windows. Moisture lock walls and s-pray foam insulation above ceiling gris. Insulate below with foam board and sheet rock.

**Remediation Protocol:** Plan " C "

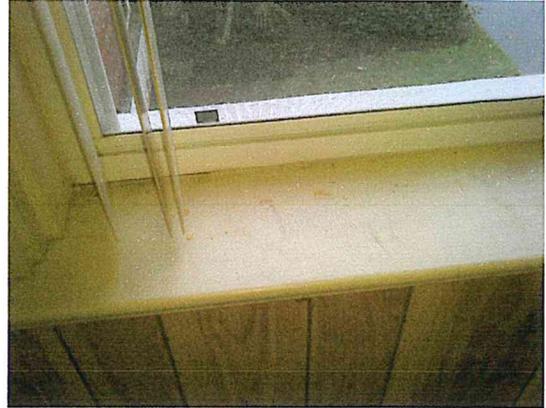
Date	1/2/2014	Location:	Room 221
Image Time	2:03:19 PM	<b>Other remarks: Sills are becoming wet due to high RH%</b>	
Ar1 Max. Temperature	68.6 °F		
Ar1 Min. Temperature	66.4 °F		
Ar1 Average Temperature	67.6 °F		
Air Temperature 1	70.7 °F		
Relative Humidity 1	70.1 %

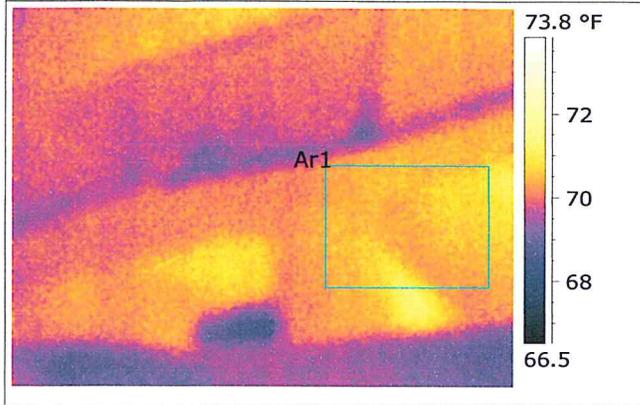
Date	1/2/2014	Location: Room 221  <b>Other remarks:</b>  Ceilings: Acceptable moisture
Image Time	2:05:04 PM	
Ar1 Max. Temperature	71.4 °F	
Ar1 Min. Temperature	69.9 °F	
Ar1 Average Temperature	70.5 °F	
Air Temperature 1	70.9 °F	
Relative Humidity 1	69.9 %

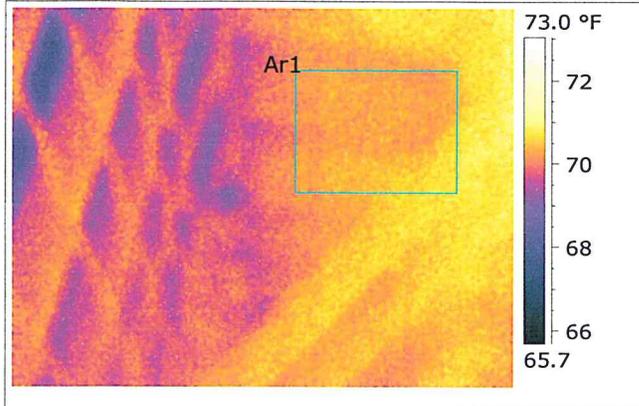
Date	1/2/2014	Location:	Room 221
Image Time	2:05:54 PM	<b>Other remarks:</b>	
Ar1 Max. Temperature	71.1 °F	Ceilings: Acceptable	
Ar1 Min. Temperature	69.7 °F		
Ar1 Average Temperature	70.3 °F		
Air Temperature 1	70.9 °F		
Relative Humidity 1	69.9 %

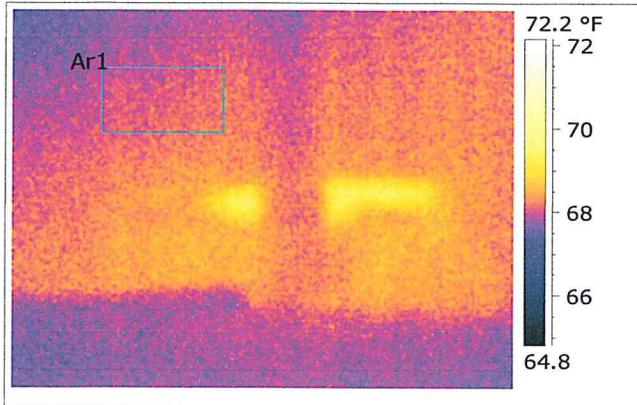
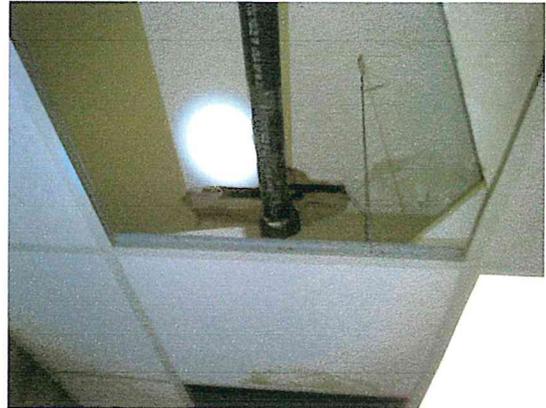
Date	1/2/2014	Location:	Old Building-Room 223
Image Time	11:27:31 AM	<b>Other remarks:</b>	
Ar1 Max. Temperature	68.6 °F	Wall: Surface dry at inspection	
Ar1 Min. Temperature	67.5 °F	Ceilings: Surface dry at inspection	
Ar1 Average Temperature	68.1 °F	Lab Results: 3,213	
		Mold Rating: 2	
		Mold Rating: 1-5 (5 being worst)

**Comment: all outer room walls need to be reveled and remediated along with ceilings**

**Recommendation: Remove all paneling, carpet ceiling tiles, lathe and plaster, insdie window trim and sill. Reseal windows. Moisture lock walls and spray foam insulation above ceiling gris. Insulate below with foam board and sheet rock.**

**Remediation Protocol: Plan " C "**

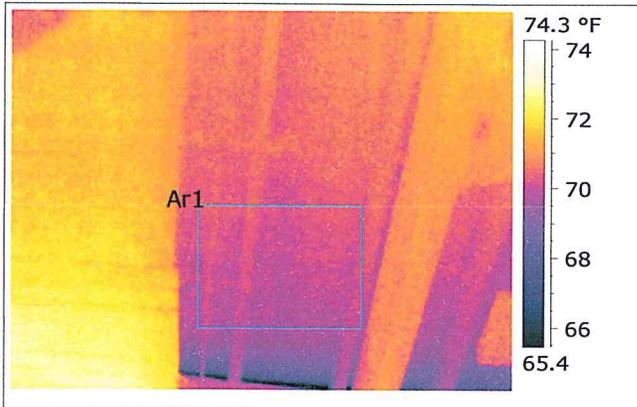
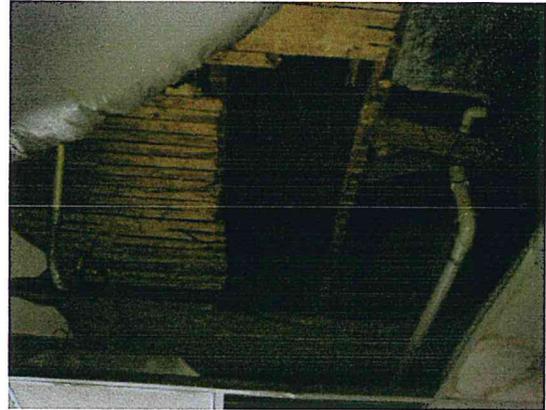
Date	1/2/2014	Location:	Old building-2 <sup>nd</sup> floor-Room 224
Image Time	10:34:28 AM	<b>Other remarks:</b>	
Ar1 Max. Temperature	70.8 °F	Wall:	Surface dry
Ar1 Min. Temperature	69.3 °F	Ceilings:	Dry at inspection
Ar1 Average Temperature	70.0 °F	Lab Results:	9,080 spores c/m <sup>3</sup>
		Mold Rating:	4
		Mold Rating:	1-5 (5 being worst)

**Comment:** All shelves need to be removed to reveal outer wall. High RH% and condition 2 mold count.

**Recommendation:** All paneling, ceiling tiles and grid, lathe and plaster, shelves, carpet and window trim need to be removed. Full remiation require. Seal and insulate to bring RH% bck to under 60%

**Remediation Protocol:** Plan " C "

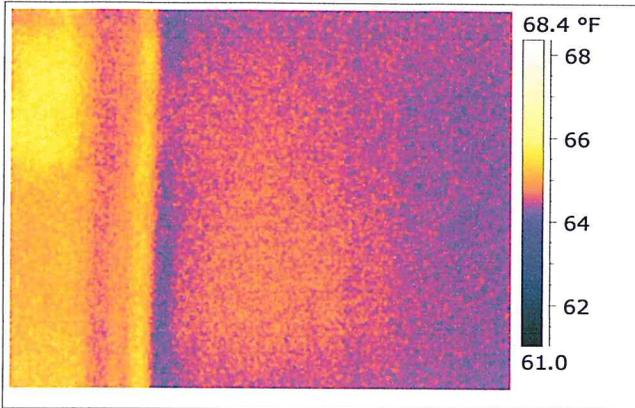
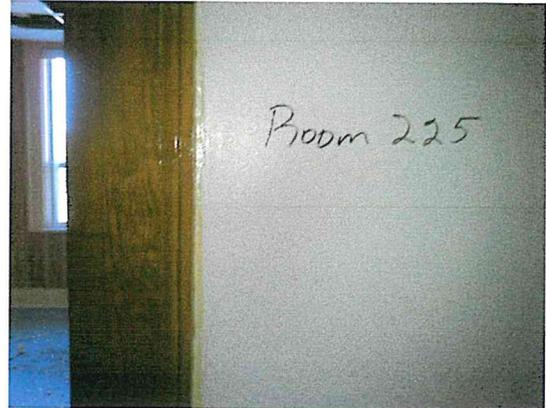
Date	1/10/2014	Location:	Old Building-Room 225
Image Time	11:23:56 AM	<b>Other remarks:</b>	
Air Temperature 1	65.8 °F	Wall: Surface dry at inspection	
Relative Humidity 1	79.7 %	Ceilings: Surface dry at inspection	
		Lab Results: 3,613 w/ Stachy	
		Mold Rating: 3	
		Mold Rating: 1-5 (5 being worst)

**Comment:** Very high humidity readings. Dry dry except moisture drops on window sill.

**Recommendation:** Full removal of paneling, ceiling tiles, carpet, inside window framing, plaster and lathe. Seal walls and insulate as before.

**Remediation Protocol:** Plan " C "

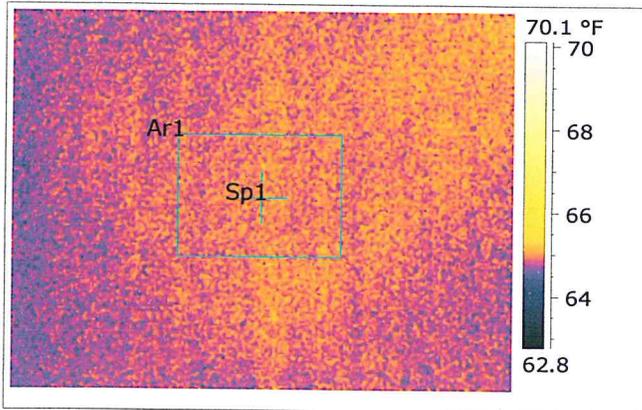
Date	1/10/2014	Location:	Room 225
Image Time	11:24:52 AM	<b>Other remarks:</b>	
Ar1 Max. Temperature	65.5 °F	Floor: Dry	
Ar1 Min. Temperature	64.5 °F		
Ar1 Average Temperature	64.9 °F		
Sp1 Temperature	65.0 °F		
Air Temperature 1	66.4 °F		
Relative Humidity 1	78.6 %

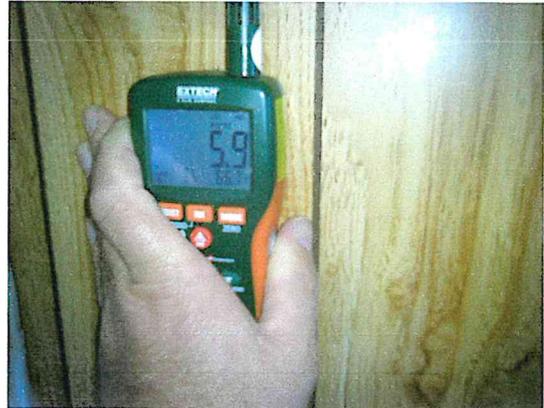
Date	1/10/2014	Location:	Room 225
Image Time	11:25:29 AM	<b>Other remarks:</b>	
Air Temperature 1	66.7 °F	Wall: Surface dry	
Internal Moisture 1	5.9 %

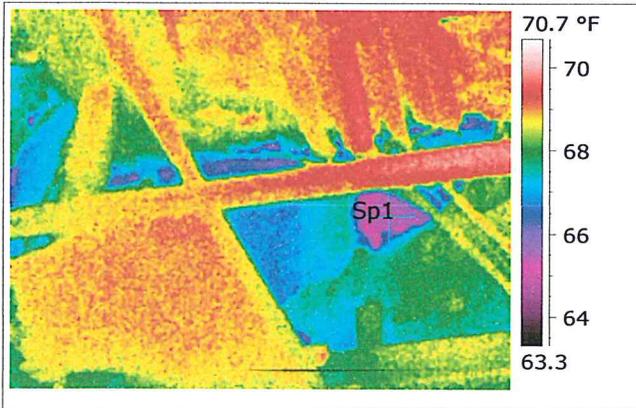
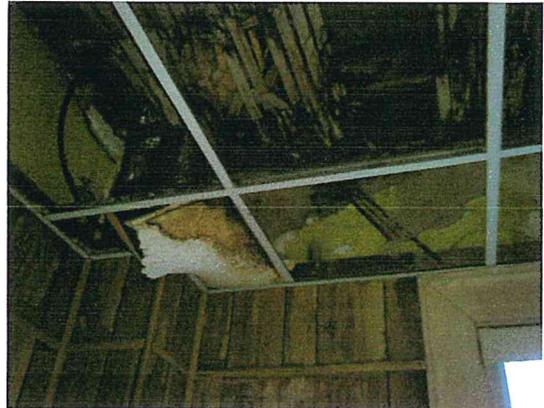
Date	1/2/2014	Location:	Old Building-Room 226
Image Time	10:18:24 AM	<b>Other remarks: Tested insulation here for asbestos. Paint sample also taken here</b>	
Sp1 Temperature	65.6 °F	Wall: Dry at inspection Ceilings: Dry at inspection Lab Results: <b>13,587</b> Mold Rating: <b>5</b>	
		Mold Rating: 1-5 (5 being worst)

**Comment: This room also had previous issues with the northeast drain. It appears to be fixed at this time.**

**Recommendation: Full removal of carpet, paneling, ceiling tiles, plaster & lathe and window trim required. Seal and insulate like beofre**

**Remediation Protocol: Plan "C"**

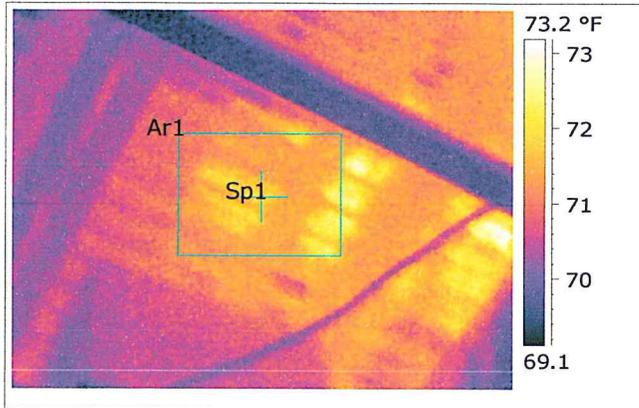
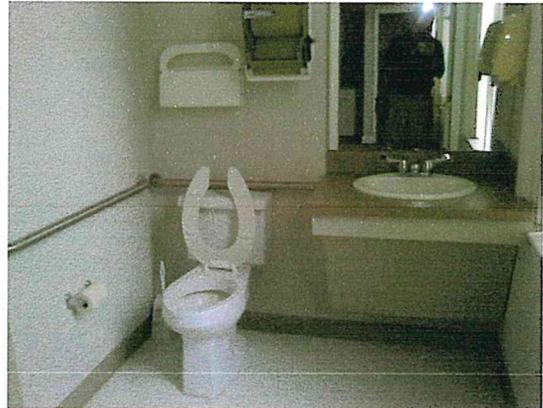
Date	12/30/2013	Location:	<b>Bathrooms of courtroom</b>
Image Time	2:08:32 PM	<b>Other remarks:</b>	
Ar1 Max. Temperature	72.6 °F	Lab Results:	No testing taken
Ar1 Min. Temperature	70.6 °F		
Ar1 Average Temperature	71.5 °F		
Sp1 Temperature	72.0 °F		
Air Temperature 1	70.2 °F		
Relative Humidity 1	53.1 %

**Recommendation: "A" cleaning required**

**Remediation Protocol: Plan " A "**

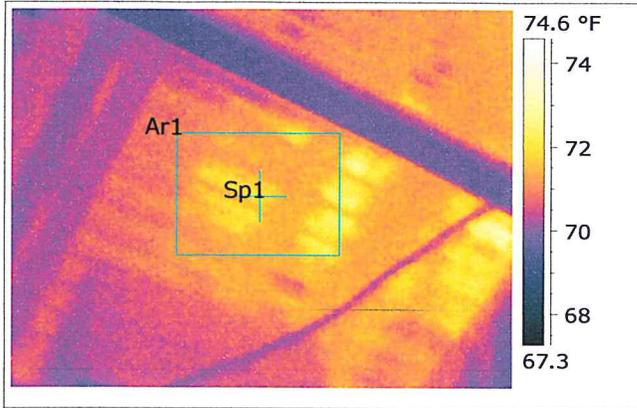
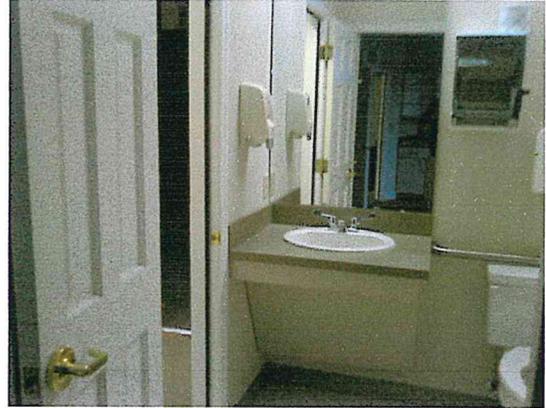
Date	12/30/2013	Location: Bathroom off of courtroom  <b>Other remarks:</b>  Lab Results: No testing taken
Image Time	2:08:32 PM	
Ar1 Max. Temperature	72.6 °F	
Ar1 Min. Temperature	70.6 °F	
Ar1 Average Temperature	71.5 °F	
Sp1 Temperature	72.0 °F	
Air Temperature 1	70.2 °F	
Relative Humidity 1	53.1 %

**Recommendation: "A" cleaning required**

**Remediation Protocol: Plan " A "**

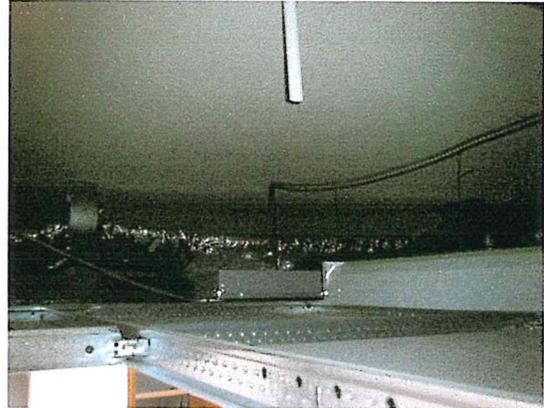
Date	1/2/2014	Location: (Where)  <b>Other remarks:</b>  Ceilings: It appears that the plaster is in good condition under the drop ceiling.
Image Time	9:28:49 AM	
Ar1 Max. Temperature	79.5 °F	
Ar1 Min. Temperature	76.6 °F	
Ar1 Average Temperature	77.9 °F	
Air Temperature 1	73.2 °F	
Relative Humidity 1	62.0 %

**Recommendation: Remove ceiling tiles to evaluate the plaster ceiling. If the plaster is in good condition fog and seal the old plaster.**

**Remediation Protocol: Plan " A "**

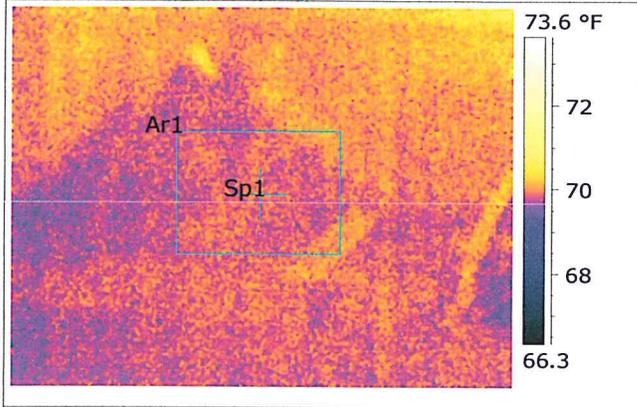
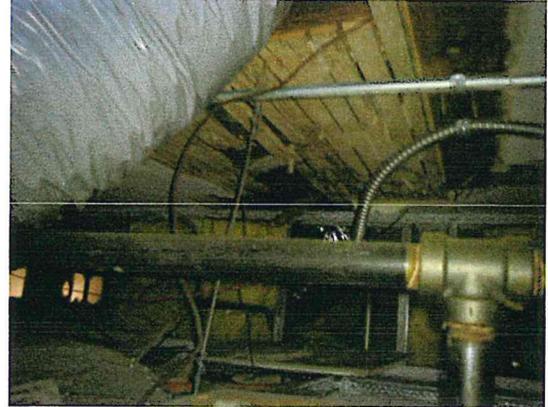
Date	1/2/2014	Location: (Judges Room)  <b>Other remarks:</b>  Ceilings: Remove all lathe
Image Time	10:00:29 AM	
Ar1 Max. Temperature	70.4 °F	
Ar1 Min. Temperature	69.3 °F	
Ar1 Average Temperature	69.9 °F	
Sp1 Temperature	70.0 °F	
Air Temperature 1	71.6 °F	
Relative Humidity 1	65.4 %

**Comment: All lathe and plaster needs to be removed.**

**Recommendation: Seal and use spray foam insulation on deck and outer wall**

**Remediation Protocol: Plan " C "**

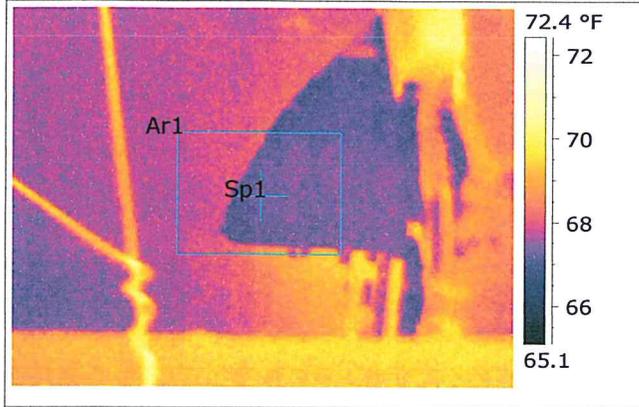
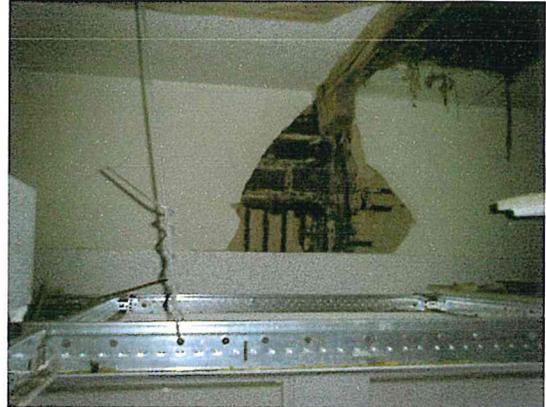
Date	1/2/2014	Location: Judges Room  <b>Other remarks:</b>
Image Time	10:01:21 AM	
Ar1 Max. Temperature	69.6 °F	
Ar1 Min. Temperature	66.8 °F	
Ar1 Average Temperature	67.6 °F	
Sp1 Temperature	67.4 °F	
Air Temperature 1	71.6 °F	
Relative Humidity 1	65.5 %

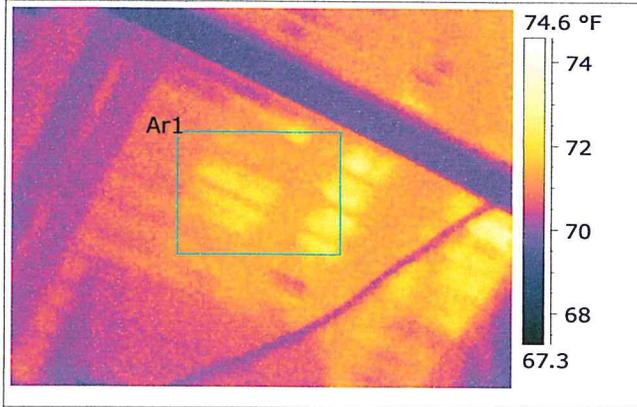
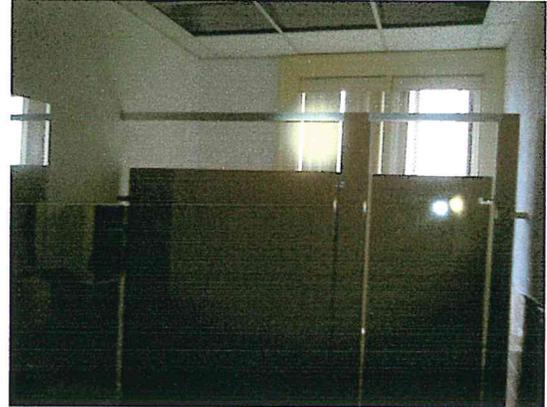
Date	12/30/2013	Location:	Old Building-Northeast Bathroom
Image Time	2:08:32 PM	<b>Other remarks:</b>	
Ar1 Max. Temperature	72.6 °F	Wall: All dry at inspection	
Ar1 Min. Temperature	70.6 °F	Ceilings: All dry at inspection	
Ar1 Average Temperature	71.5 °F	Lab Results: Not required	
Air Temperature 1	70.2 °F		
Relative Humidity 1	53.1 %

**Recommendation: Remove ceiling tiles and remove lathe and plaster from above.**

**Remediation Protocol: Plan "C"**

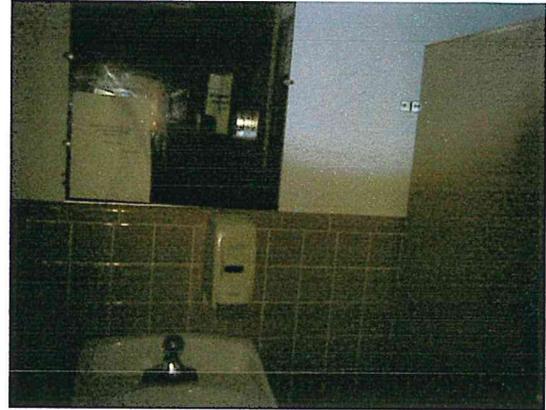
Date	12/30/2013	Location:	Old Building-Northwest Bathroom
Image Time	2:08:32 PM	<b>Other remarks:</b>	
Ar1 Max. Temperature	72.6 °F	Wall:	Dry at time of inspection
Ar1 Min. Temperature	70.6 °F	Ceilings:	Dry at time of inspection
Ar1 Average Temperature	71.5 °F	Lab Results:	Not required
Air Temperature 1	70.2 °F		
Relative Humidity 1	53.1 %

**Recommendation: Remove ceiling tiles and remove plaster and lathe from above. Seal and insulate**

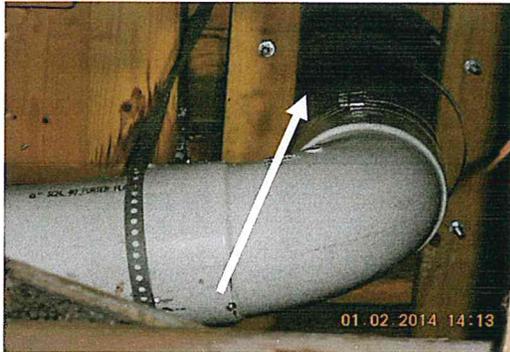
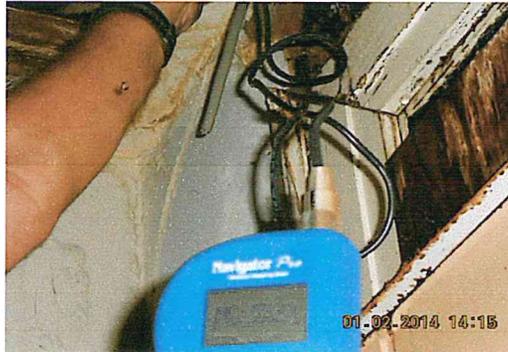
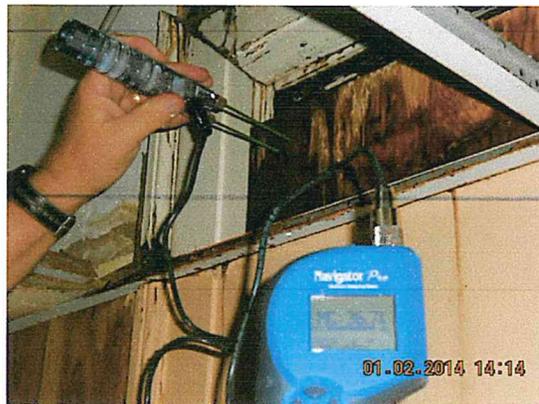
**Old Building -2<sup>nd</sup> Floor- Room 219**

Leak appears to be between drain cover and TPO material

Leak evident at white arrow. Meter confirms wet condition.

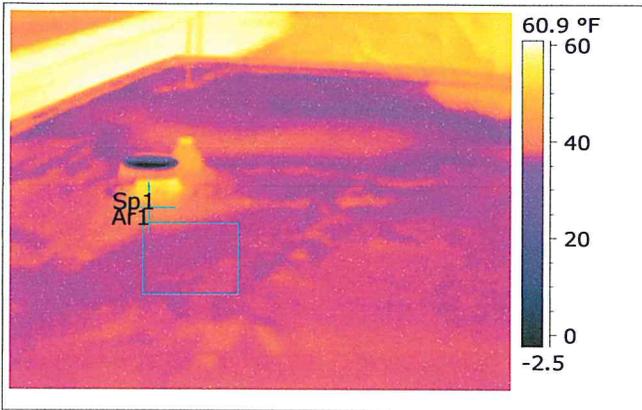
Location: New Building roof

Date	12/30/2013
Image Time	5:59:47 PM
Ar1 Max. Temperature	38.7 °F
Ar1 Min. Temperature	35.8 °F
Ar1 Average Temperature	36.8 °F
Sp1 Temperature	42.6 °F

**Other remarks: The purple areas are surface water puddles. The temperatures are an average of 36.8 degrees in these areas. The spot (sp1) temperature is in a dry area which is 42.6 degrees.**

**Conclusion: Just surface water**

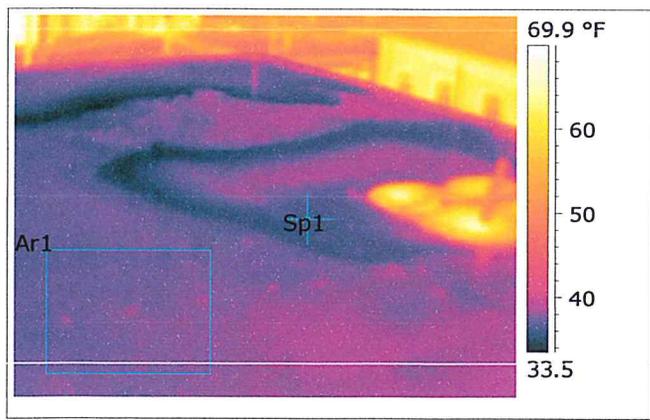
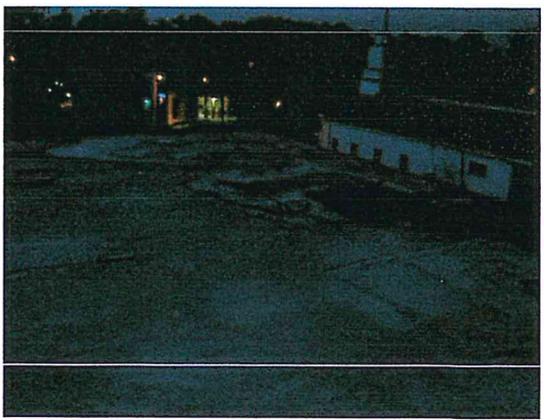
**Other remarks: The water is deeper  
therefore cooler at 37.6 and 36 degrees**

**Conclusion: Just surface water**

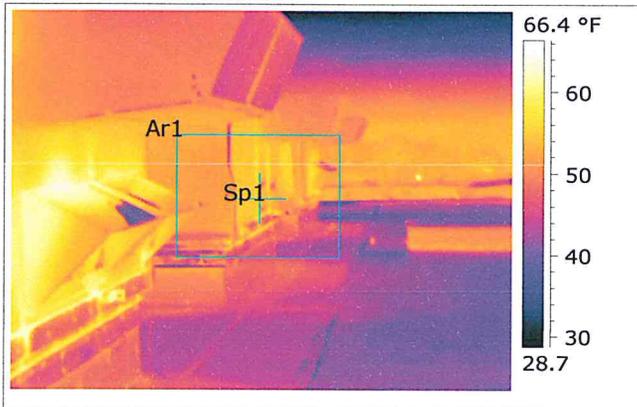
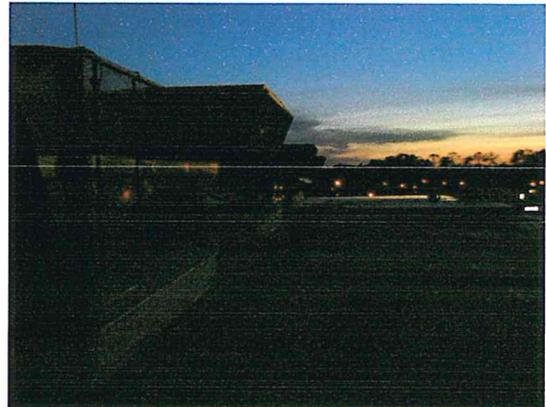
Date	12/30/2013
Image Time	6:00:53 PM
Ar1 Max. Temperature	59.7 °F
Ar1 Min. Temperature	37.5 °F
Ar1 Average Temperature	50.9 °F
Sp1 Temperature	53.3 °F

No issues noted. Area was visually dry

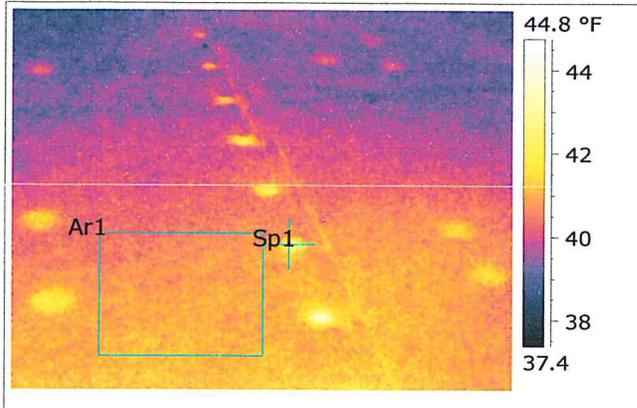
Date	12/30/2013	Location: New building
Image Time	6:01:59 PM	
Ar1 Max. Temperature	41.7 °F	<b>Other remarks:</b> No issues noted. Area was visually dry. Round orange spots are patches. They hold heat under them therefore show at 43.1 degrees
Ar1 Min. Temperature	39.8 °F	
Ar1 Average Temperature	40.9 °F	
Sp1 Temperature	43.1 °F

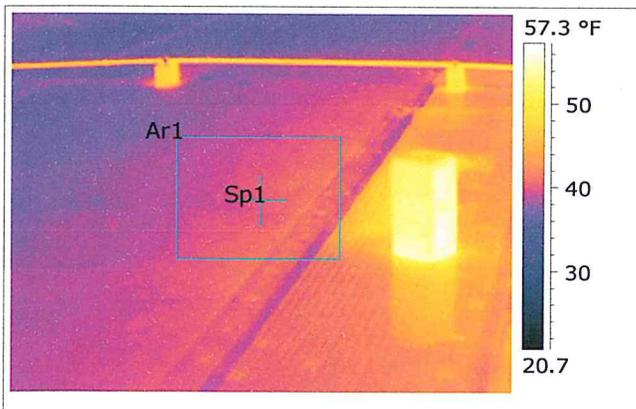
No issues noted

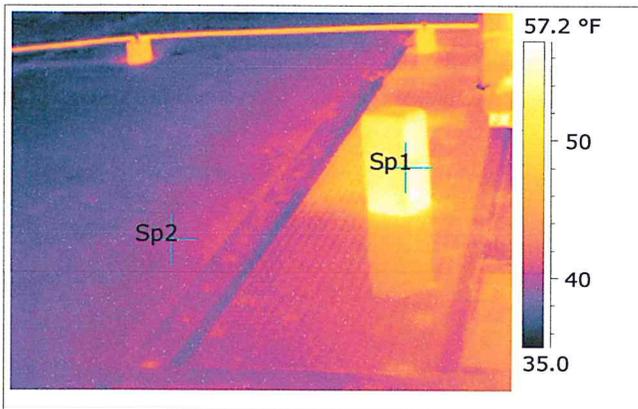
Location: New building

Date	12/30/2013
Image Time	6:04:11 PM
Sp1 Temperature	54.0 °F
Sp2 Temperature	39.9 °F

No issues noted

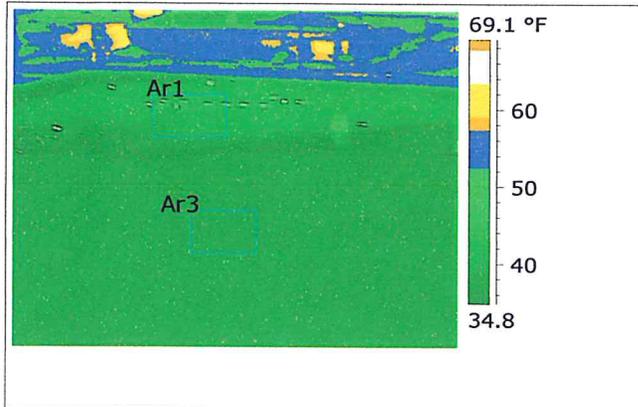
Date	12/30/2013	Location: (Where)  <b>Other remarks: Palette changed to see any differential. None observed</b>
Image Time	6:05:44 PM	
Ar1 Max. Temperature	43.7 °F	
Ar3 Max. Temperature	38.8 °F	
Ar1 Min. Temperature	37.9 °F	
Ar3 Min. Temperature	37.1 °F	
Ar1 Average Temperature	41.3 °F	
Ar3 Average Temperature	37.7 °F

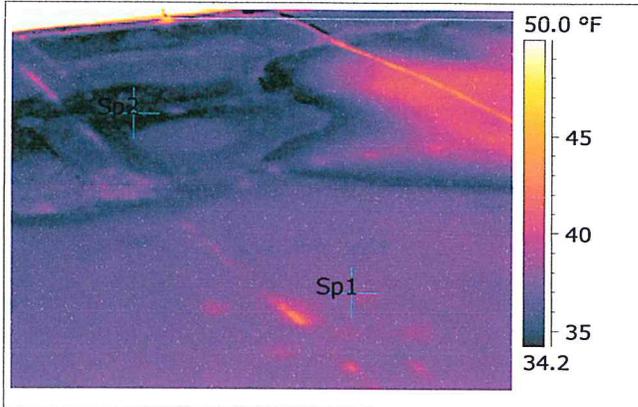
Date	12/30/2013	Location:	New Building
Image Time	6:06:50 PM	<b>Other remarks:</b>	
Sp1 Temperature	38.3 °F	<b>Other remarks: The water is deeper therefore cooler at 38.3 and 34.4 degrees</b>	
Sp2 Temperature	34.4 °F	<b>Conclusion: Just surface water</b>

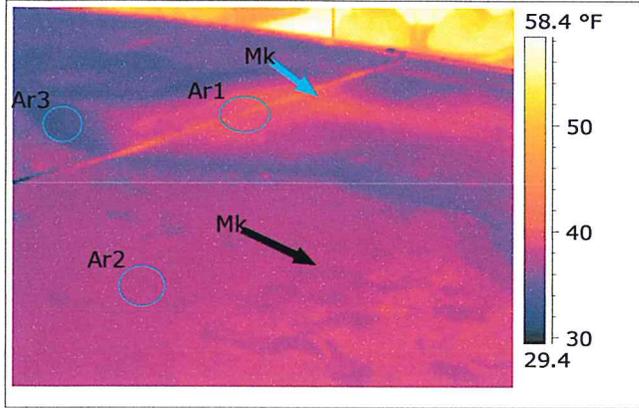
Location: New Building West side

Date	12/30/2013
Image Time	6:08:26 PM
Ar1 Max. Temperature	41.4 °F
Ar2 Max. Temperature	38.2 °F
Ar3 Max. Temperature	35.1 °F
Ar1 Min. Temperature	38.3 °F
Ar2 Min. Temperature	37.2 °F
Ar3 Min. Temperature	32.7 °F
Ar1 Average Temperature	39.3 °F
Ar2 Average Temperature	37.6 °F
Ar3 Average Temperature	33.6 °F

**Other remarks: The spot area at AR1 average may be an issue. AR 3 which is surface water is averaging at 33.6 degrees which is consistent with the other wet areas. The area at AR 2 which is dry is consistent at 37.6 degrees. The area at AR1 however which is at a seam is showing a delta T of 1.7 degrees over the other dry area and a delta T of 5.6 degrees. The area noted by the blue arrow should be check by a professional roofer. The black arrow shows my foot prints.**

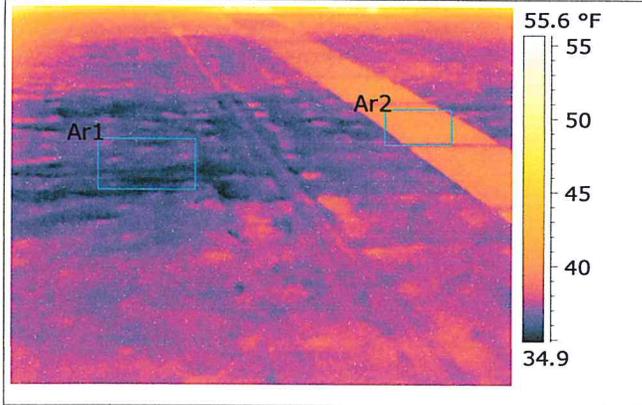
Date	12/30/2013	Location: Old Building roof  <b>Other remarks: The rectangle in AR1 is show surface moisture. The AR2 is showing the surface path way.</b>  <b>No issues noted.</b>
Image Time	6:10:18 PM	
Ar1 Max. Temperature	37.9 °F	
Ar2 Max. Temperature	40.7 °F	
Ar1 Min. Temperature	34.9 °F	
Ar2 Min. Temperature	36.4 °F	
Ar1 Average Temperature	36.1 °F	
Ar2 Average Temperature	39.7 °F

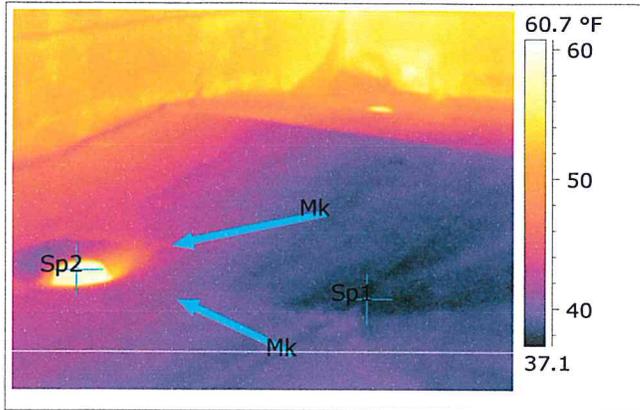
Date	12/30/2013	Location: Old Building Northeast corner
Image Time	6:12:38 PM	
Sp1 Temperature	37.7 °F	
Sp2 Temperature	59.4 °F	
		<p><b>Other remarks:</b> The picture shows the drain pocket in the corner. The blue arrows show the drainage of the water. Sp2 is surface water. Sp1 is showing the heat from the pipe and the cover of the drain. No issues noted.</p>

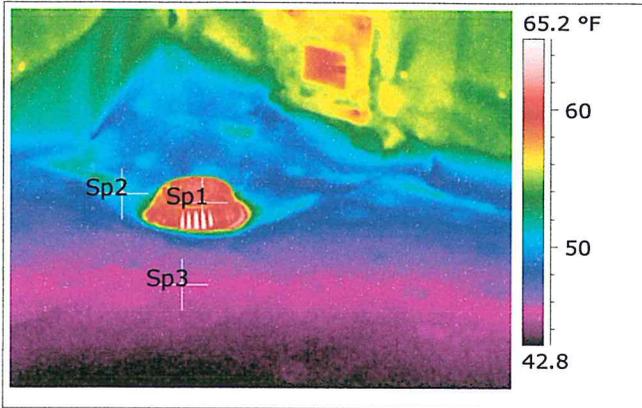
Date	12/30/2013	Location: Old Building-Northwest corner  <b>Other remarks:</b> This drain pocket shows good slope. The palette has been changed to rainbow to show the temperature differences. The colder the sp is noted in the lighter blue colors.  No issues here.
Image Time	6:13:15 PM	
Sp1 Temperature	59.8 °F	
Sp2 Temperature	50.5 °F	
Sp3 Temperature	45.2 °F

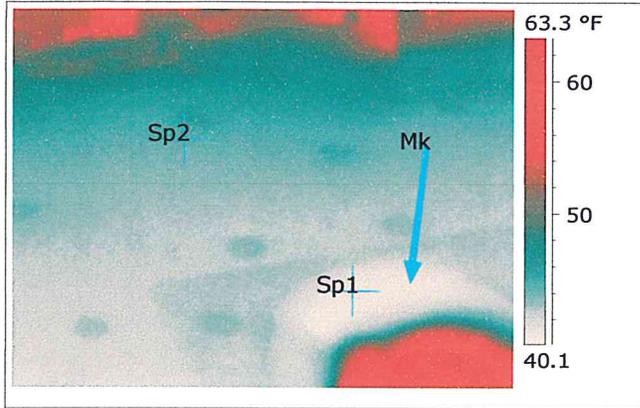
Date	12/30/2013	Location:	Middle drain shown before
Image Time	6:17:53 PM	<b>Other remarks: Anomaly is seen again with a different palette.</b>	
Sp1 Temperature	40.8 °F		
Sp2 Temperature	44.4 °F

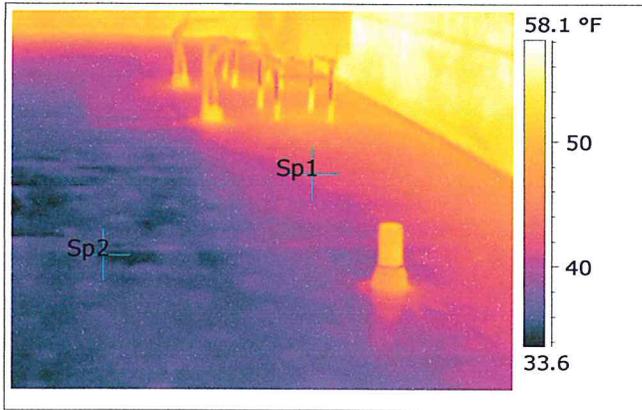
Date	12/30/2013	Location: Old Roof by air handlers on west side
Image Time	6:18:32 PM	
Sp1 Temperature	41.3 °F	
Sp2 Temperature	34.8 °F	
		<b>Other remarks:</b>
		No issues noted. Sp2 are wet puddles

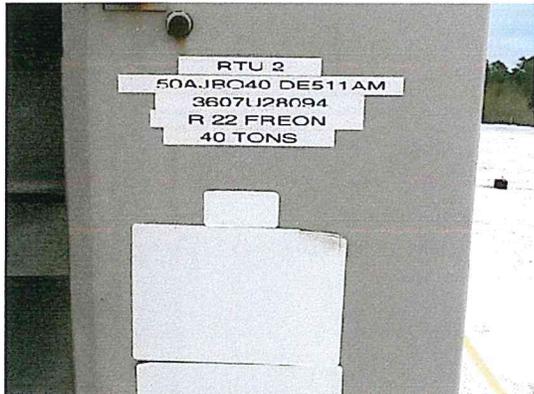
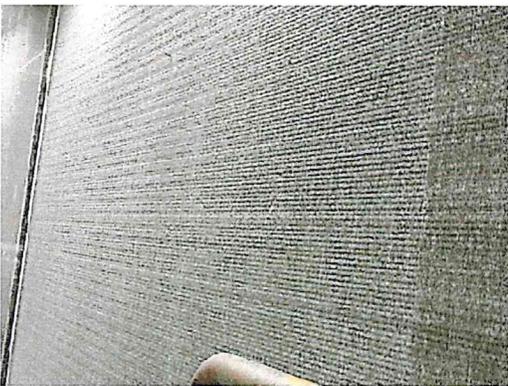
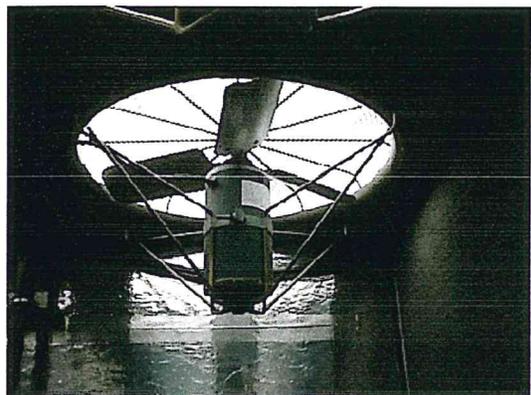
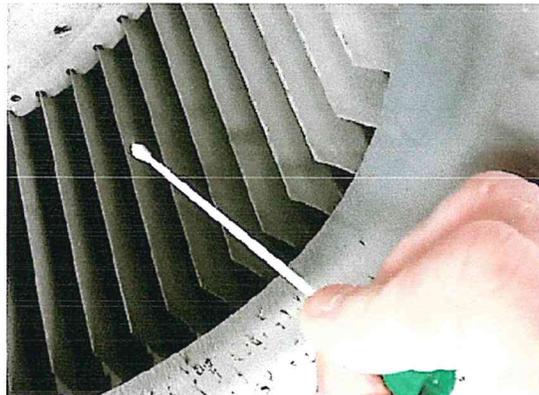
**RTU-2**

Observations: Filter & Coil and blower wheel needs cleaning. Fan in good condition.

Lab Results: Blower wheel Tested: Total Spores 436,832 cm/2. This level is un-acceptable based on location. This unit needs to be thoroughly cleaned and fogged with microbial cleaner.

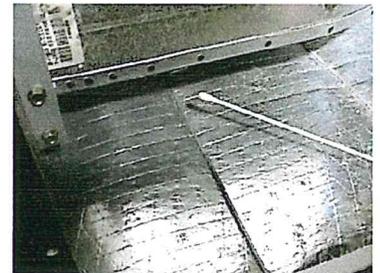
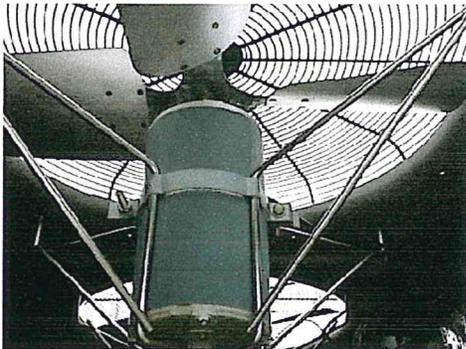
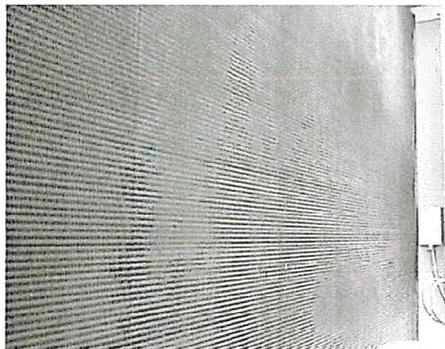
**RTU 3**

Observations: Filter & Coil needs cleaning. Overall blower and fan in good condition.

Lab Results: Blower wheel tested: Total Spores 5,082 cm/2. This level is marginal based on location. This unit needs to be thoroughly cleaned and fogged with microbial cleaner.

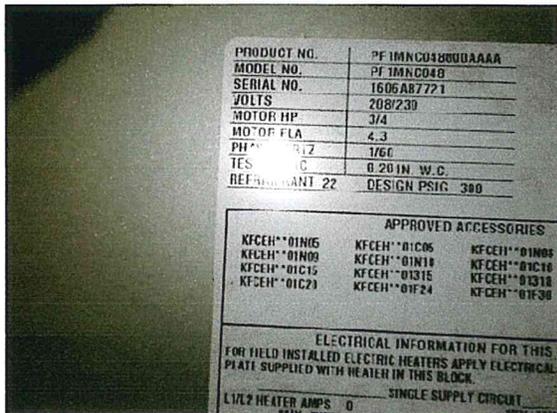
**Old Bldg. East Room 111C:**

Observations: Filter needs cleaning. Overall blower in good condition.

Lab Results: Cabin tested: Total Spores 497 cm/2. This level is acceptable based on location.

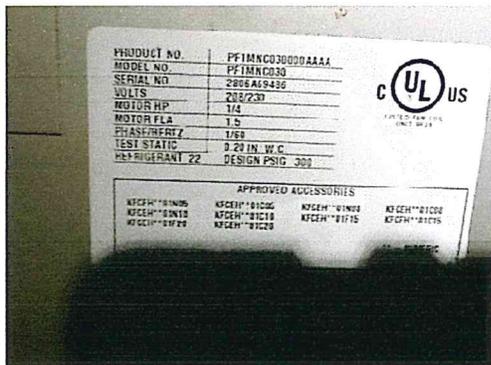
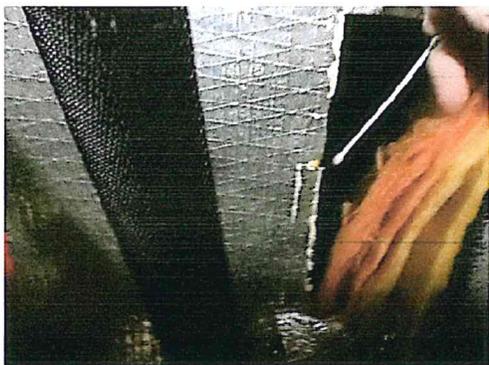
**Attic Unit 1 East:**

Lab Results: Discharge Duct tested: Total Spores 10,683 cm/2. This level is marginal based on location. This unit needs to be thoroughly cleaned and fogged with microbial cleaner.

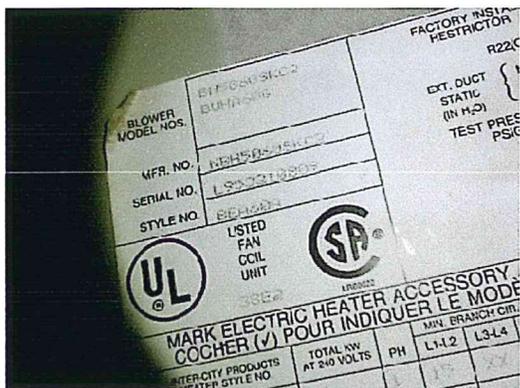
**1<sup>st</sup> Floor Old Building-Unit D**

Lab Results: Discharge duct tested: Total Spores 10,186 cm/2. This level is marginal based on location. This unit needs to be thoroughly cleaned and fogged with microbial cleaner

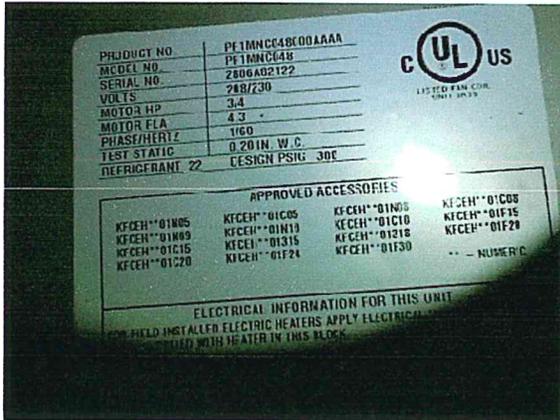
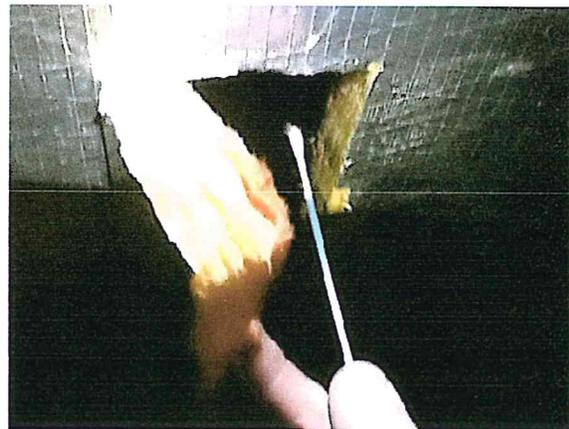
**1<sup>st</sup> floor Old Building-Unit A**

Lab Results: Discharge duct tested: Total Spores 10,549 cm/2. This level is marginal based on location. This unit needs to be thoroughly cleaned and fogged with microbial cleaner.

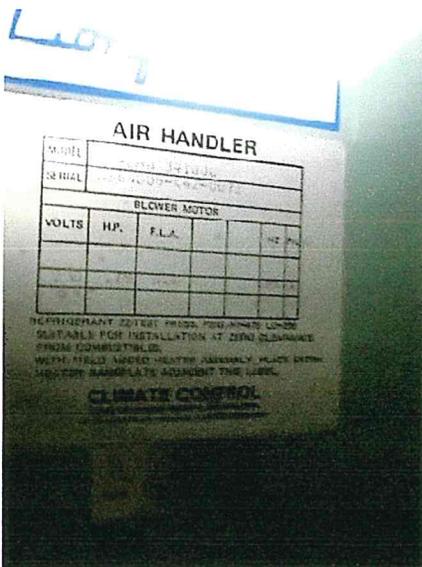
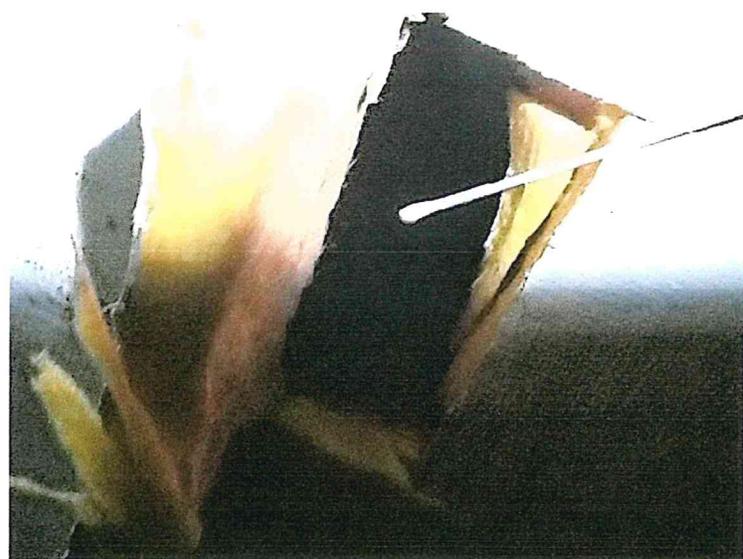
**1<sup>st</sup>, Floor Old Building-Unit 3**

Lab Results: Total Spores 51,205 cm/2. This level is un-acceptable based on location. This unit needs to be thoroughly cleaned and fogged with microbial cleaner.

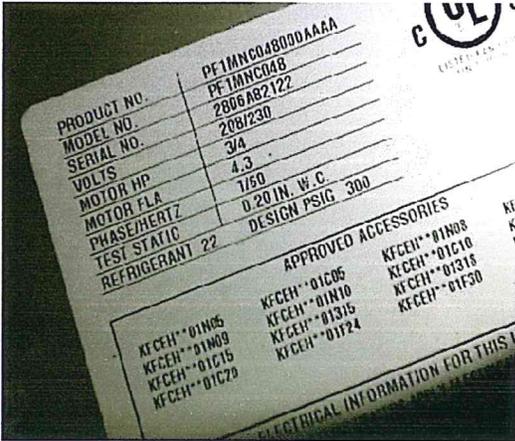
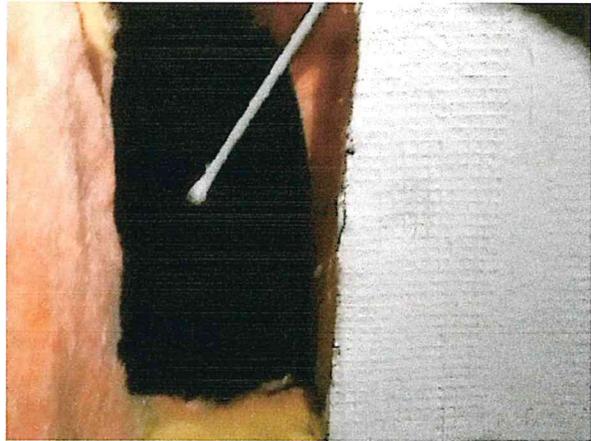
**Old Building- North Unit 7**

Lab Results: Total Spores 42,708 cm/2. This level is un-acceptable based on location. This unit needs to be thoroughly cleaned and fogged with microbial cleaner.

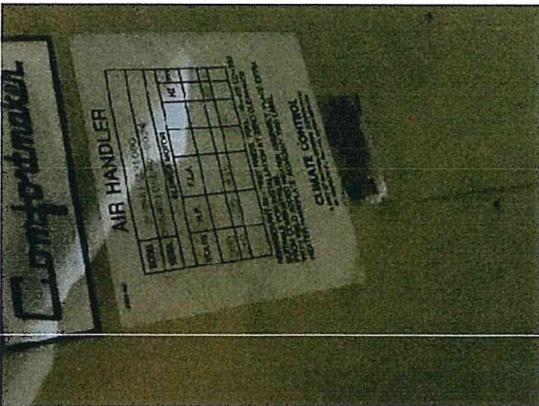
**Old Building North-Unit 6**

Lab Results: Total Spores 819,130 cm/2. This level is un-acceptable based on location. This unit needs to be thoroughly cleaned and fogged with microbial cleaner.

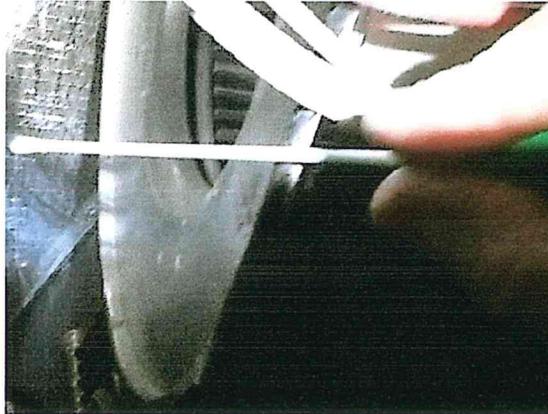
Lab Results: Blower wheel tested: Total Spores 119,354 cm/2. This level is unacceptable based on location. This unit needs to be thoroughly cleaned and fogged with microbial cleaner.
