Mold Assessment-Protocol Report

For Bunnell Courthouse  
200 East Moody Blvd.  
Bunnell FL.

Date: January 12, 2014

Job #: 13-235-2

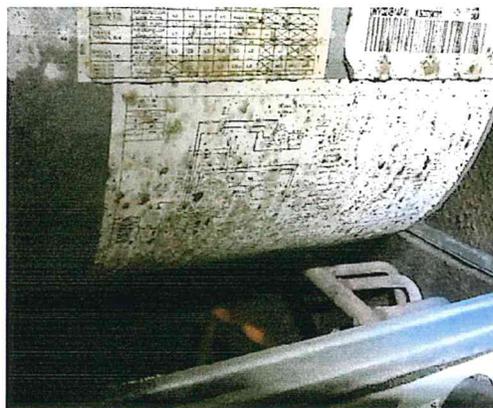
Lab Results: Blower wheel tested: Total Spores 2.932 cm/2. This level is marginal based on location. This unit needs to be thoroughly cleaned and fogged with microbial cleaner.

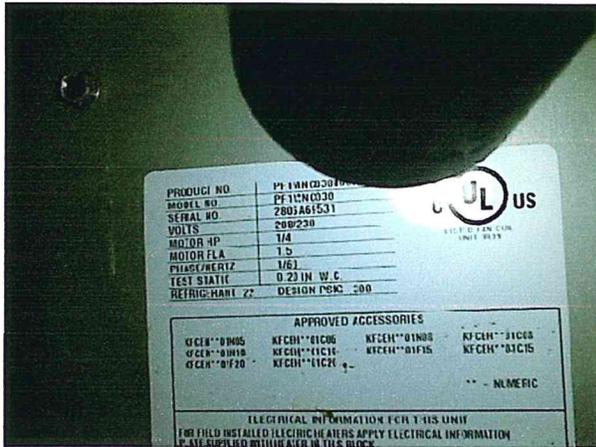
1<sup>st</sup> floor Old Building –Unit C

Observations: Discharge duct test with tape lift.

Lab Results: Total Spores 1,371 cm/2. This level is acceptable based on location

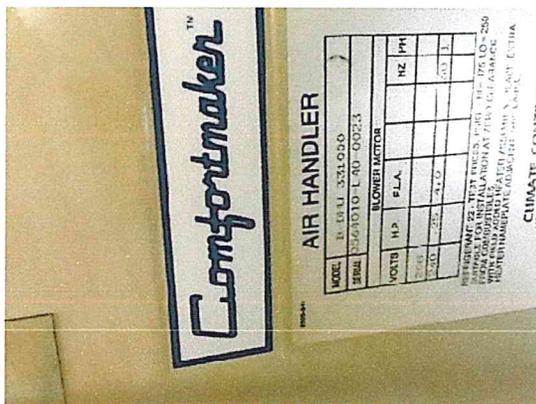
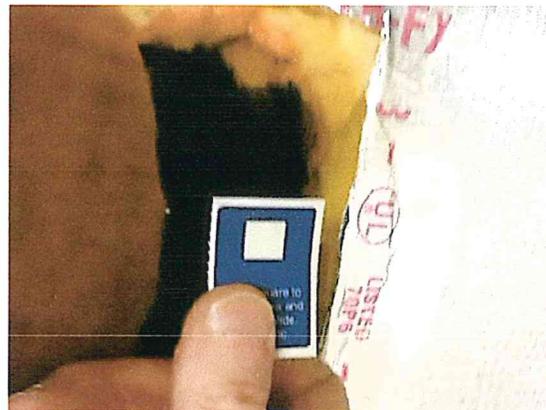
1<sup>st</sup> Floor- Old Bldg.- Unit A

Observations: Discharge duct test with tape lift.

Lab Results: Total Spores 10,549 cm/2. . This level is unacceptable based on location. This unit needs to be thoroughly cleaned and fogged with microbial cleaner.
