Structural Assessment of the Flagler County Historic Courthouse

County Project No. FC-07-007

20 February 2009

**FLAGLER COUNTY HISTORIC COURTHOUSE
ASSESSMENT of EXISTING STRUCTURE**

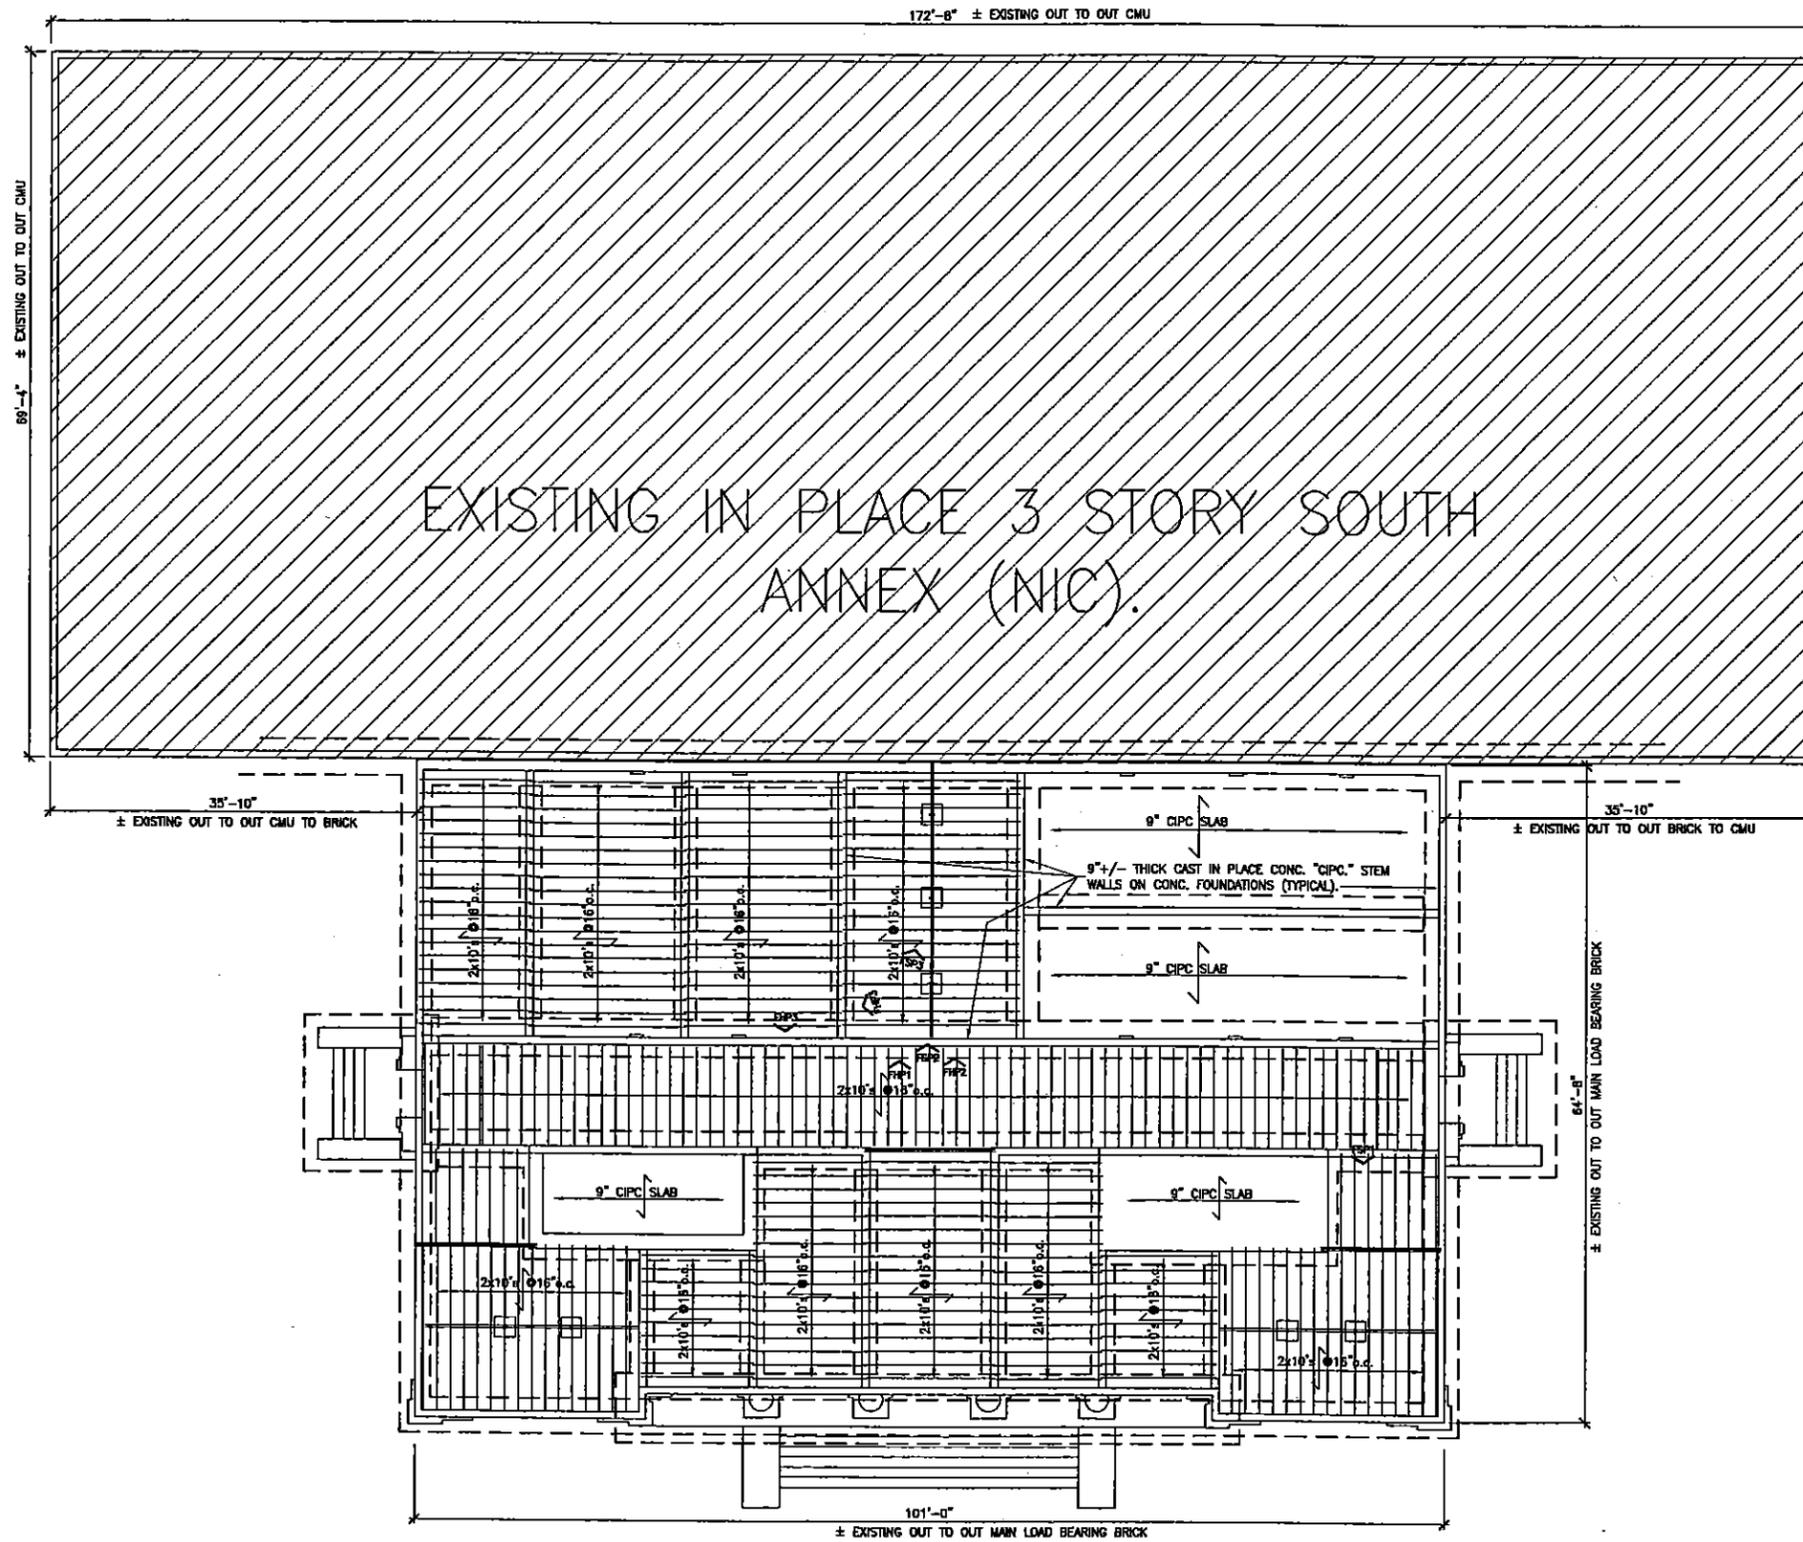
structural existing foundation and 1st. floor framing plan

From BEC's observations of the foundation and stem wall system, we rate its existing condition an "8". We observed (3) headers in stem walls with bearing cracks that, in our opinion, are probably due to previous differential settlement and have been in this condition for some time. It is our opinion that the differential settlement that has occurred in the past has settled out and unless an event such as water erosion from a severe roof or pipe leak were to occur, future cracking and settlement should be minimal and structurally negligible. BEC did not observe structural member conditions that would indicate a deficiency that would cause an imminent structural failure due to gravity loads.

From BEC's observations of the first floor framing, we rate its existing condition a "9". We observed only superficial very minimal marks from old termite activity on only a couple of framing members that in our opinion are structurally negligible. We observed 5 or 6 shoring piers that were probably inserted long ago to reduce deflection (spring, bounce or vibration) of the 1st. floor framing in some areas, although not as proper as the original construction, these shoring piers apparently are performing adequately. BEC did not observe structural member conditions that would indicate a deficiency that would cause an imminent structural failure due to gravity loads. The maximum floor loading in the first floors should not exceed 125psf. in the vaults and 50psf. for all other rooms.
