LEAD-BASED PAINT SURVEY

OLD FLAGLER COURTHOUSE
201 EAST MOODY BOULEVARD
BUNNELL, FLAGLER COUNTY, FLORIDA

UES Project No. 0940.0900009.0000
UES Report No. 758786

February 2009

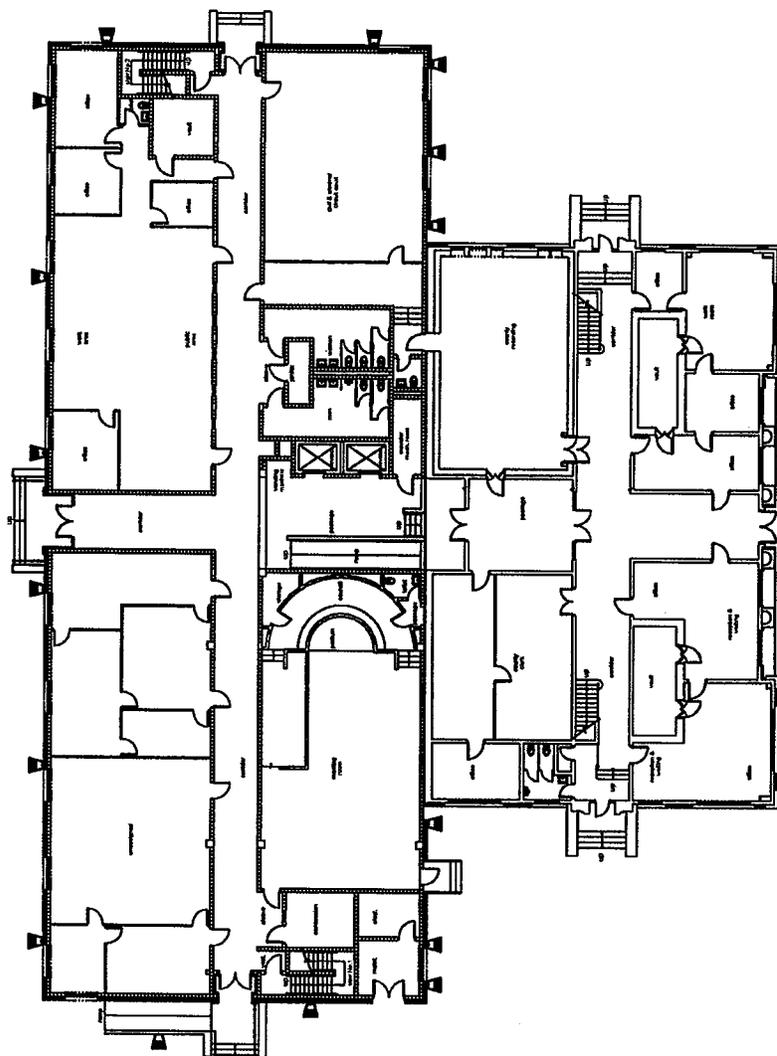
FIRST FLOOR

LEAD-BASED PAINT SURVEY
OLD FLAGLER COURTHOUSE
201 EAST MOODY BOULEVARD
BUNNELL, FLORIDA

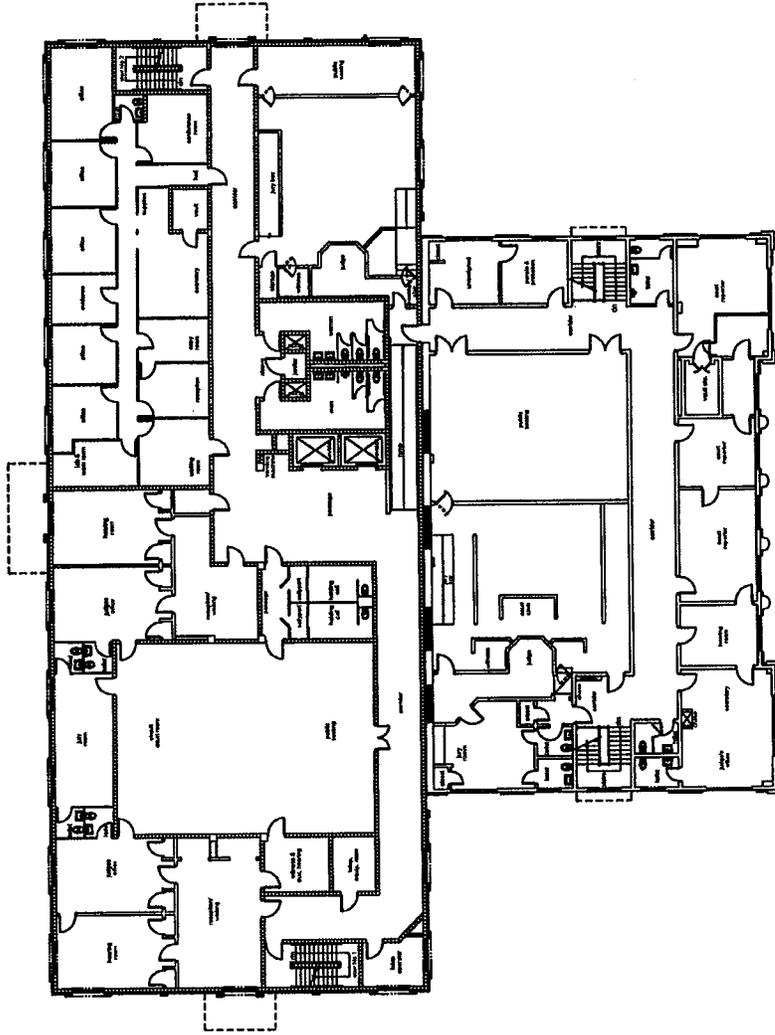
LEAD-BASED PAINT SURVEY
OLD FLAGLER COURTHOUSE
201 EAST MOODY BOULEVARD
BUNNELL, FLORIDA

SECOND FLOOR FIGURE A-3

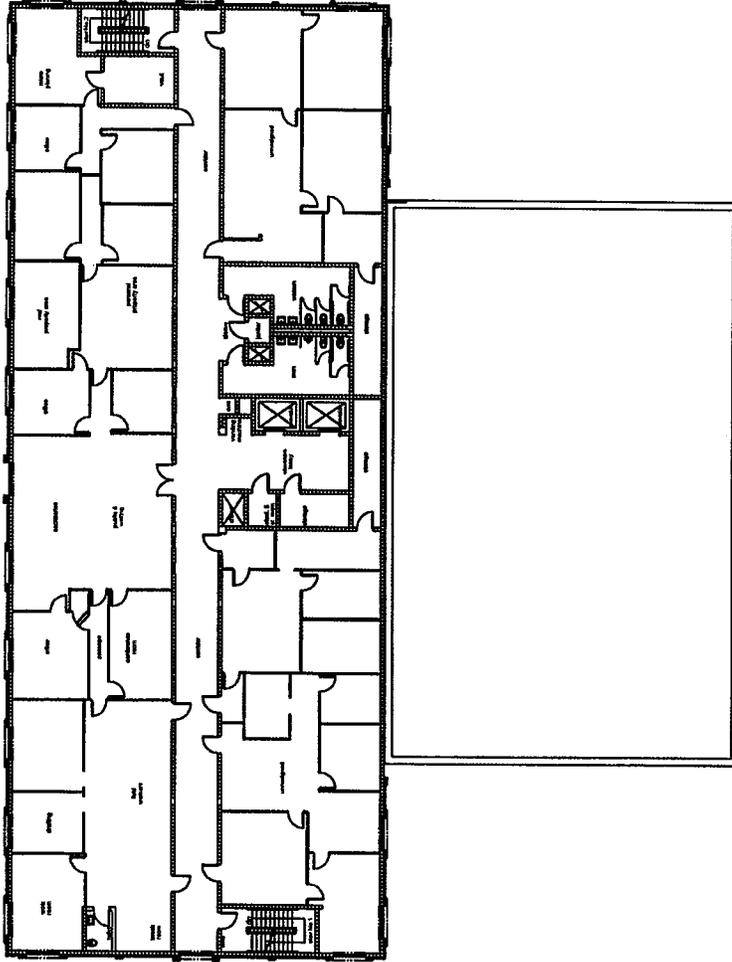
THIRD FLOOR

LEAD-BASED PAINT SURVEY
OLD FLAGLER COURTHOUSE
201 EAST MOODY BOULEVARD
BUNNELL, FLORIDA

THIRD FLOOR..... FIGURE A-4
